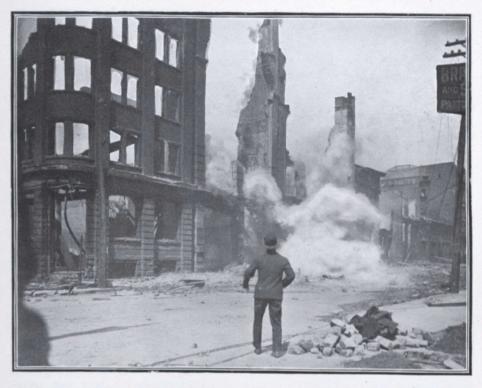
DYNAMITING THE DANGEROUS WALLS AFTER THE FIRE-PHOTO TAKEN AT INSTANT OF THE EXPLOSION
