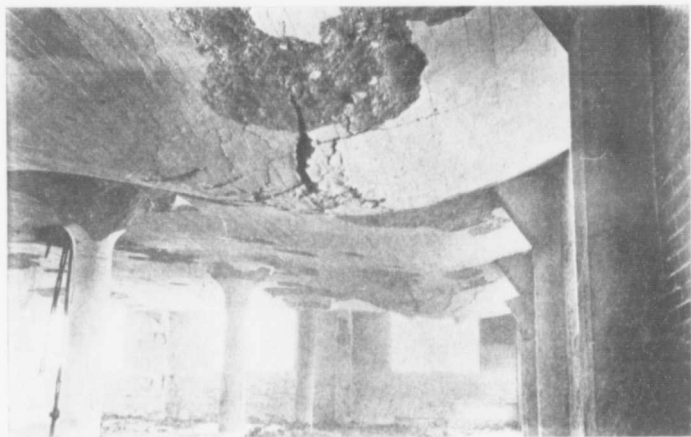
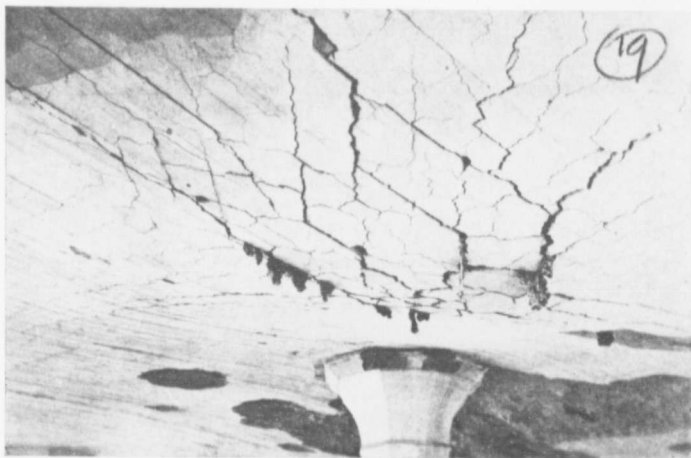
Figs. 14 and 15. Sagging of floors.

loads upon them, it is surprising that the building did not collapse long before it did. The standing portions of the building show that the floors must have failed first and thus caused the collapse of the building. The wall panels in the standing portion sag much more than do the centre panels. This is probably due to the fact that a ten-foot trucking space was reserved down the centre of the building.
