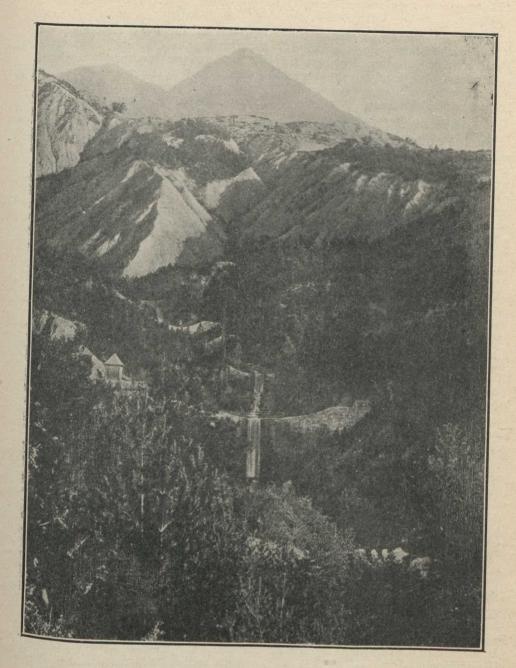
A picture of the same torrent twenty years after. The barrages by preventing the cutting down of the bed of the river have also prevented, the erosion of the banks which are now covered with forest.
