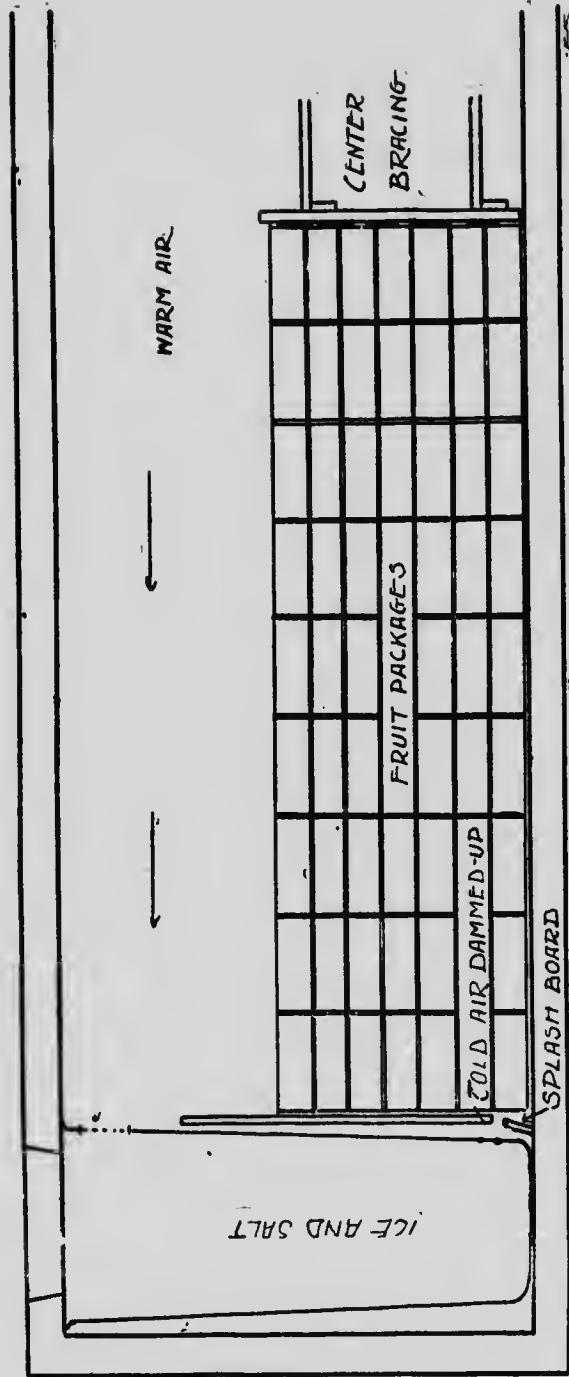
Diagram 1. Showing wrong arrangement of splash board in brine tank cars which prevents free circulation of air.
