THE EARNSCLEUGH No. 1 DREDGE.

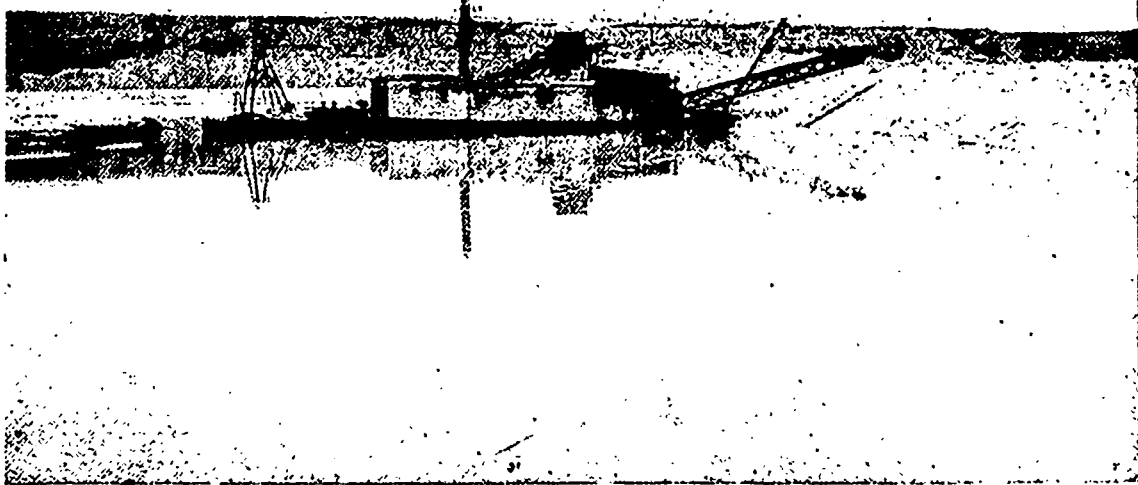
A tailings elevator is here seen at work and the variation between the height of the loosely stacked tailings and the face of the ground being attacked is apparent.

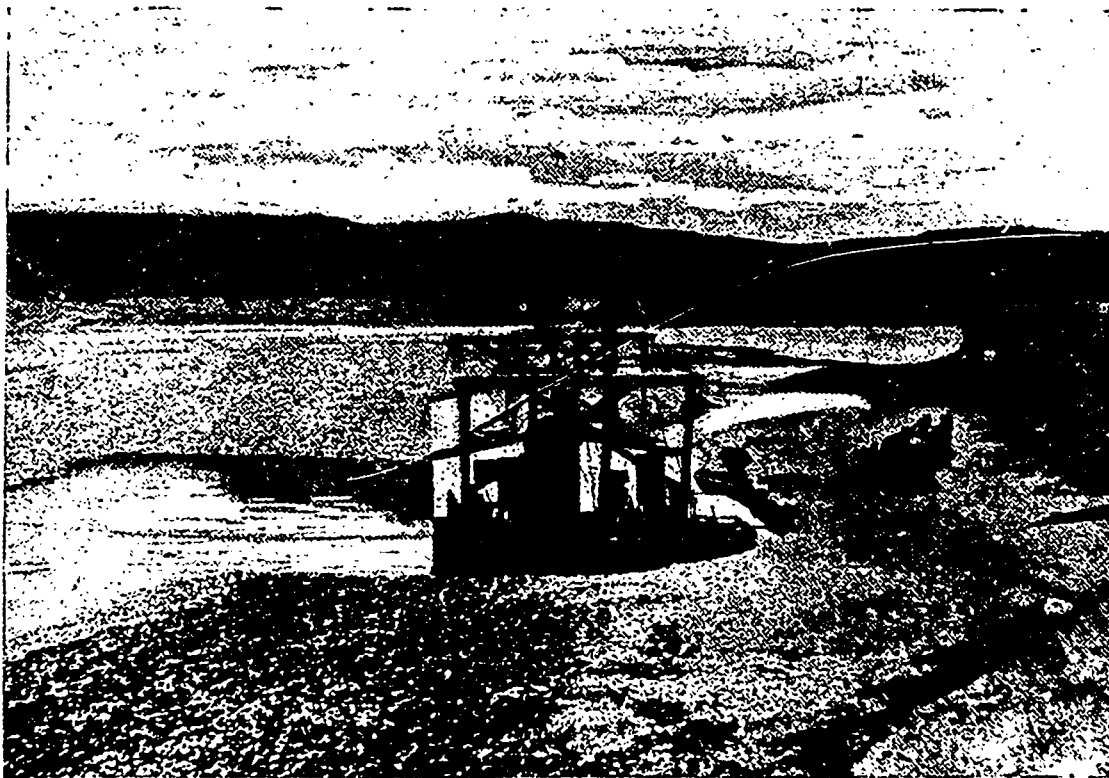
This dredge is represented leaving the Clutha River and commencing to attack a river flat.
