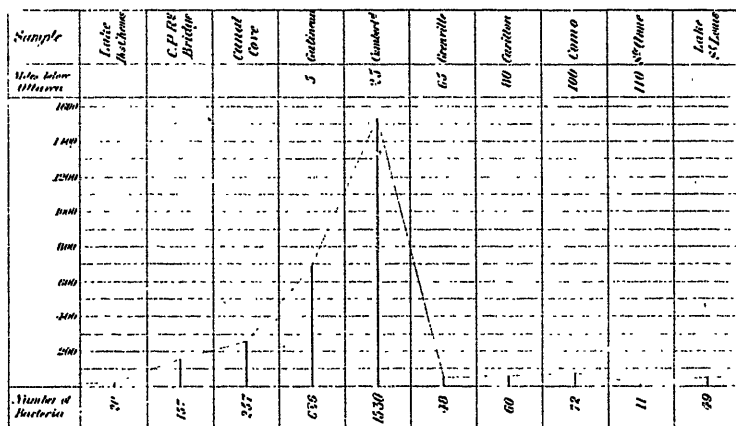
Fig. 7—Diagram showing the condition of Ottawa water above Montreal. (First examination, July 30th, 1891.)

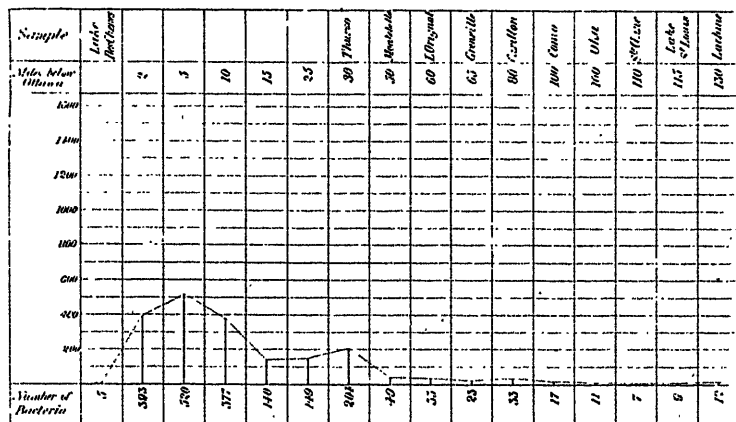
Fig. 8—Diagram showing the condition of Ottawa water above Montreal. (Second examination, Sept. 24th, 1891.)
