Canadian Society of Civil Engineers.

NOTES ON RETAINING WALLS IN MONTREAL.

By H. IRWIN, M.CAN.SOC. C.E.

(To be read Thursday, October 25th, 1894.)

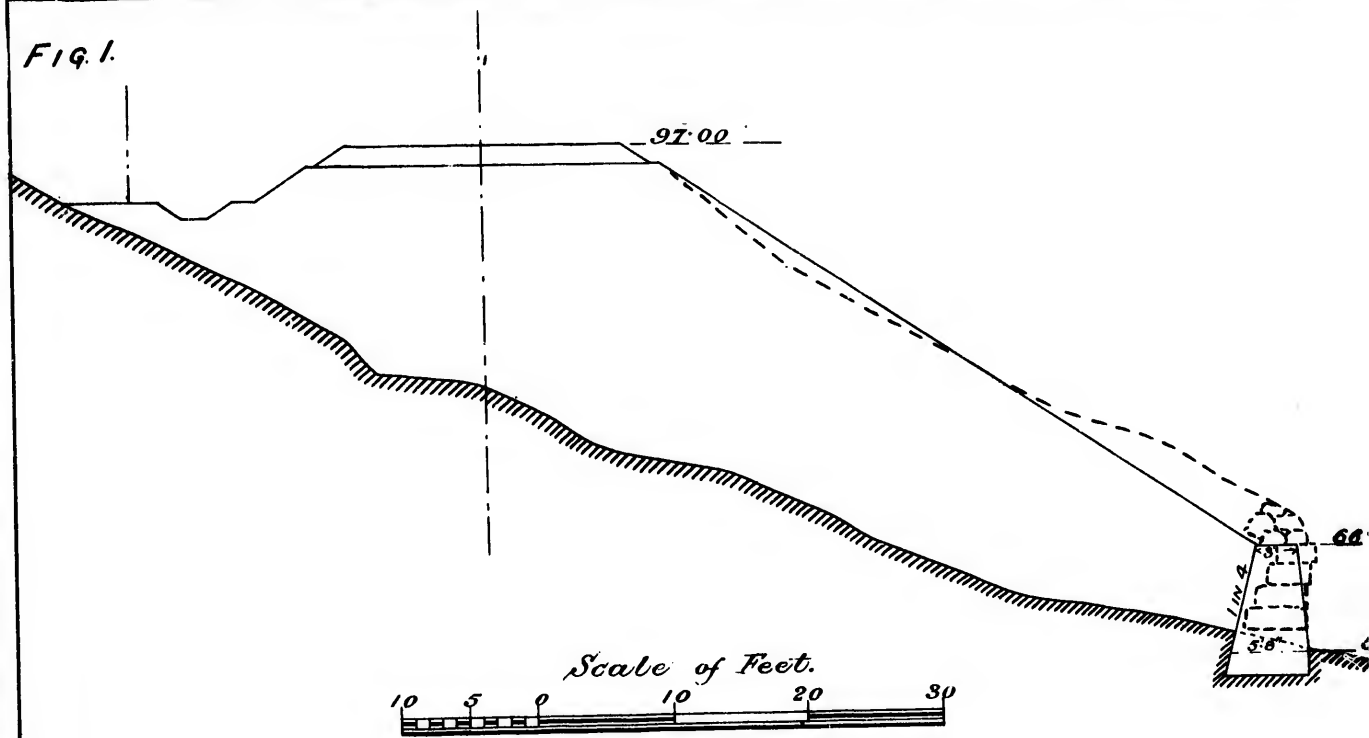
FIG. 1.

The wall shown in section by Fig. 1 is of dry masonry, built of stones from three feet to eight feet in length, by from ten inches to fourteen inches thick, the beds of the stones being fairly flat, but the back of the wall, in some places, seems to be rather poor, the stones being too small; the top front course was built with large, flat stones from five feet to eight feet six inches in length, but the writer has not been able to find out what proportion of through stones were used. The filling behind the wall is principally clay, a small proportion being earth and sandy clay, and was dumped from cars running on a temporary trestle.

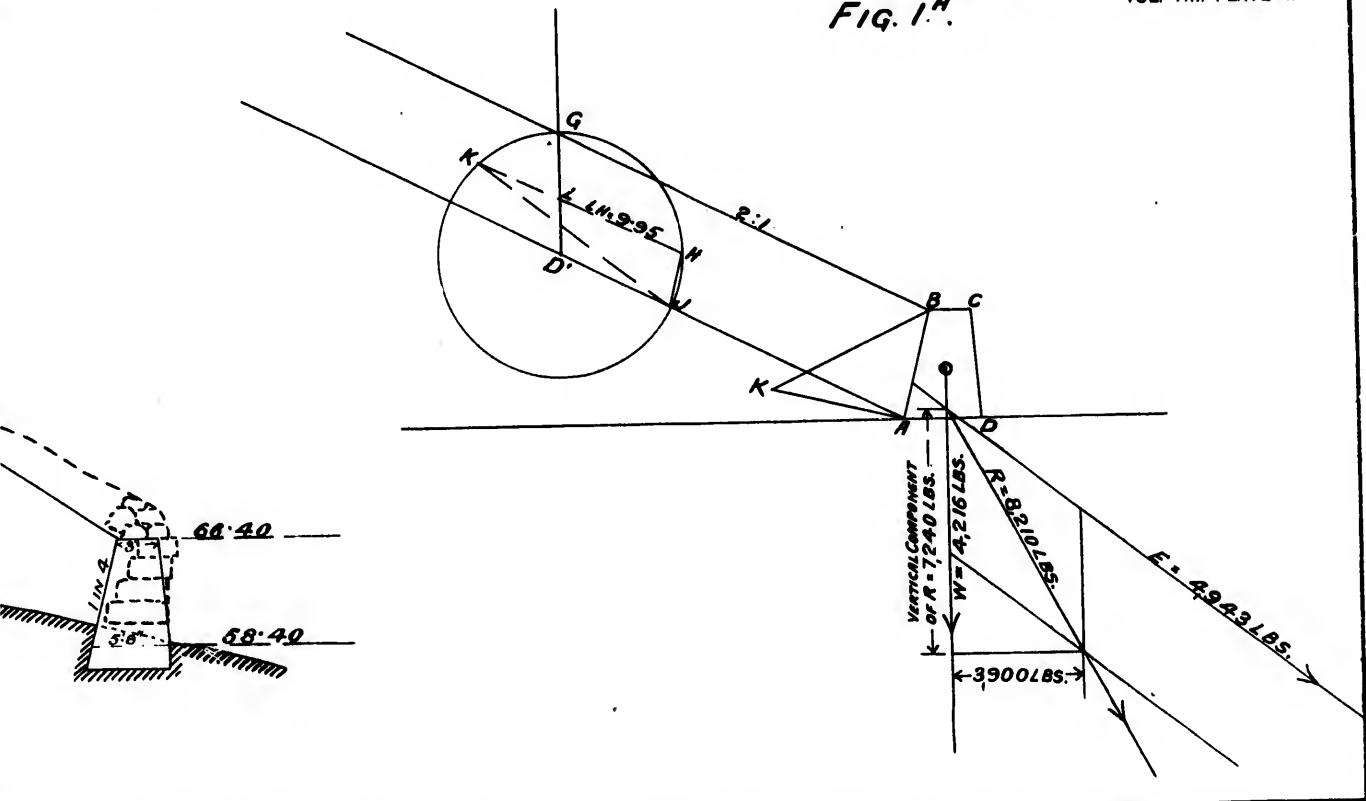
FIG. 1.A.

wall should have been strong enough to resist overturning, but that, at the ground level, the horizontal component of the thrust would be 4,500 lbs., per foot run, while the vertical component of the resultant pressure, divided by 2 to give the frictional resistance to sliding, was 4,790 lbs., without taking the vibration caused by trains into account. Had the wall been built of the dimensions given above as derived from "Trautwine," it would have appeared to be quite strong enough, according to Weyrauch's theory, to resist the extra thrust from vibrations.

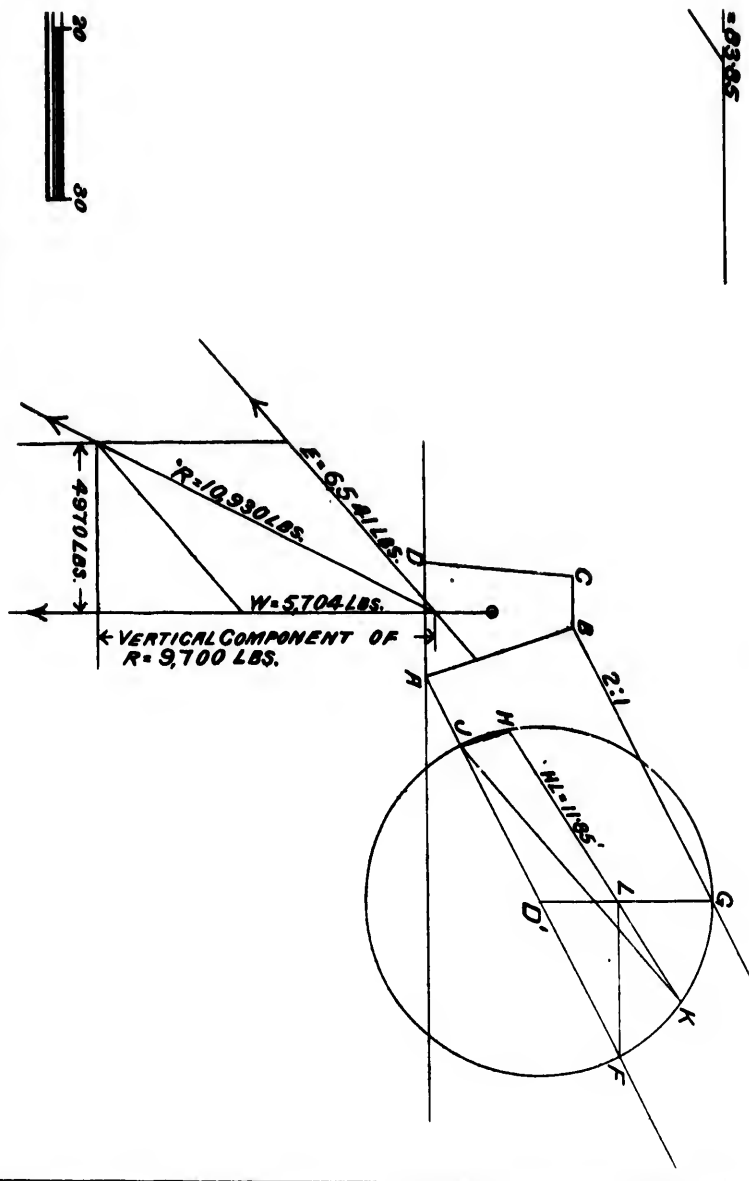
Fig. 3^a

The wall shown in Fig. 3 was also of dry rubble, built of the same class of stones as No. 2, the embankment behind it being of the same nature as that in Case 2.

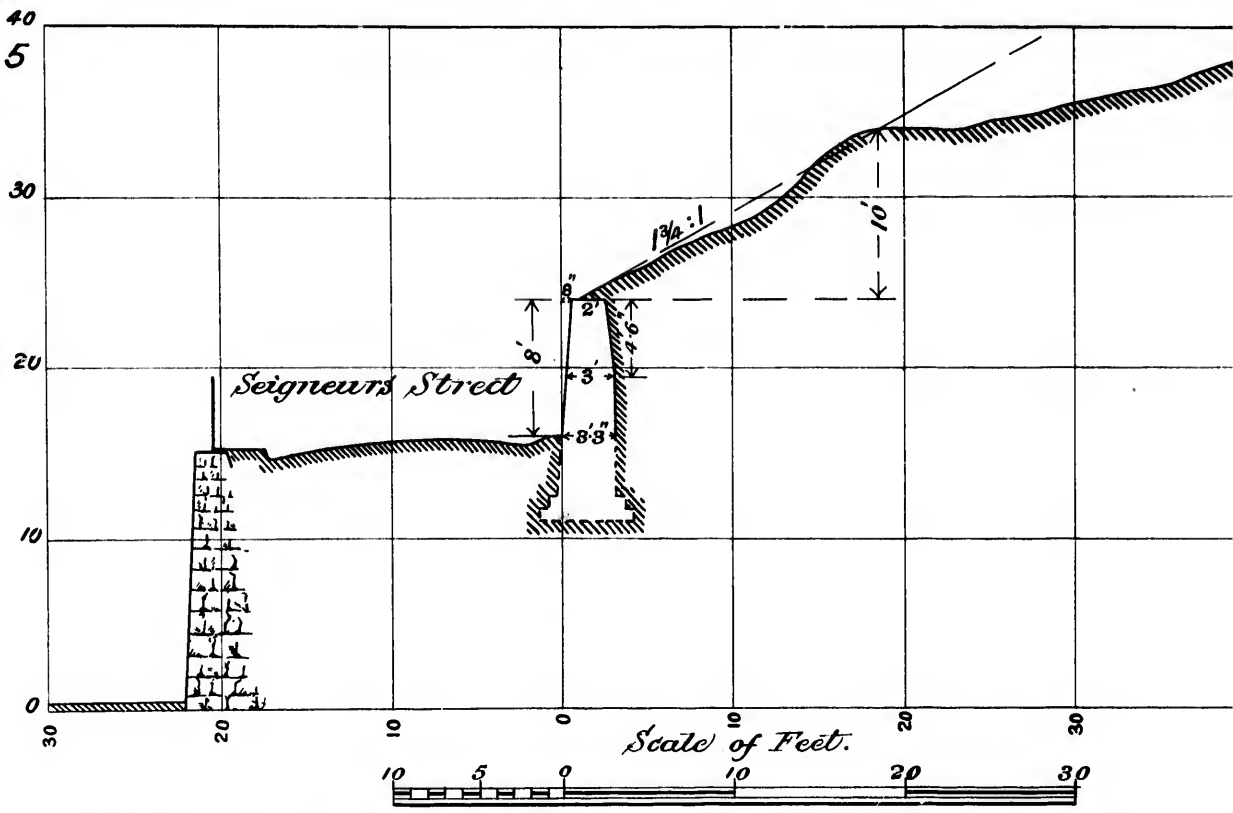
FIG. 5^A.

The Fig. 5A is drawn according to Weyrauch's theory for a surface surcharge sloping back at the same angle as the natural slope and for material standing at a slope of $1\frac{1}{2}$ to 1. The weight of the bank is taken at 110 lbs. per cubic foot and of the wall at 160 lbs.; and the bank is assumed to come within a foot of the front of the wall.

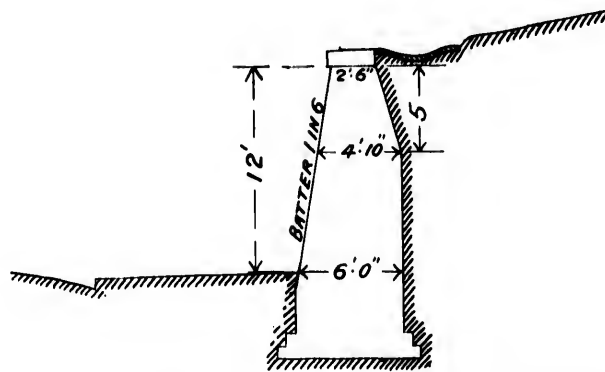
Fig. 6.

Fig. 6 is a section of the wall in front of the Archbishop's Palace on Lagnuchetière street, from dimensions given to the writer by the contractor, who built it about 30 years ago, and repaired the portion from the entrance easterly to Mansfield street, a length of about two hundred and twenty feet, about nine years ago.

There is a thin cement catchwater drain behind the eastern portion, as shown in Fig. 6, which takes away the surface water from behind the wall.

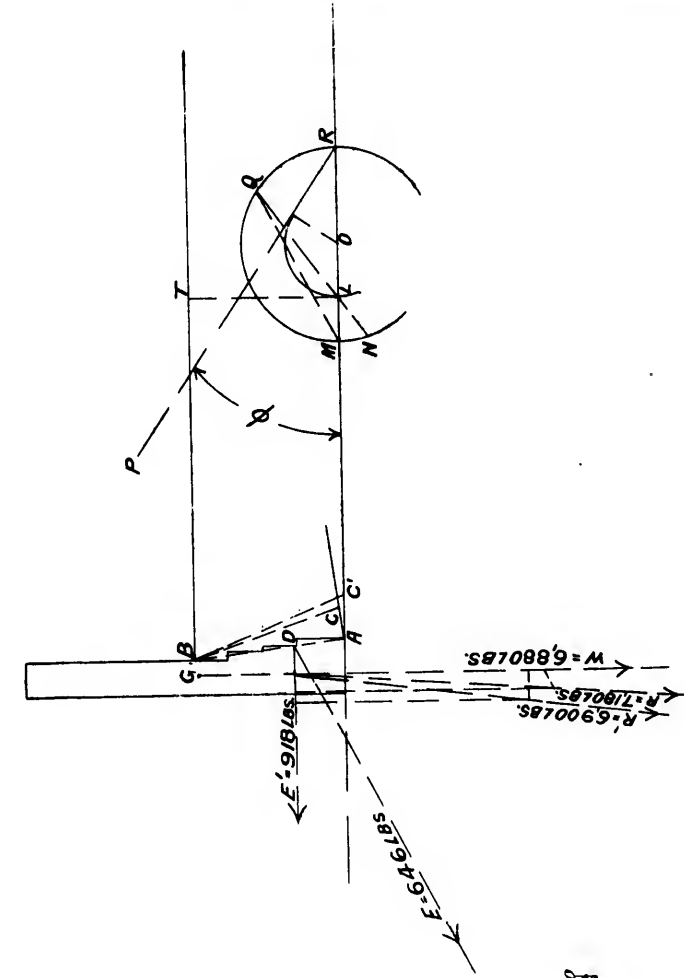
Fig. 7 A.

The diagram down in Fig. 7A, drawn according to Weyrauch's theory, shows that the wall would be in no danger of overturning and that the courses would not slide on each other.

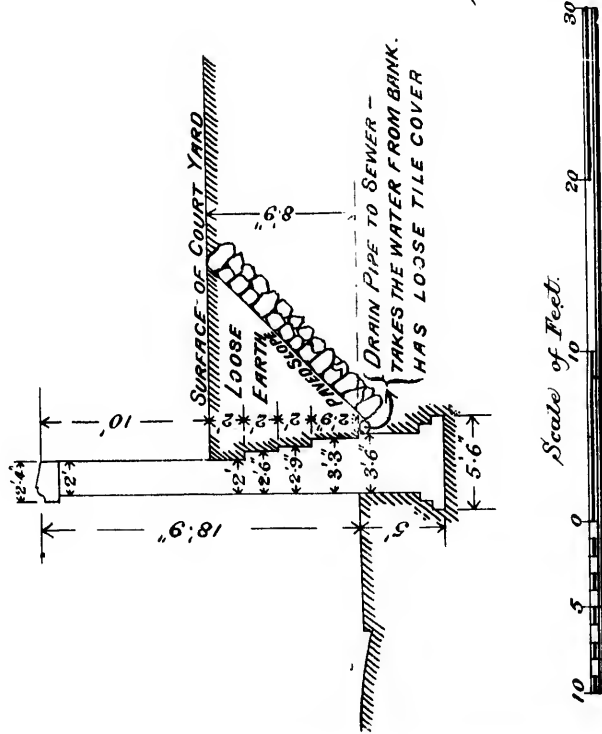
Fig. 7.

According to "Trantwine," this wall, if built with the same batter on front and back, should have a thickness of ten feet one inch at the base and five feet six inches at the top, instead of seven feet seven inches at the ground level and three feet at the top, as it was actually built, and Trantwine's dimensions are based on the assumption that the filling behind the wall would be of good material such as would stand at a slope of $1\frac{1}{2}$ to 1.

Considering that the filling would not stand at a steeper slope than 2 to 1, while moist, the writer thinks that, according to "Trantwine," the wall should have been at least ten feet seven inches at the base and six feet at the top, or about fifty per cent. thicker than it was built, and that it would have been better to have built a wall in cement mortar about ten per cent. thicker than the wall which failed.

Fig. 7 is a section of the wall on the west side of Bleury street and just above Dorchester street.
