VOL. VII—PART I.
(JAN. TO JUNE, 1893.)

THE QUEBEC LAND SLIDE OF SEPTEMBER 19, 1889.

By CHAS. BAILLAIRGÉ, M. Can. Soc. C. E.

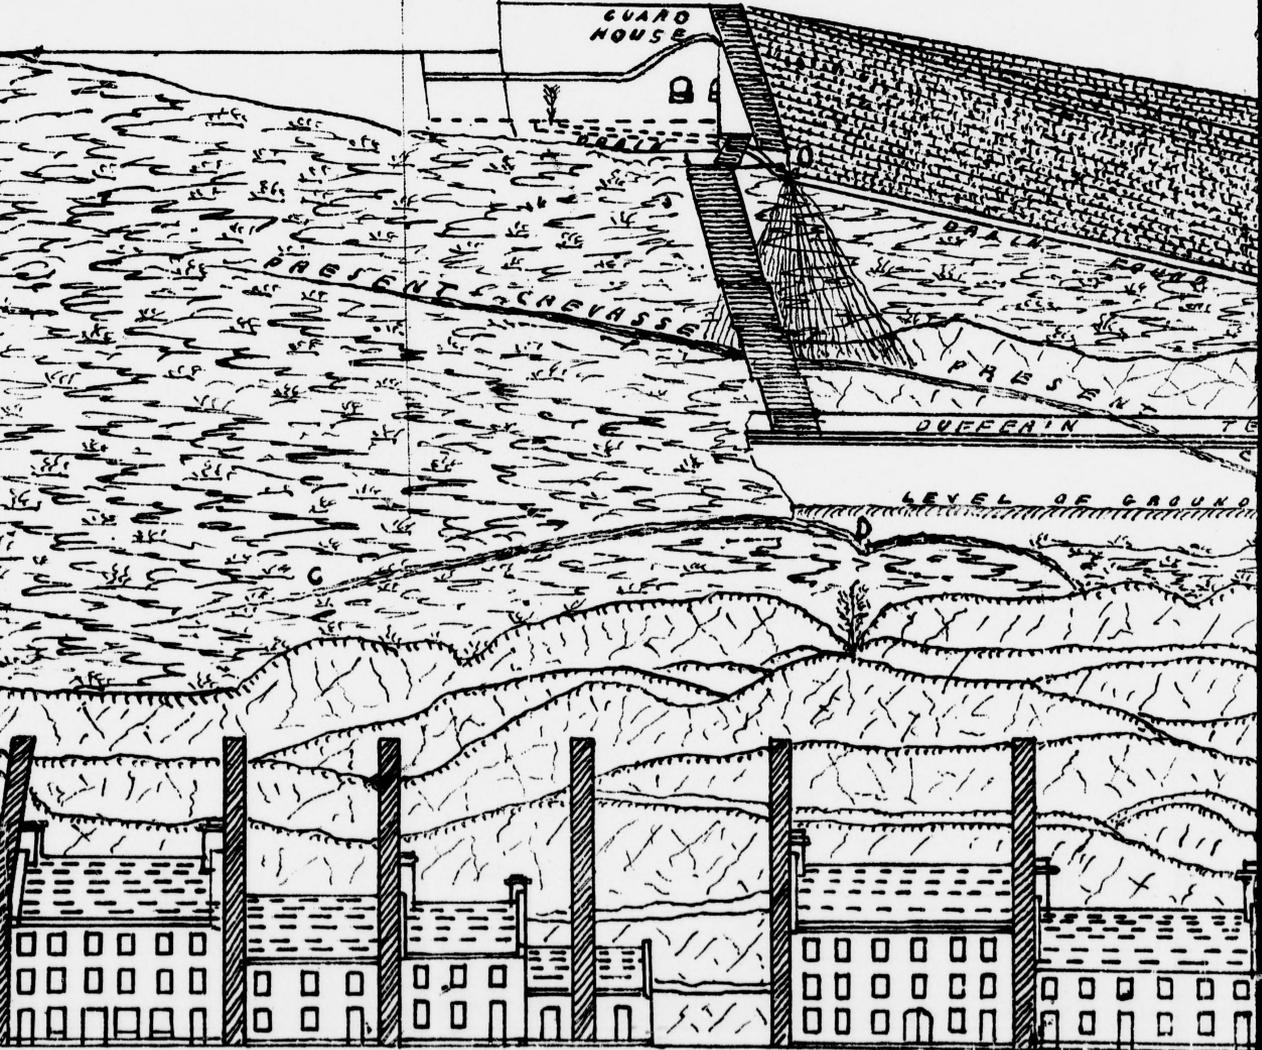
N. B. The "houses" so indicated along west side of Champlain St were after 1880 purchased by the Fed. Govt. demolished and a screen wall built along a b c d e to widen street and guard against stones from cliff rolling over roadway and thus causing accidents.

Elevation or front view of dangerous cliff
along Champlain Street from old land
slide of 1841 to Smith's lane or to the
U. S. S. Co's. office, a distance of say 675
ft. Scale 40ft. to one inch English measure

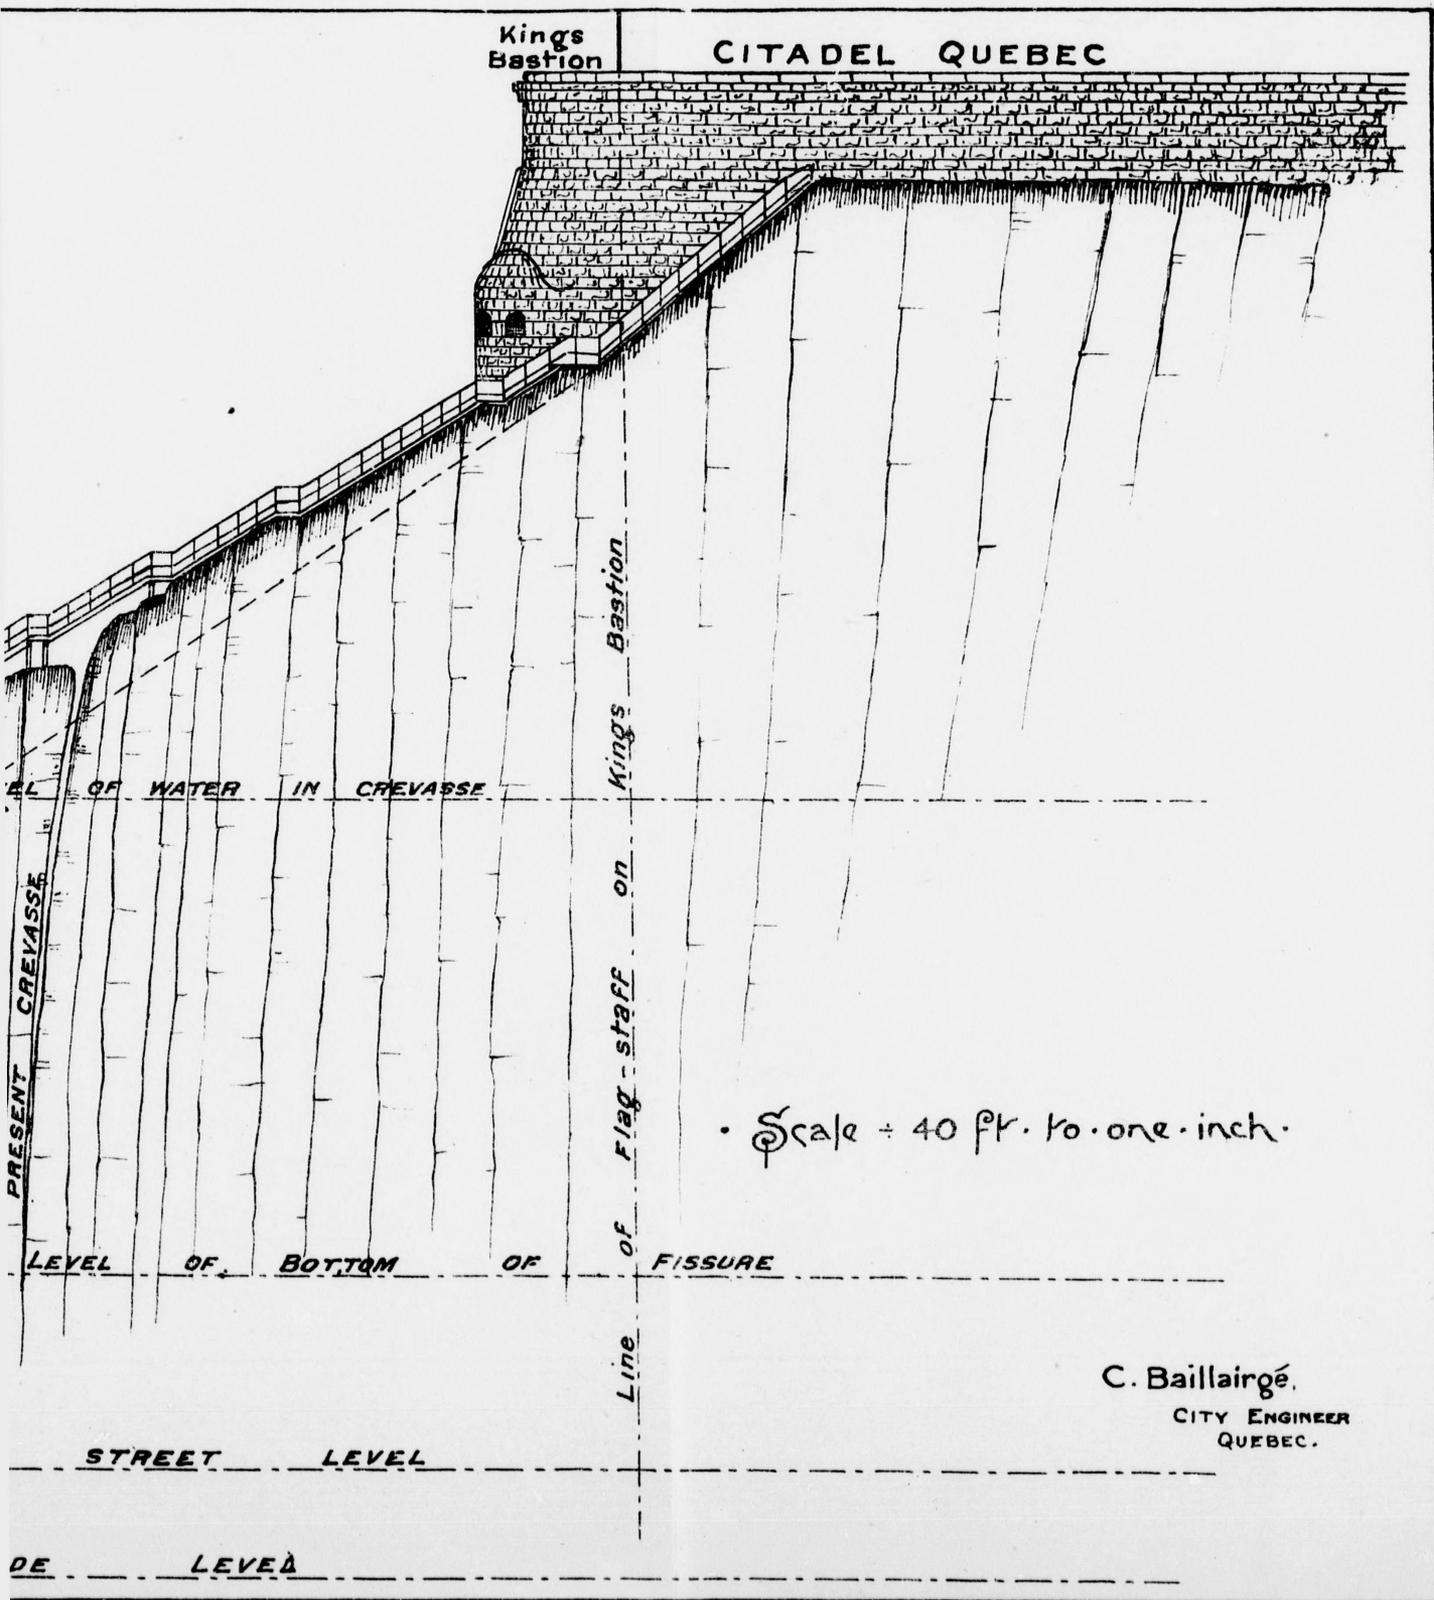
The crevasse indicated on plan and elevation as "present crevasse" is the one now existing, into which the water poured from the broken drain at *D*, filled the crevasse as hereinafter described, forced out the rock between the two fissures, and caused the portion beyond *CDE* to fall forward.

This fissure *A* up to the time of the accident had been mostly hidden from view by debris from above fallen into it at its outcrop, and public attention was concentrated on, and that of the Government called to, the alarming appearance of the fissure at *B*, where the rock gave way at the south-western end of Dufferin Terrace.

Much more apprehension was felt about the crack at *B* than that at *A*, and the Government caused the upper portion of it for some feet below the outcrop to be filled in with concrete, with the idea of preventing water from above from reaching and falling into it, which it was supposed, acting both by its disintegrating power and by swelling under the effect of frost, might gradually overthrow that portion of the cliff which has since fallen. This was a very foolish thing to do, as will soon be made apparent; for first of all, no water from the Citadel drainage above could reach the fissure, since it must on its way be intercepted by and enter the crevasse *A*; and secondly, by bringing about a contact between the opposite faces of the crack at *B*, which were some two or more feet apart, any shock or push from the rear must inevitably thrust forward that portion of the cliff to the right of *B* (as you look at the section), and hasten its destruction.

A is the crack, if any, which should have been filled in; but, being hardly noticeable to the untutored eye, and so remote from *B* or *F*, was not suspected of any foul intent.

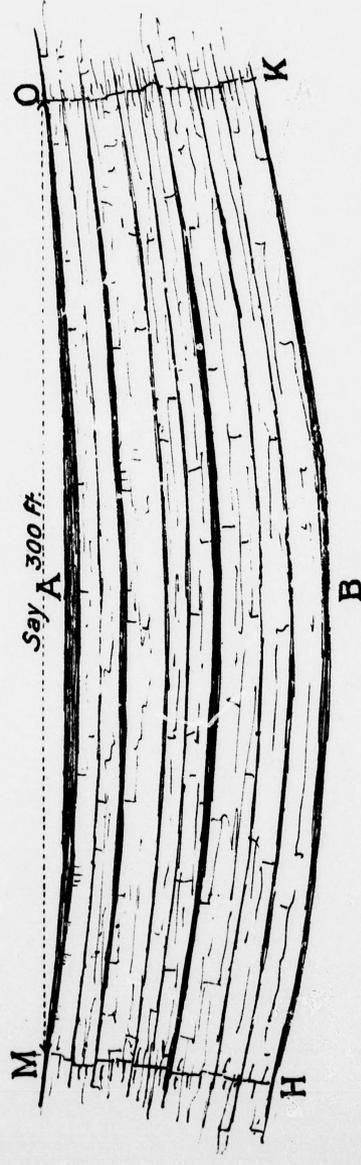
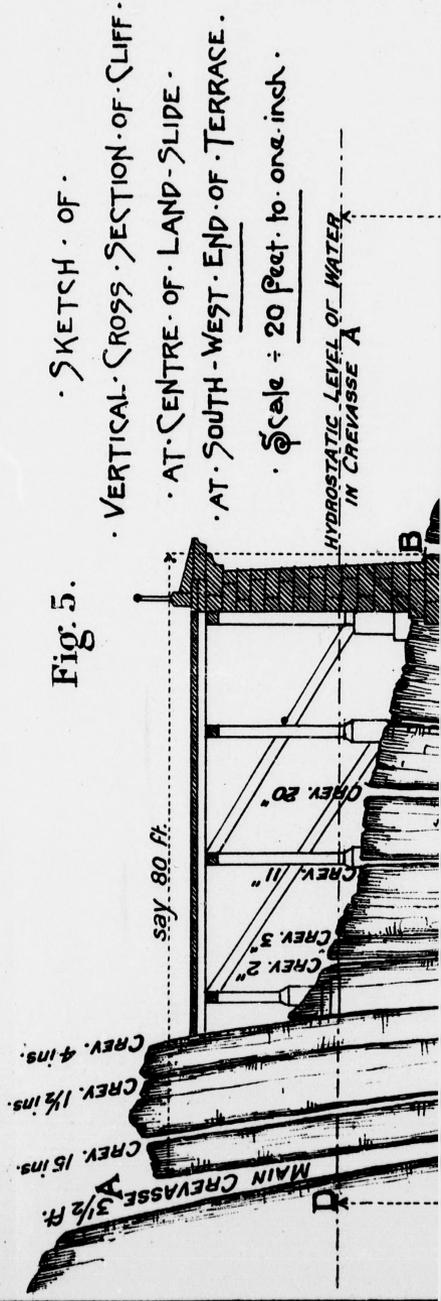
Fig. 5. · SKETCH · OF ·

But as already seen, the cliff is not a homogeneous mass, and on the contrary the section shows it to be thoroughly divided into nearly vertical and parallel strata ranging from a few inches to several feet in thickness; and these strata are again divided by planes of cleavage, as indicated by the lines drawn obliquely across the strata* into

The planes of cleavage, therefore, had the strata been vertical at *BE*, would have inclined some 20° from the horizontal, or say 1 in 3; but it has already been shown that the inclination outward at *BE* is 1 in 10 or another 7 degrees, together 27° , an inclination of 1 in 2, and such that just one-half the force need be exerted to thrust the rock forward as would have to be exerted on a horizontal plane.

· VERTICAL · CROSS · SECTION · OF · CLIFF ·
