Canadian Society of Civil Engineers.

TRANSACTIONS.

THE CORNWALL CANAL.

By S. KEEFER, M. CAN. SOC. C. E.

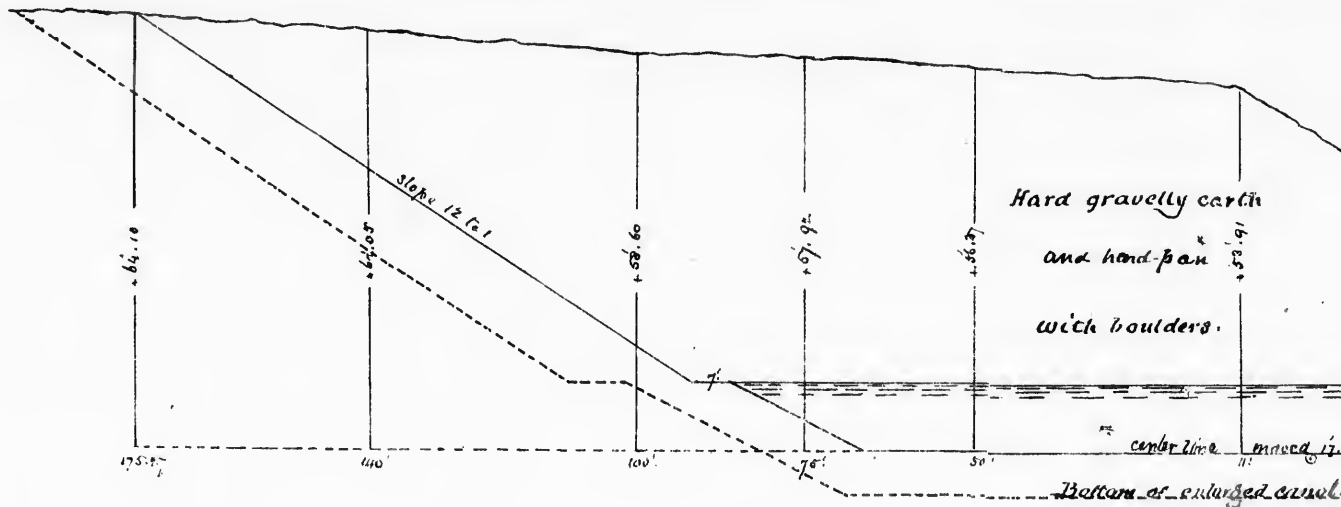
Cross-section No. 2.—This section is taken a short distance below Moulinette, and is a fair sample of the doubtful character of the soil on which the integrity of the navigation depends. It was near this that the first breach occurred in December, 1843, shortly after the canal was first opened. Small streaks of sand were found in excavating the canal, which made their way in some unknown manner through the natural "drift" on which the embankment rests. These were discovered were cut off by a puddle trench, six to eight feet deep, another bank and canal bottom protected by an apron of puddle three feet in thickness. The second breach took place on the 30th October, 1850, just above the road culvert at Moulinette, after the canal has been seven years in use. The cause of the breach in this instance was attributed to a small rivulet that crossed the canal nearly at right angles, some fifteen feet below the bottom of the canal. It was a sort of blind water-course that had not been thoroughly cleared of the sand and vegetable deposits before the bank was built across it. Through this, without any previous warning, the canal water found a passage, and in a very short time, a gap 280 feet long and 26 feet deep was made, emptying the canal, and carrying away some 1500 cubic yards of the bank. The gap took the following shape. Fig. 1.

As originally constructed

It was here the first breach occurred.
