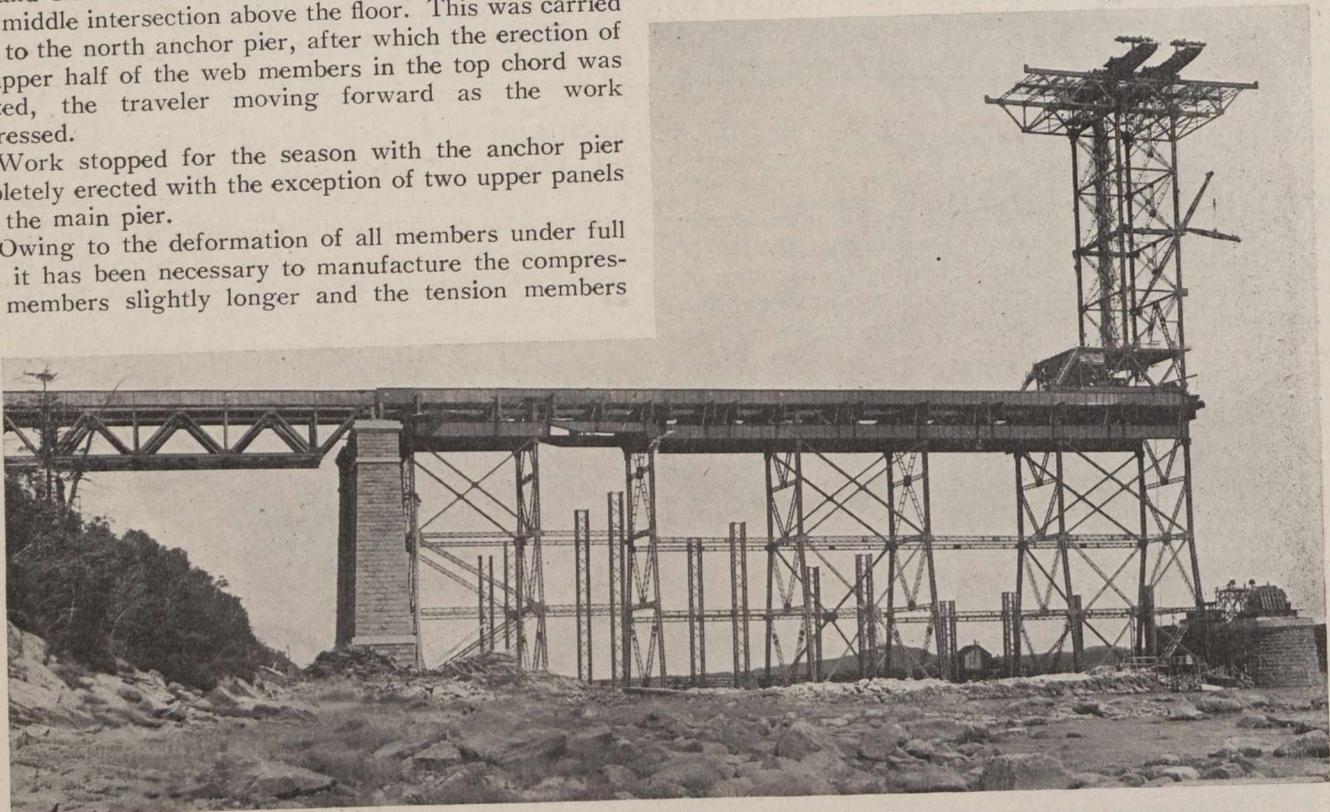
Fig. 2.—Falsework and Floor Erected, and a Start Being Made on the Erection of the Main Shoes.

When this falsework had been completed out to the north main pier the main shoes were erected, and the bases for these shoes were accurately placed and the entire shoe erected. An elaborate series of triangulations and measurements, extending over several months, were made to locate the longitudinal and transverse centre lines of these shoes. Once the bases had been placed in their proper position the rest of the shoe went forward rapidly, and a start on the erection of the bottom chords was made.
