It is the intention to have two railway tracks extending the length of the pier through the centre of the shed, and two outside, one on each side. The flooring is raised to the car deck level above the tracks to facilitate and expedite the handling of freight. There are two roadway ramps at the Water Street end, one on each side, for the accommodation of dray traffic.

Superstructure on Pier.—The shed will consist of fire-proof material having reinforced concrete walls and floors. It is necessarily of substantial construction as upwards of 3,000 immigrants and their effects will be housed in the building when two large well-filled steamships reach port at the same time. The building is a two-story structure. The ground floor is a plain floor for freight purposes, covering the whole area of the building with a series of railway, steamship and custom offices and storerooms at the shore end and in each side of the two central freight tracks. Along each wall, outside of which are the exterior tracks above referred to, there is

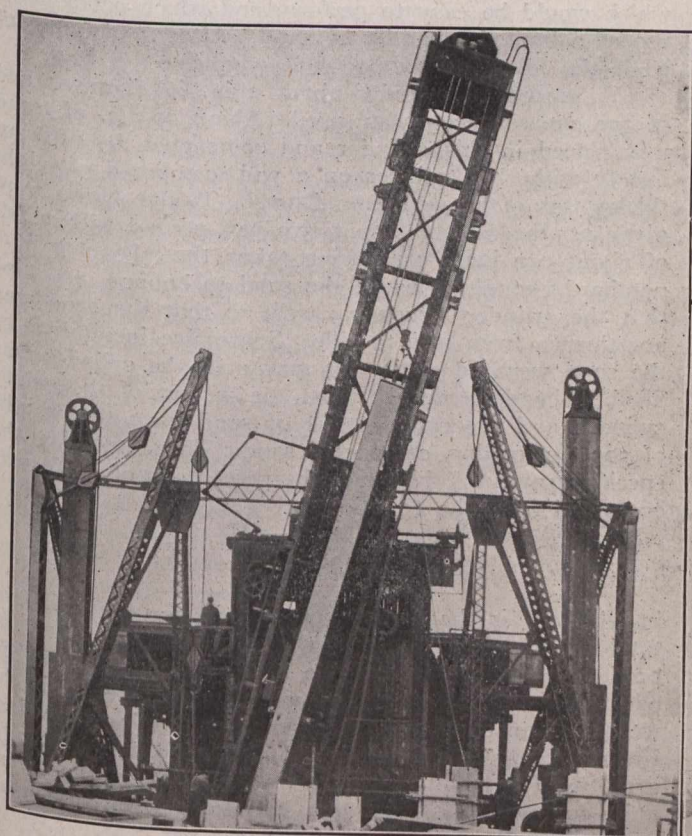
Fig. 7.—Leads of Driver Canted With Brace Pile Ready for Lowering into Position.

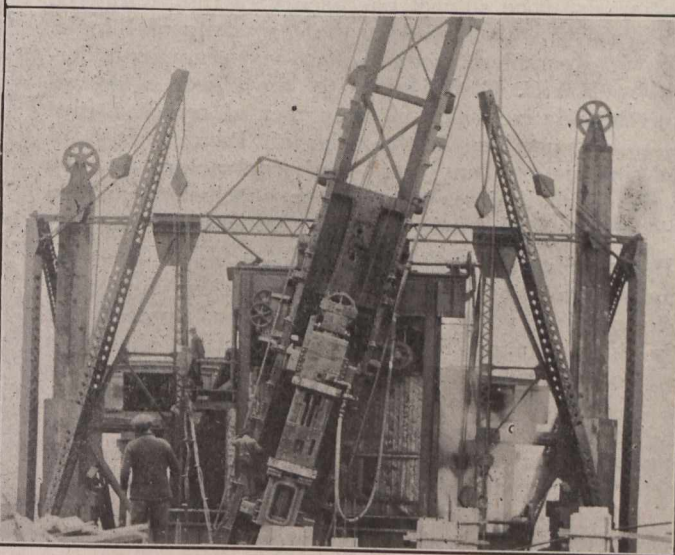
Fig. 8.—Details of Pile Hammer, on Head of Pile and Ready for Driving.

Separate cushions were used between the concrete of the pile and the ram of the hammer. On top of the pile was placed a 3-in. spruce plank. On this rested a cast-steel follower about 4 ft. high consisting of a hollow cylinder or post with top and bottom flanges. The bottom flange was flat, and in it were eight holes through which the projecting rods of the pile reinforcement passed and were protected. The top flange had cast on its upper side a rectangular depression in which was placed a hardwood block about 15 in. thick, bound round with a steel band. This block received the direct blows of the hammer and had to be frequently renewed; sometimes it would
