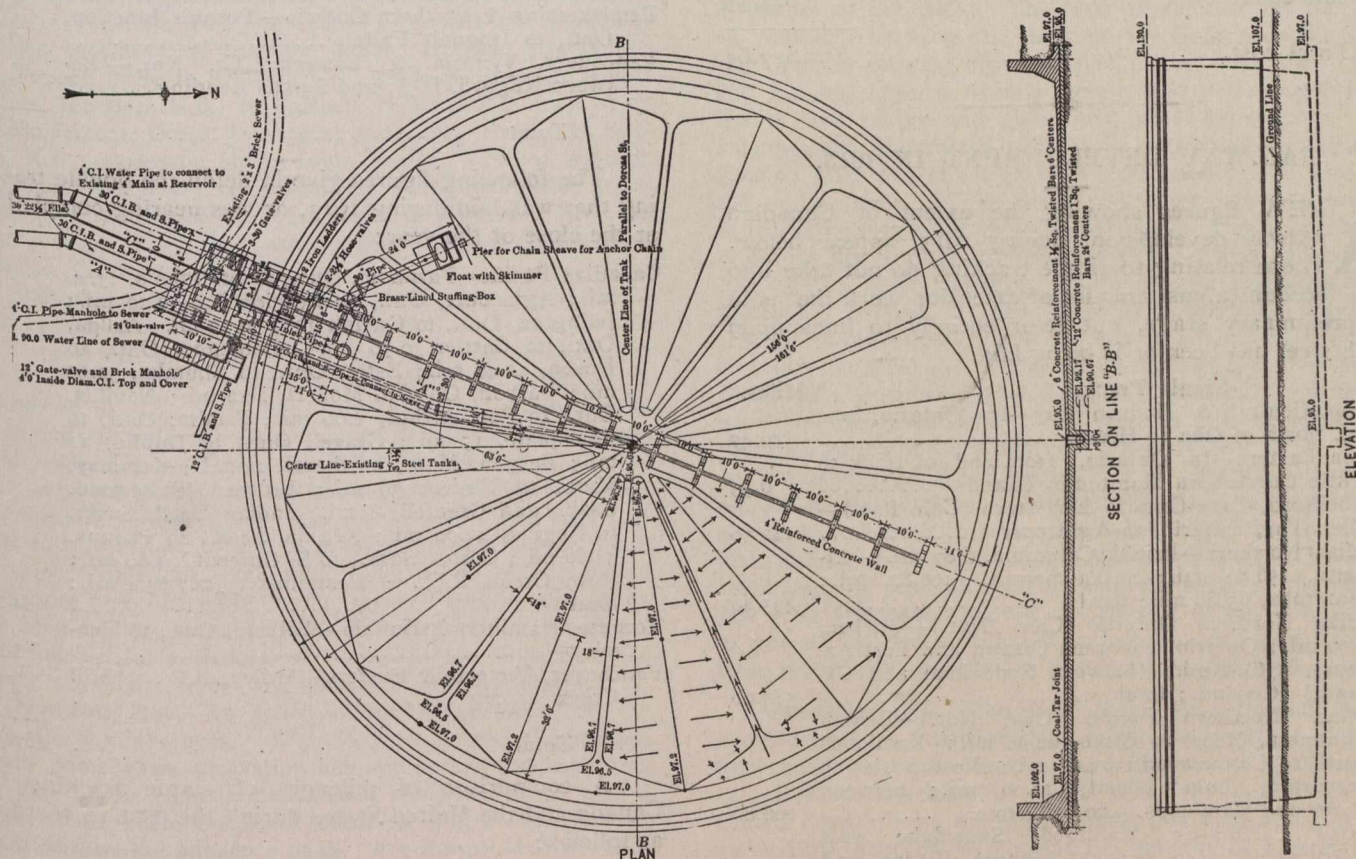
Fig. 3.—Foundation Plan of Settling Tank.

Arrangements for Washing Out.—The bottom of the tank slopes toward the centre from all sides, the 24-in. waste outlet being at the centre. The slope toward the centre could not readily be made more than 2 in 75, being limited by the depth of the sewer which was already built. In order to facilitate the removal of sediment, therefore, the bottom was laid out in a series of star-shaped mounds, as indicated in Fig. 3, each mound draining into a shallow gutter. Hose connections furnish water under pressure for cleaning out.

At the junction of the side-wall with the bottom, knee-bars are provided to reinforce this connection. These bars are 1 in. square and 12 in. from centre to centre.
