# Diagnosing fractured components— Electron fractography

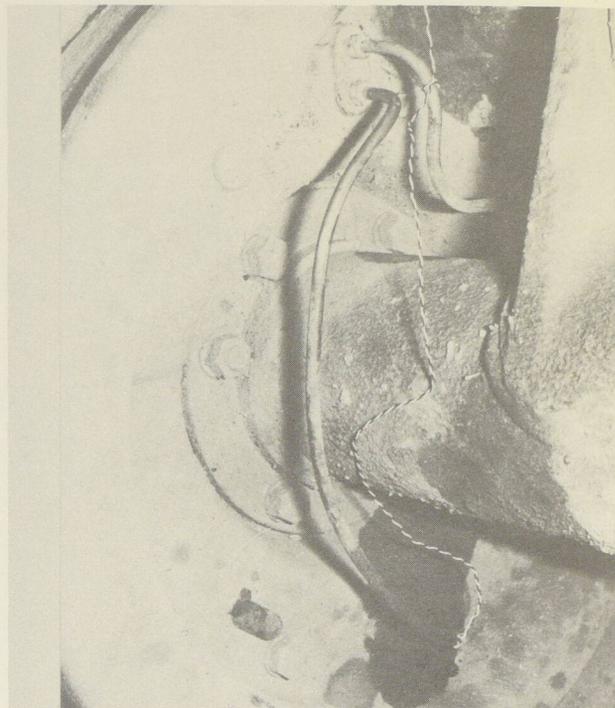
**Brake line tubing installed on a truck, with instrumentation for road test vibration measurements.**

**Conduite du circuit de freinage installé sur un camion équipé d'instruments pour mesurer les vibrations durant le roulement.**
