NEW RAIL SPECIFICATIONS, C.P.R. SYSTEM.

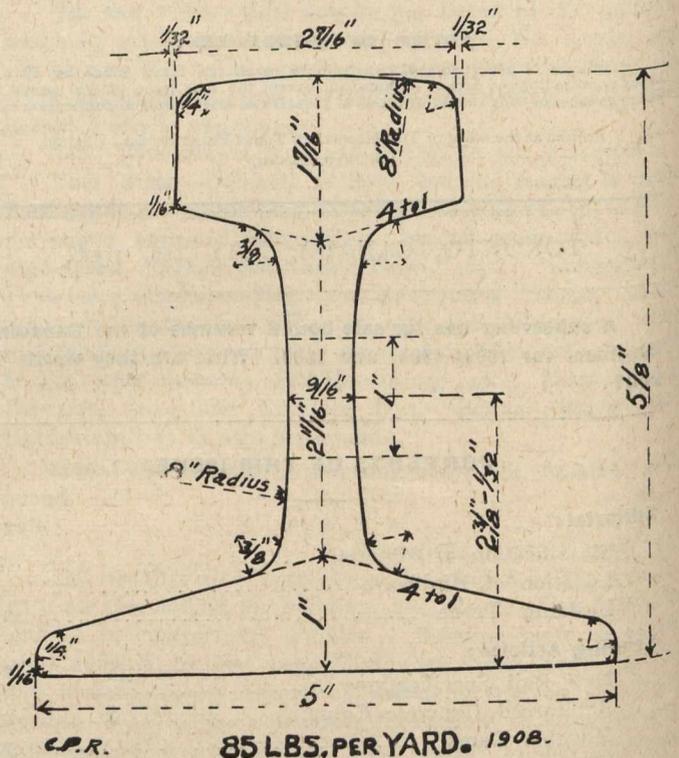
Steel rails frequently show weakness where the web joins the head and where it joins the base of the rail. The C.P.R. system in their new standard rail section have attempted to overcome this weakness by adding more metal at these points. Long usage alone will demonstrate whether the defects that occurred here were the result of insufficient metal or to a mechanical defect in rolling.

Section 1.—The section shall be the Canadian Pacific at a temperature of 60 degrees Fahrenheit. Ten (10) per cent. of the entire order will be accepted in lengths of 27 ft. and 30 ft. All such short rails shall be painted green on both ends. A variation in length of 1/4 of an inch longer or shorter will be allowed.
