Launching of Centre Span.—It had been decided to float the span on the morning of September 11th, provided suitable weather conditions were predicted and existed. On September 10th at 11 a.m. the Weather Bureau at Toronto telephoned that there was a centre of low pressure over the Western provinces, Saskatchewan in particular, the barometer reading there being 29.4 inches; and that a centre of high pressure existed over the provinces of Ontario and Quebec, the barometer reading in these localities being 30.4 inches. The forecast for wind was a fresh breeze from the northeast of about 20 miles an hour velocity. On the evening of the 10th at 11 p.m. the report came from Toronto of the existing meteorological conditions and the

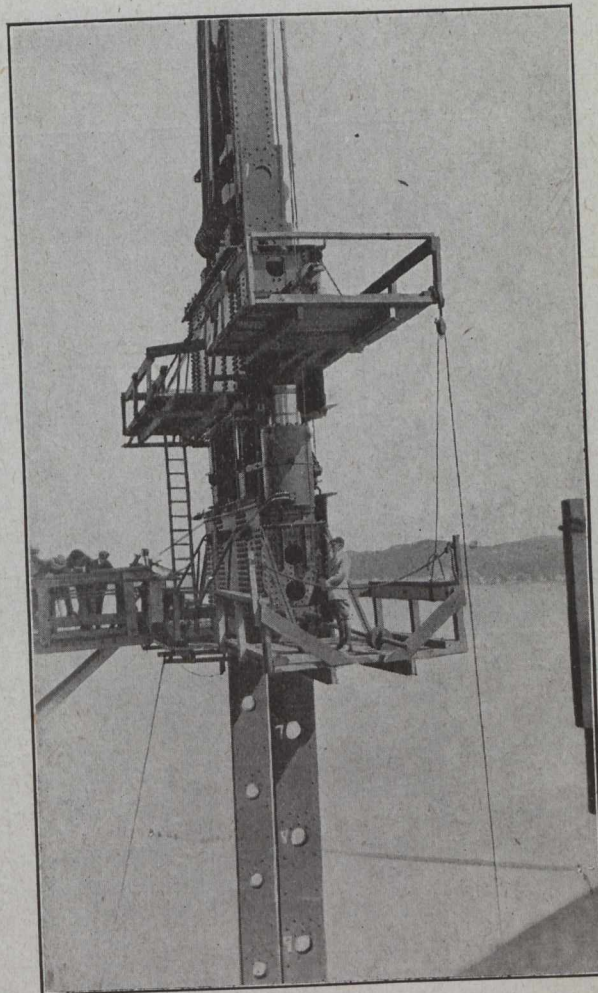
Fig. 3.—Showing Powerful Jacks in Position; Also the Lifting Chain in which Pins were Inserted as Centre Span was Elevated.

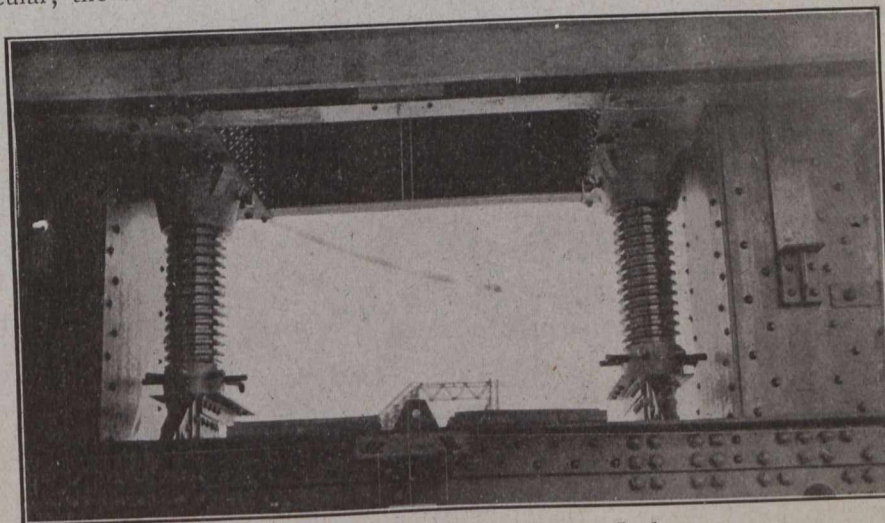
Fig. 4.—Hand-operated Screw Jacks.

The upward stroke of the hydraulic jacks was followed by these jacks to provide against dropping the load through any accident to the hydraulic connections.
