In the recent fire in the Parker building in New York (a twelve-story so-called fireproof building) many seem to find food for argument in favor of their contentions that a fireproof building is an impossibility, but the facts

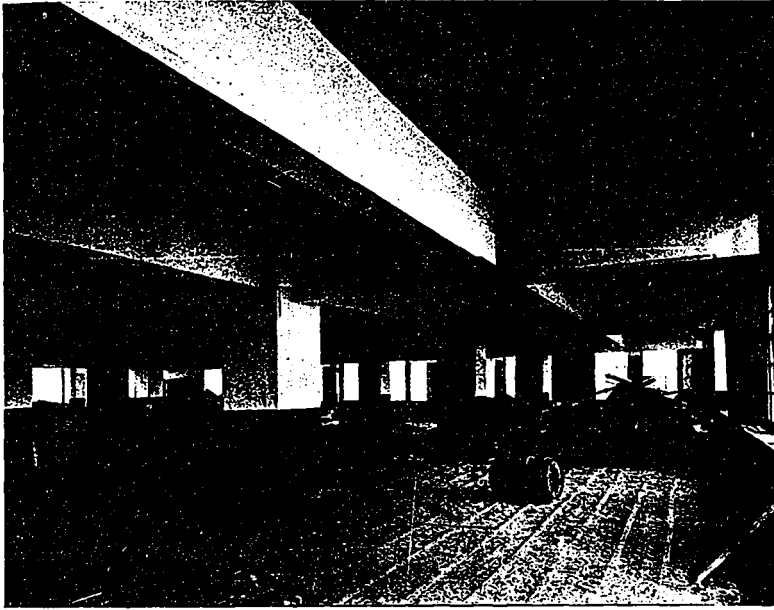
Fig. 2—INTERIOR VIEW OF GROUND FLOOR OF ANDREW DARLING BUILDING, SHOWING THE MASSIVE REINFORCED CONCRETE BEAMS, GIRDERS AND COLUMNS, THAT SUPPORT THE FLOORS. THE SPRINKLER PIPES RUNNING THROUGH THIMBLES IN THE BEAMS AND GIRDERS MAY BE SEEN. NOTE THE LARGE AMOUNT OF LIGHT THROWN TO THE CENTRE OF THE BUILDING.

Fig. 3—INTERIOR VIEW ON SEVENTH FLOOR, ANDREW DARLING BUILDING, TORONTO, SHOWING THE SMALLER DIMENSIONS OF THE BEAMS, GIRDERS AND COLUMNS AS COMPARED WITH THOSE SHOWN IN FIG. 2. A BETTER ILLUSTRATION OF THE DIMINISHING DIMENSIONS OF THESE PARTS IS SHOWN IN FIG. 4.
