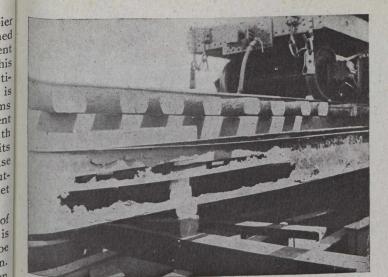
Wrecking Fig. 3.—Corrosion of Steel on Old Bridge. Crane in Background.

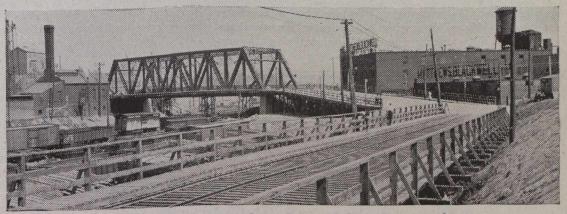
Fig. 5.-New Bathurst Street Bridge and South Approach.

on a 5 per cent. grade. This arrangement provides an undercrossing into Matthews-Blackwell's yard with a headroom of 12 feet, and a ramp is to be built, leading down to the Grand Trunk Railway yard. To take care

of Matthews-Blackwell's office entrance, a stairway is provided from the bridge floor to the level of the office floor, and to maintain this level, which is II feet above the level of the new undercrossing of Queen's Wharf Road, a retaining wall of reinforced concrete is built. Pedestrian traffic to Queen's Wharf will use this stairway also. All these various arrangements can be easily

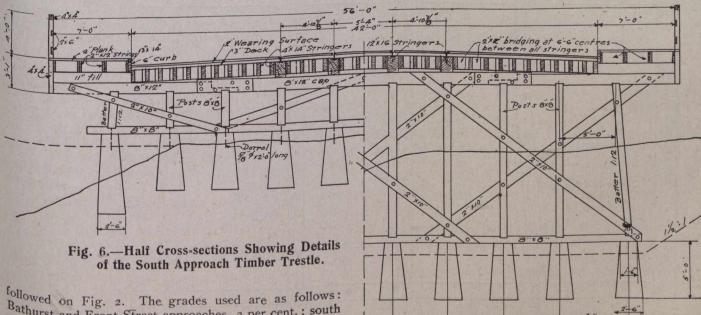
Bathurst and Front Street approaches, 3 per cent.; south approaches to bridge, 5 per cent.; sidehill trestle, 1.27 Der cent.; C.P.R. trestle, 5 per cent.; all other grades are nearly level.

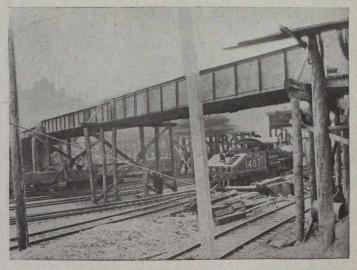
Fig. 4.—Temporary Bridge During Construction.

The steel trusses are the trusses released from the Humber River crossing when the G.T.R. raised the grade at that point in 1911. This was a double-track bridge, 202 ft. 6 in. centre to centre of bearings, and by putting in a new system of bracing, new floor beams,
