Operation of Lifting the Span

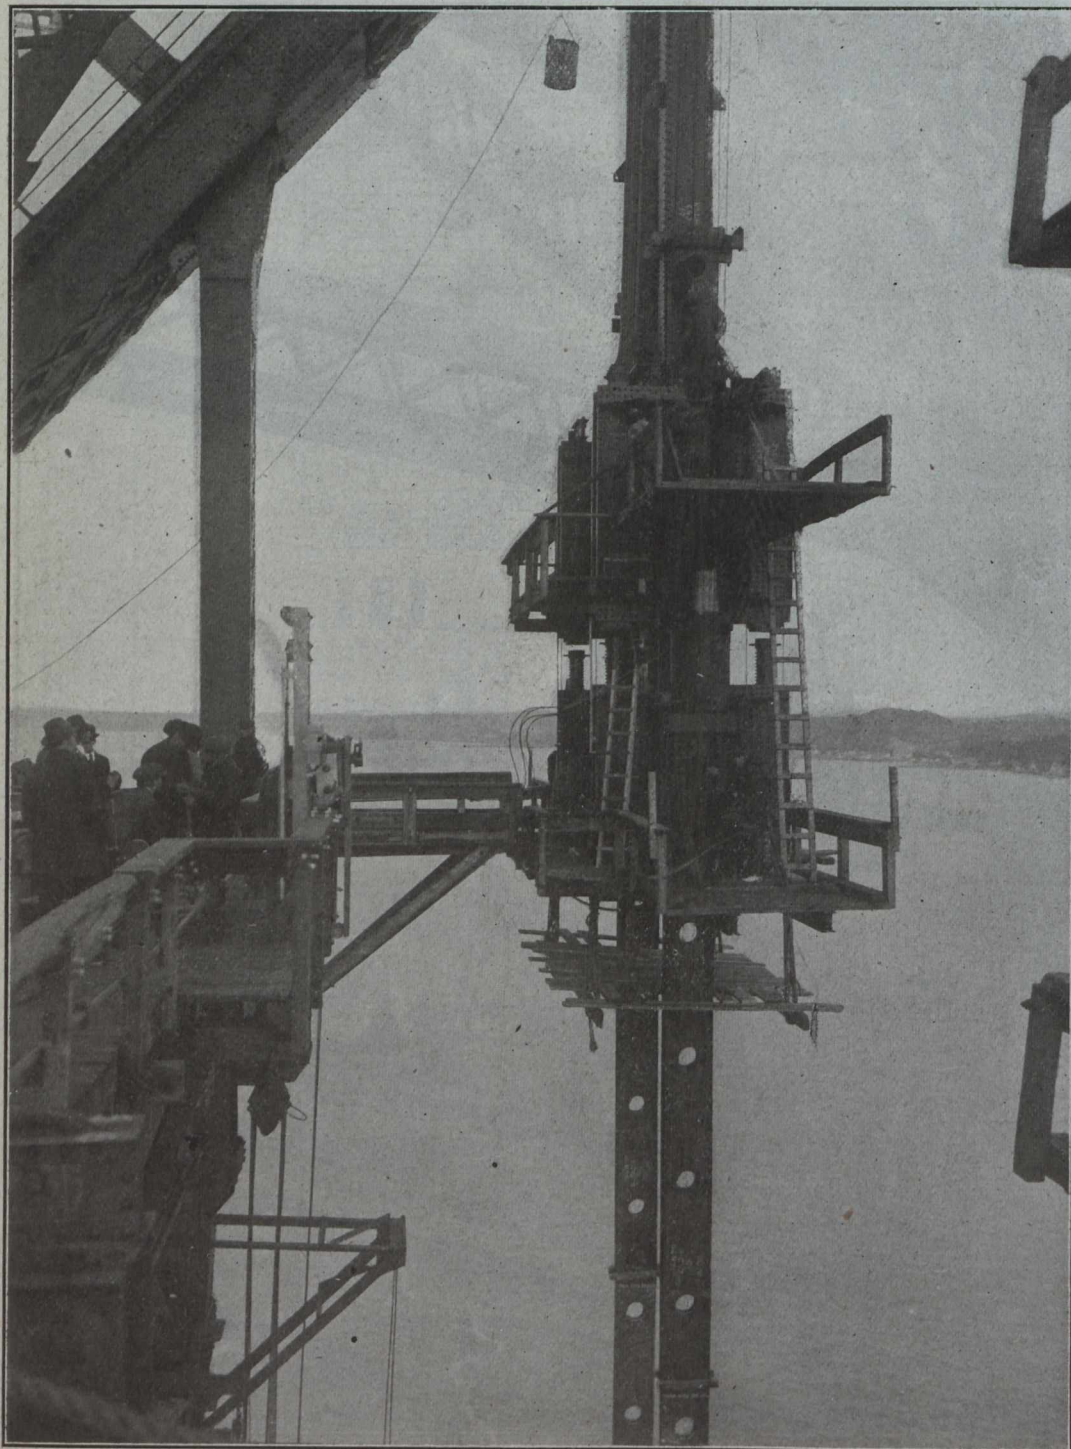
Fig. 7.—End Elevation of Jacking Equipment, Showing Hydraulic Jacks in Top Position, also Showing Safety Screws Not Quite in Contact with Lifting Girder. During Lifting Operations it was Intended that an Operator Should Attend to Each Safety Screw and Keep it Close Up Against the Lifting Girder ELG3

The operation of lifting the span was accomplished in stages of 2-ft. 0-in. lifts.

hydraulic jacks, the safety screws following up hard all the time.

When a position had been reached, as indicated by the centre tell-tale, where the lower pins could be intro-
