**Columns Nos. 45 and 45a.**—The foundations for columns Nos. 45 and 45a present several features which are worthy of special description. These columns are respectively the main and auxiliary columns at the southwest corner of the building.

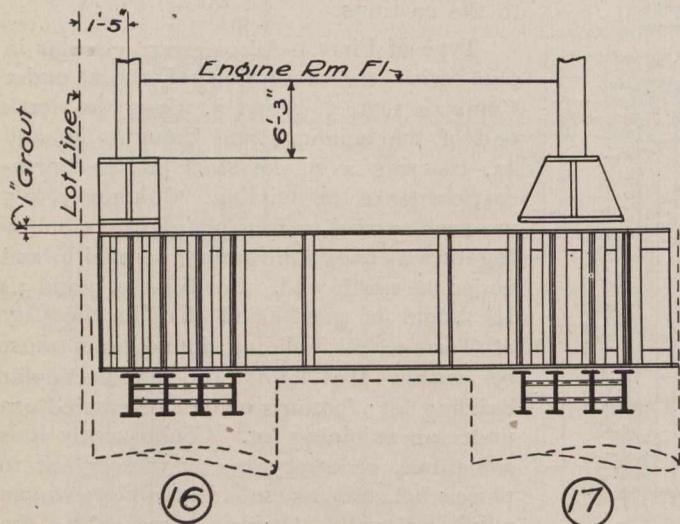
same material. A cast iron column base is set at both ends of each girder and grouted in, as shown in Fig. 6. This cut also shows the method of cantilevering.

**Cantilever Girders.**—Columns 17, 27, 28, 39 and 40 on the east side of the building abut on an existing structure, and commence from a level considerably above the rock (as very little basement excavation was required under this portion of the building). They are carried upon cantilever girders. These girders are each carried in turn by two circular caissons which are surmounted by single grillages composed of four 15-in. I-beams. This is diagrammatically shown in Figs. 4, 6 and 7.

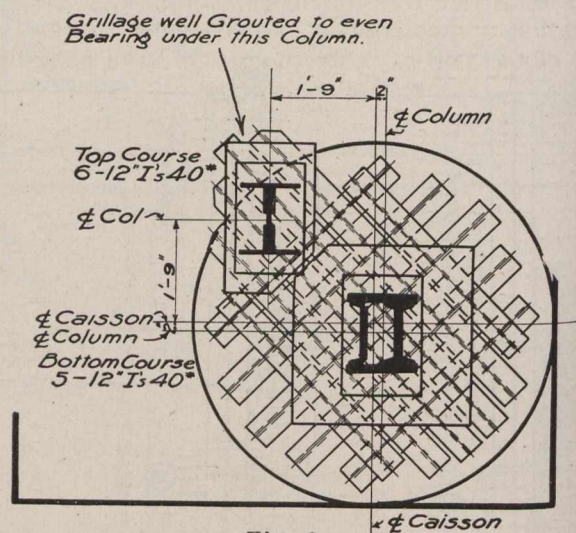
The pier for these columns is circular in plan, as shown in Fig. 9, and is surmounted by a special grillage composed of a bottom course of five and an upper course of six 12-in. @ 40 lb. I-beams, the latter course laid at right angles to the lower, as shown in Fig. 9. It will be noticed that the beams in the upper course are carried diagonally towards the

centre of the building, to form a base for the auxiliary column. The weight thus applied would cause an eccentric loading upon the pier, the load centre approaching towards the inner wall of pier. To overcome this

eccentricity of loading, the position of the pier has been moved diagonally inwards by  $2\frac{3}{4}$  in., thus concentrating the combined load about the centre of the pier.

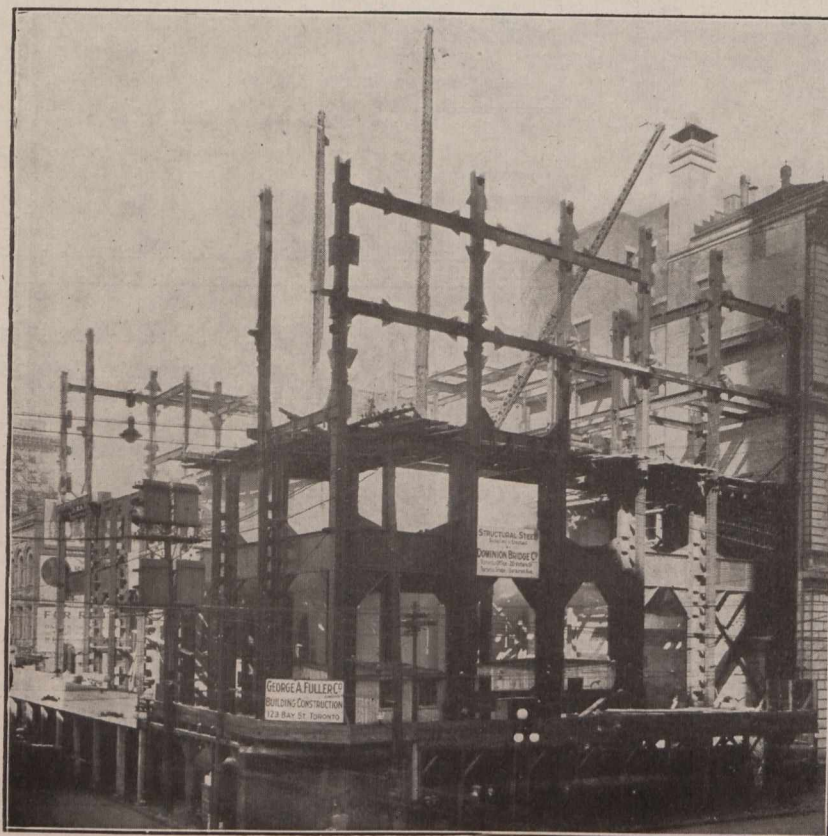
Fig. 8.—State of Erection of Royal Bank Building on March 20th, 1914.
