THE
QUEBEC BRIDGE

CARRYING THE
TRANSCONTINENTAL LINE OF THE CANADIAN GOVERNMENT RAILWAYS
OVER
THE ST. LAWRENCE RIVER
NEAR
THE CITY OF QUEBEC, CANADA

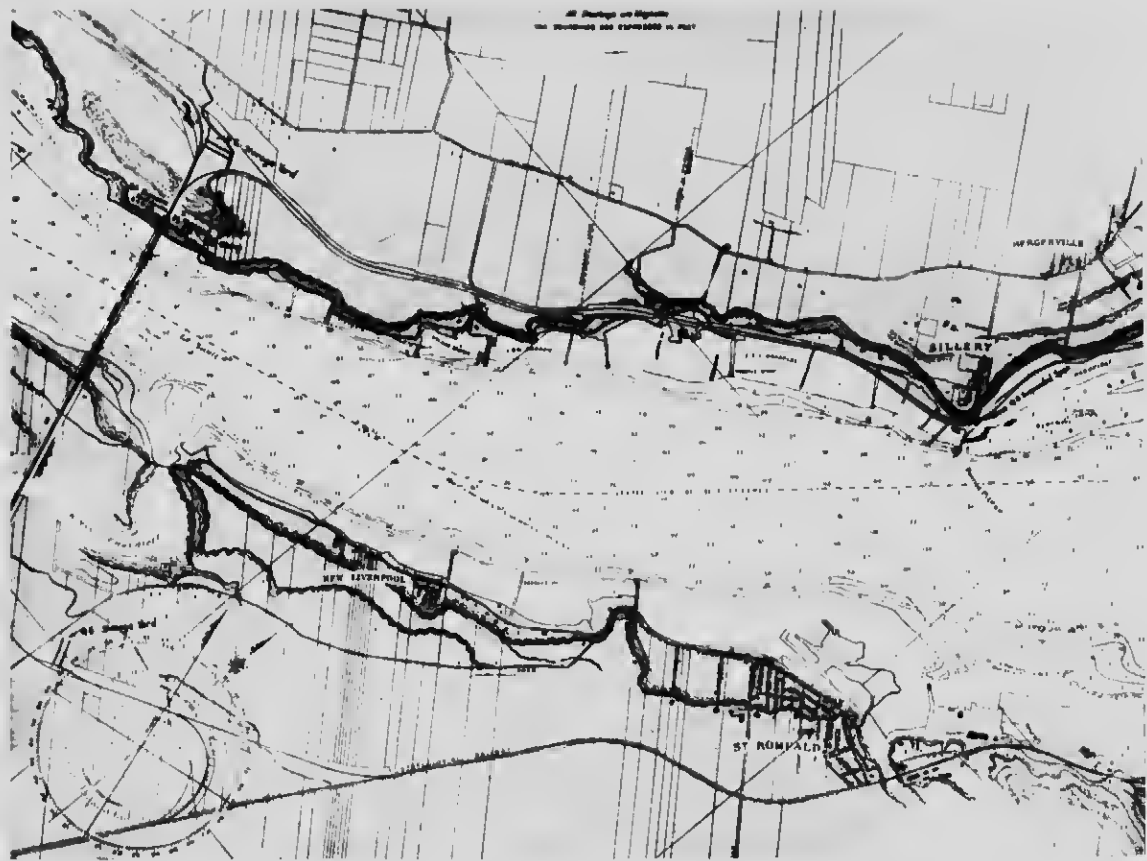
1 Chart of site showing also the positions of the storage yards camp, and Sillery Cove, as well as the railways and highways in the vicinity

Plate 1 shows the locations of the main camp and the North and South storage yards.

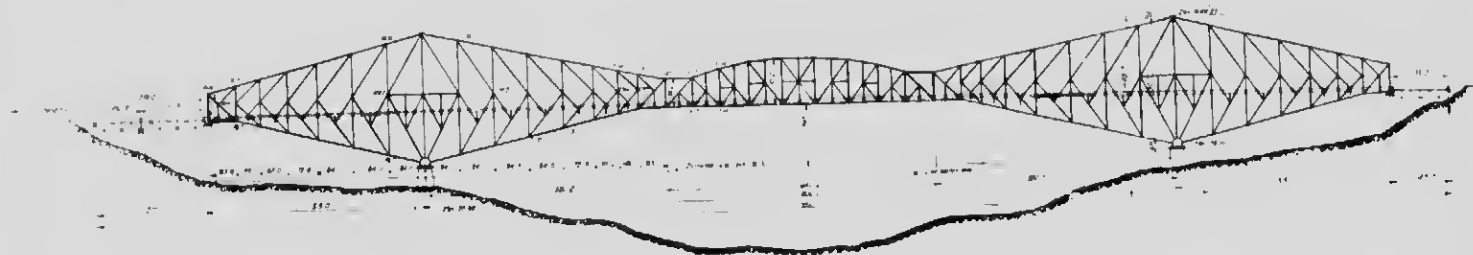
GENERAL ELEVATION SHOWING MAIN DIMENSIONS

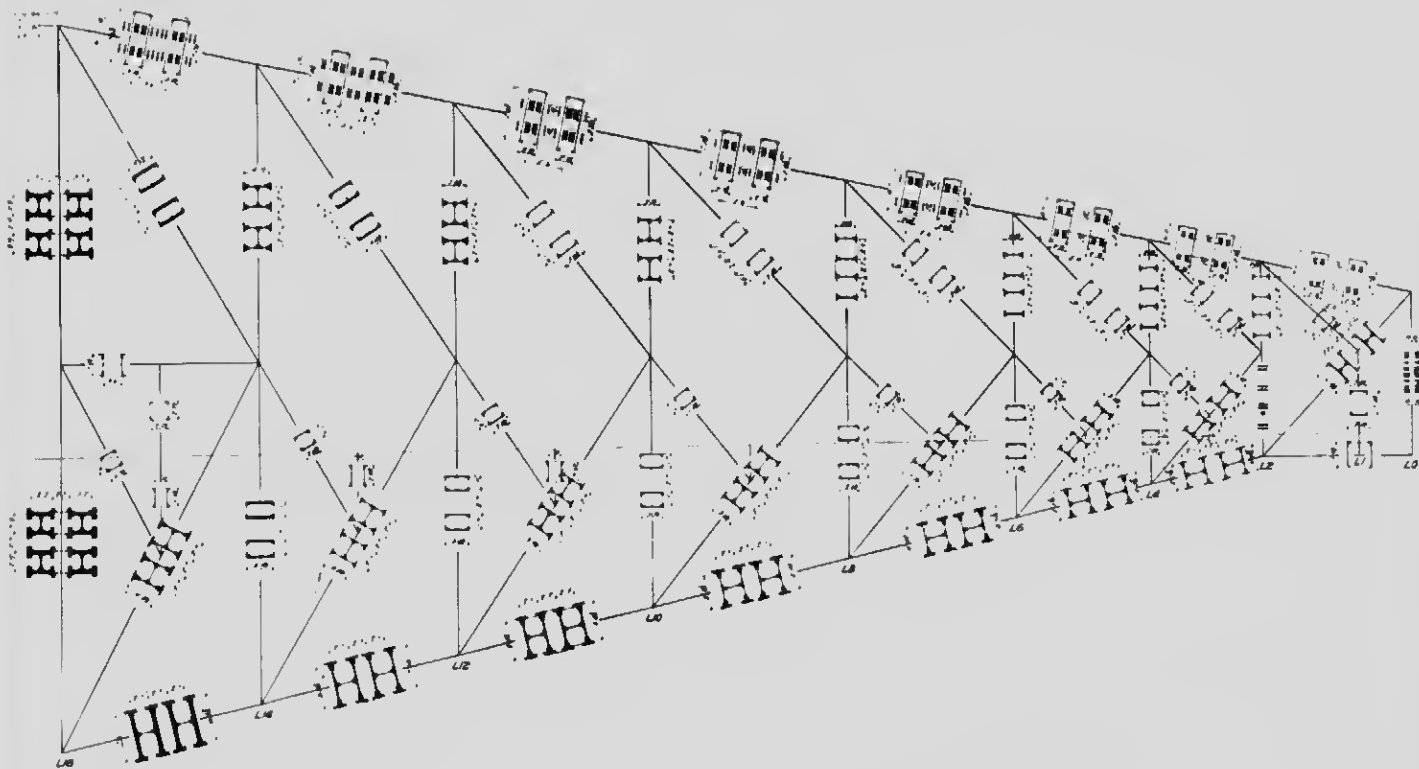
3—Cross sections of important members of the cantilever arms.
NOTE: The cross sections of the members of the anchor arms are similar.

The general make-up of the members is shown on Plate 3 and the form of the details is indicated by the photographs.

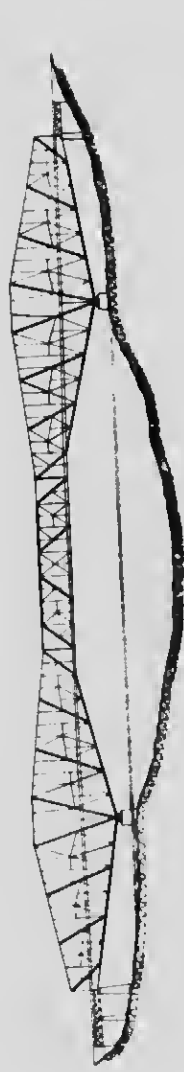
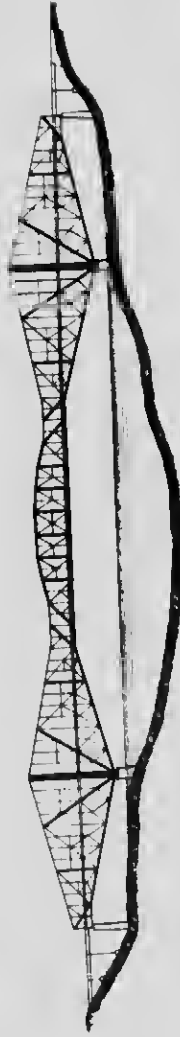
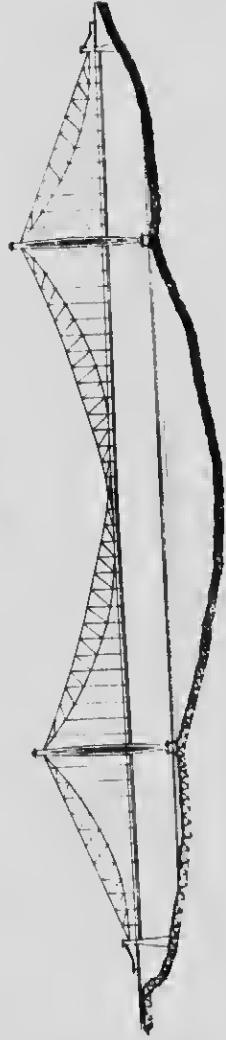
8 Other designs on which tenders were submitted:

FIG. 1 is the Official Design exhibited when the call for tenders was advertised.

FIG. 2 is a modification of the Official Design.

FIG. 3 is one of the alternative designs submitted by the St. Lawrence Bridge Company.

FIG. 4 is a German design submitted by Maschinen-Fabrik, Augsburg, Nuremberg.

FIG. 5 is a suspension bridge submitted by the Pennsylvania Steel Company.

Plate 8 shows the other designs on which tenders were submitted.

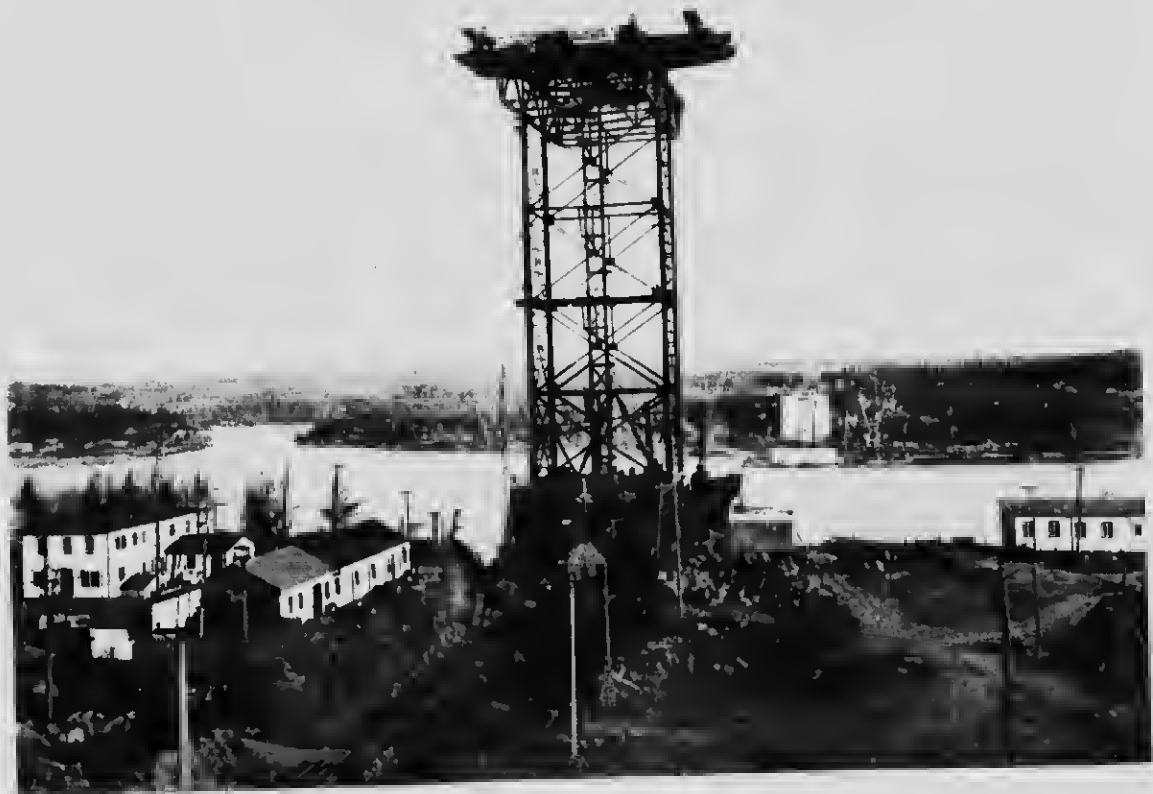
15. The North Shore traveller erected being equipped, also showing the office building and power house to the left

These travellers are illustrated on Plates 15, 16 and 17, and will be seen in many of the progress photographs. The travellers were about 210 feet high from the rails on which they ran to the top of the hoists. The travelling cranes on top carried two 60-ton hoists which had a transverse travel of about 14 feet, the maximum spread at which they worked being 96 feet. The width of the tower was 54 feet centres, its length 37 feet, and the length of the upper trusses carrying the crane runway 151 feet. There were four booms each 90 feet long capable of handling 15 tons and there were small 7-ton auxiliary gantry hoists at the end of the cranes for handling cages, pins and light work. The weight of the traveller was 940 tons about equally distributed on the two tracks when the cranes were at the rear end for moving. When the traveller was lifting its maximum loads the total reaction at the front end was about 1,300 tons. The traveller was carried by two rails on each side, the inner rail being carried by the track girder of the permanent floor and the outer rail by a girder placed temporarily for the purpose, shown on Plates 17 and 37.

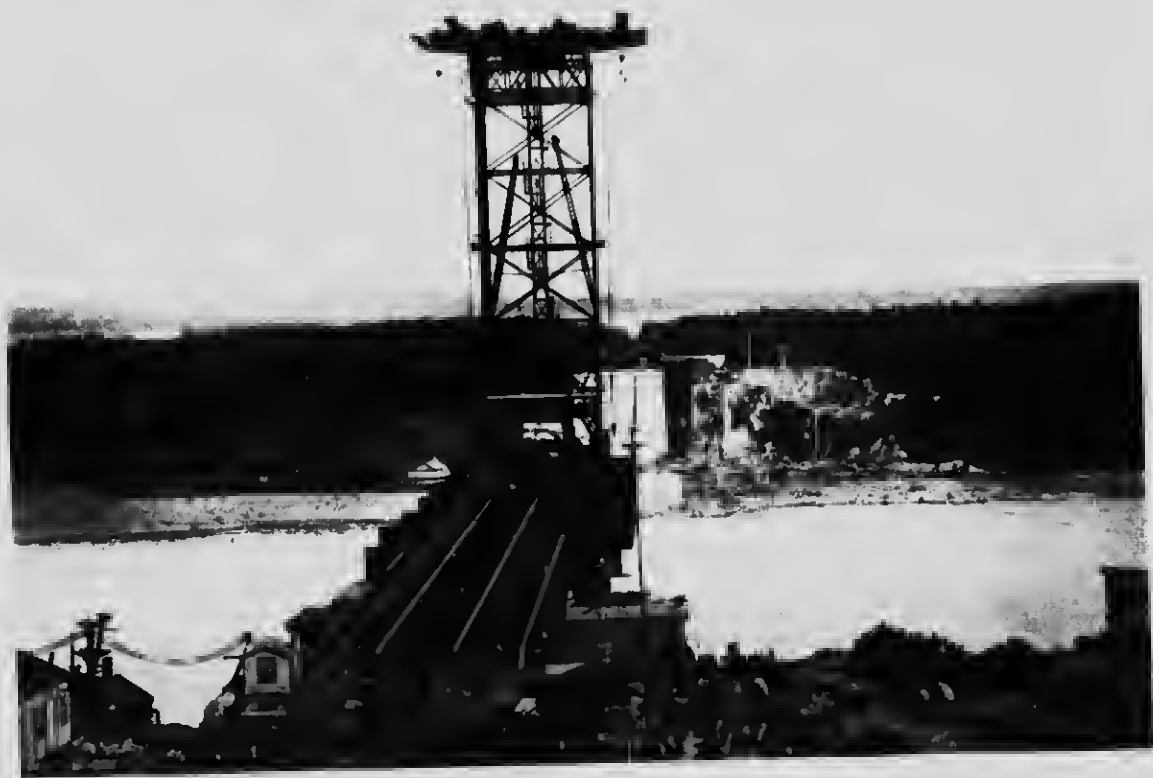
17 End elevation of the traveller at the same position as on plate 16, showing the four tracks on which it was carried and the temporary outside girders to support the outside tracks

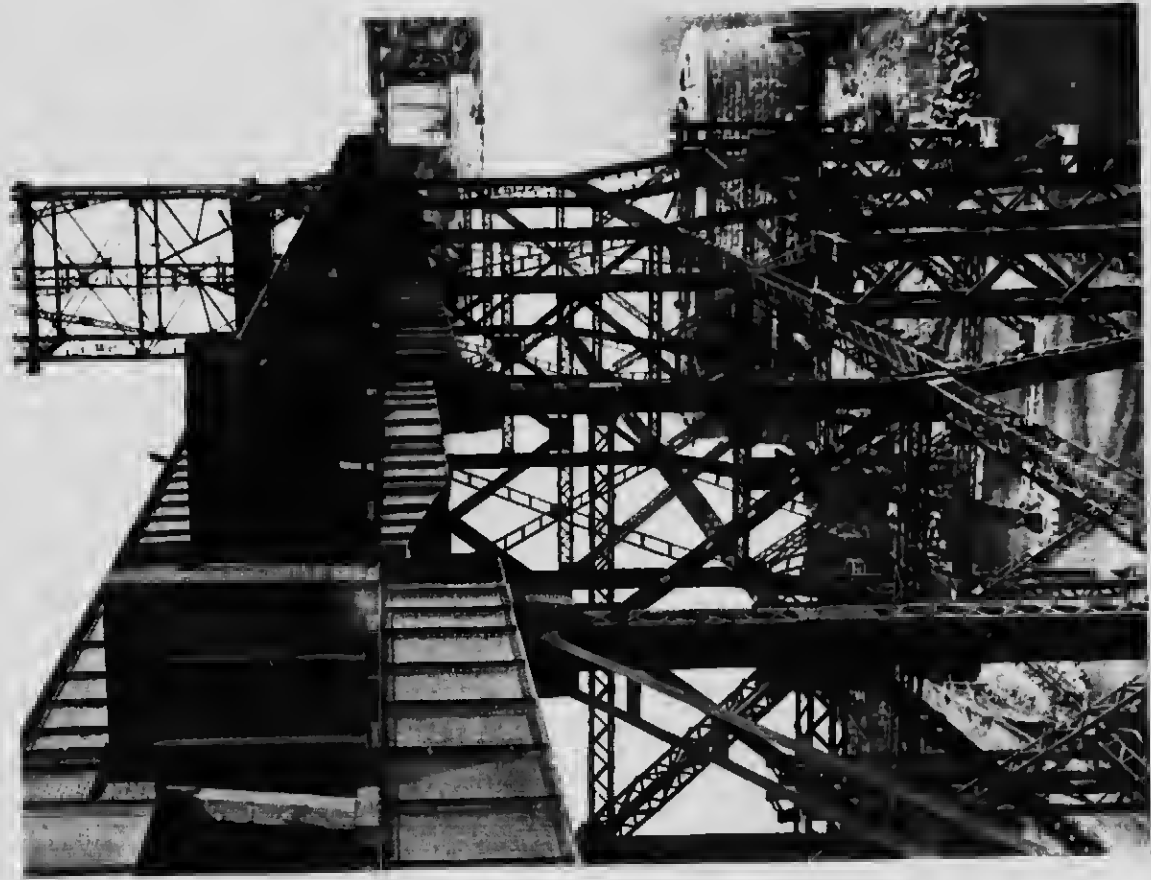
18. Permanent track girders and flow beams supported by the falsework; also shows the hatched pin holes in the end of flow beams.

used as far as practicable for the deck of this falsework, as may be seen by referring to Plates 16 and 18. Steel falsework was also used to support the anchor arm trusses during erection and until the river arms were completed.

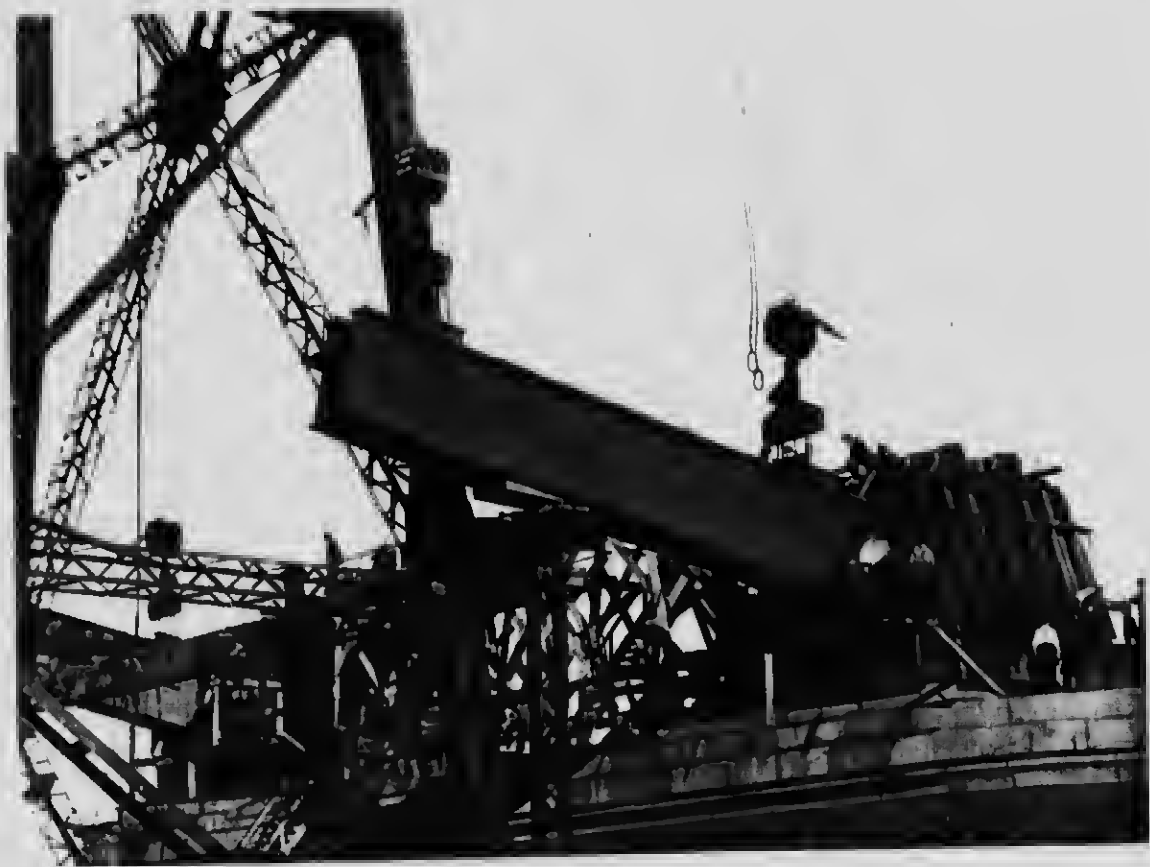
26 The Northwest shore is erected complete except the cover plates over the stiffening ribs. The first section of the lower chord of the anchor arm is being placed

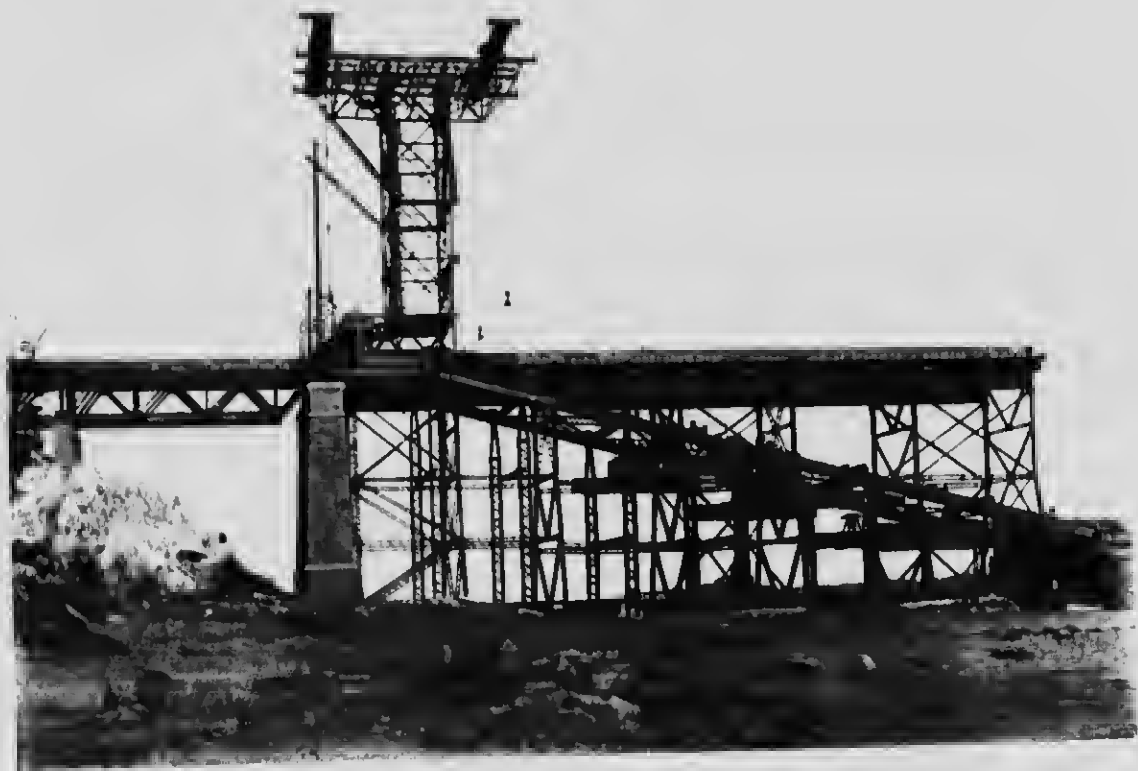
22 The anchor arm lower chord completed. Lowering anchor bars into the wells of the anchor pier

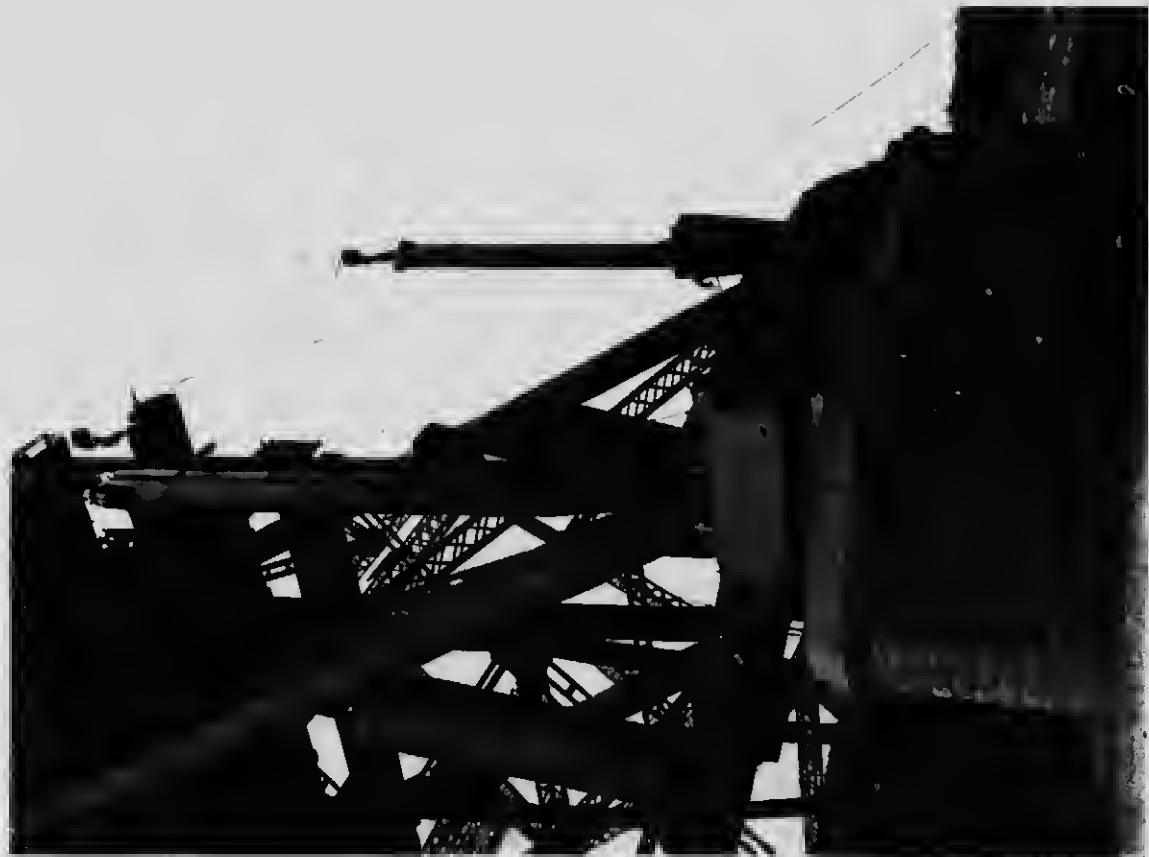
23. Starting the erection of the anchor arm web system

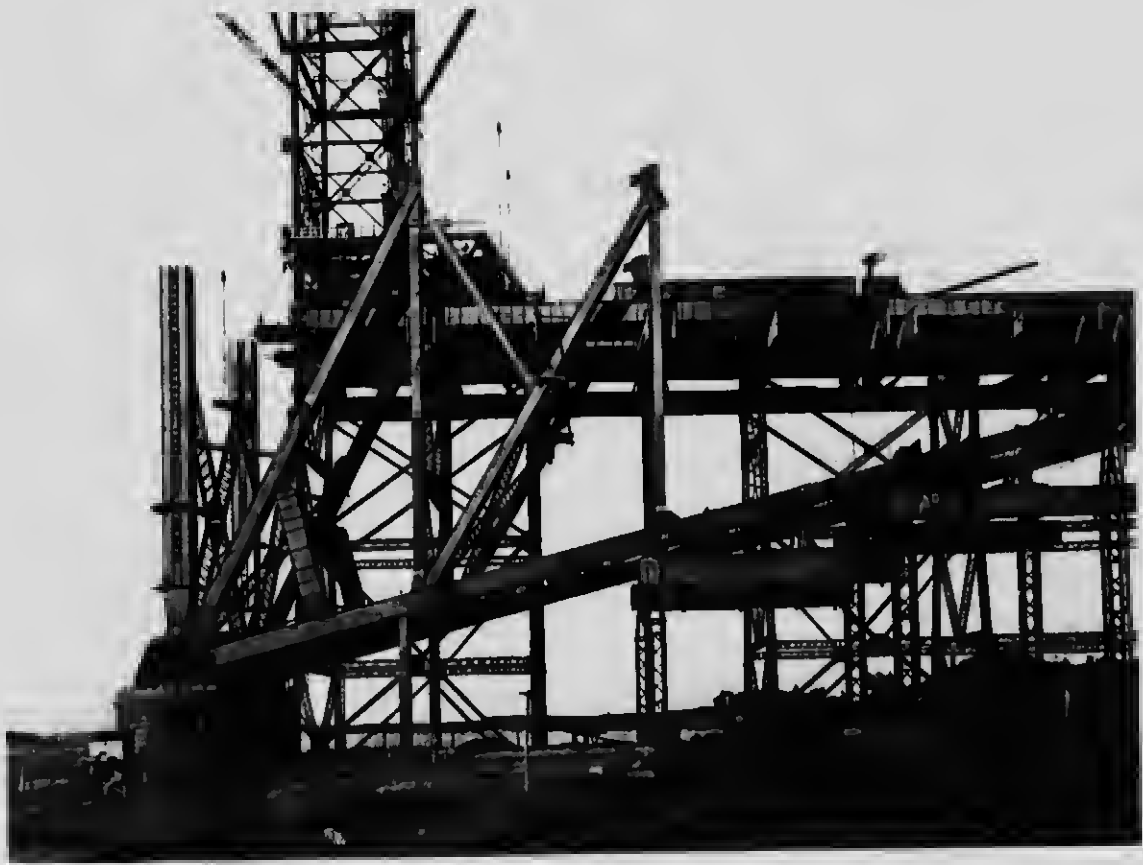
24 Two lower triangles of the web system of the anchor arm erected

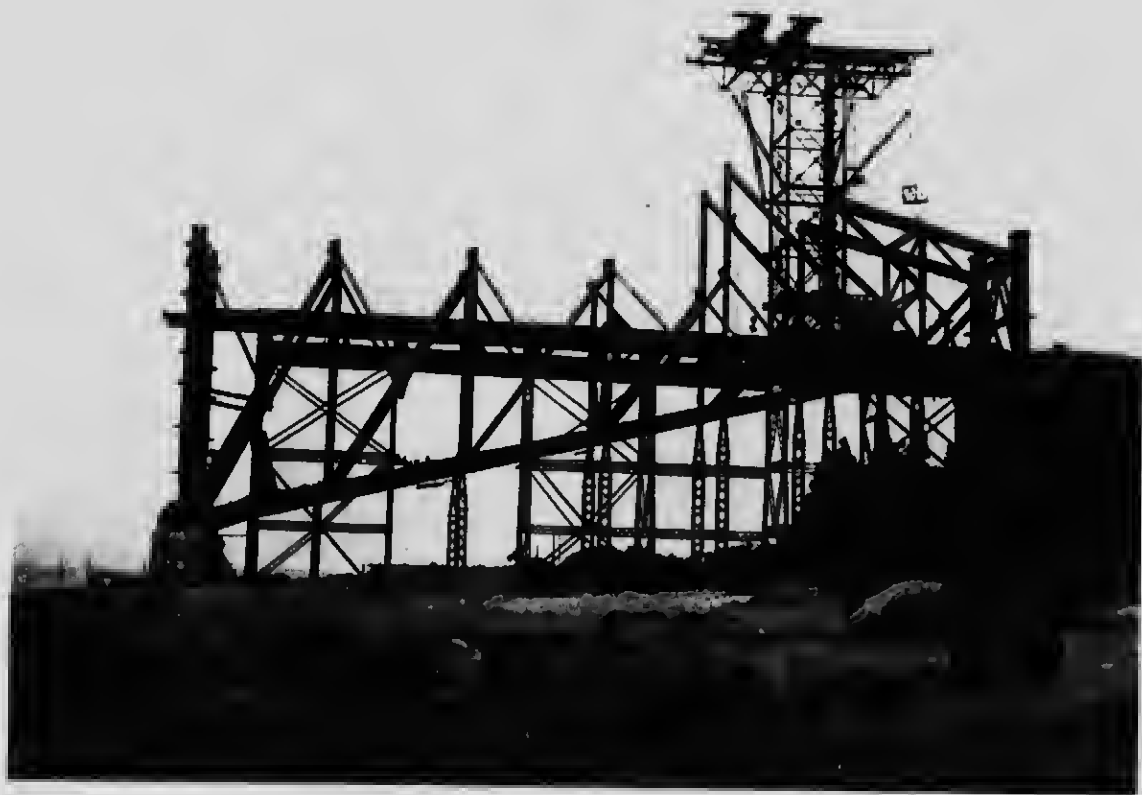
25—All of the lower triangles of the anchor arm erected. Starting the erection of the upper triangles and upper chord

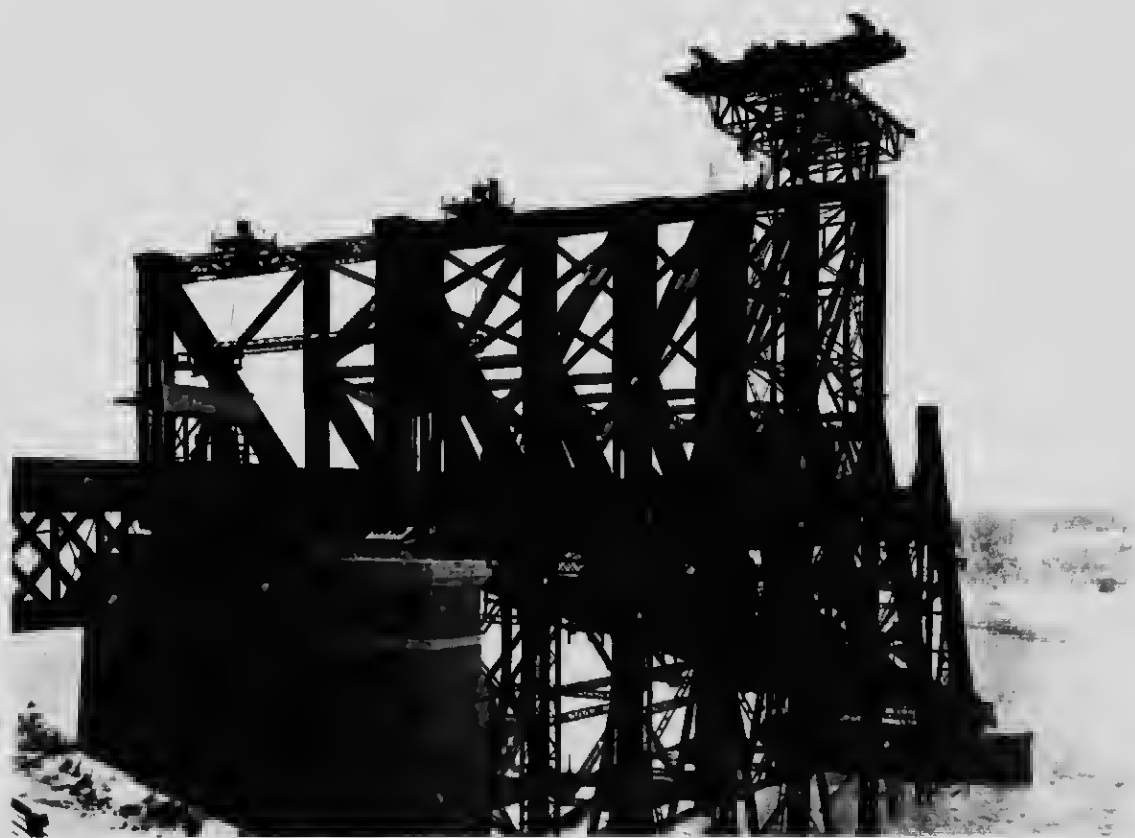
26 Condition of the North anchor arm at the close of the season of 1914

By the end of the season of 1914 the North anchor arm was completely erected with the exception of two upper triangles at the South end, as shown on Plate 26, and the work was left in this condition throughout the following Winter. The tide rising about 5 feet above the falsework foundations, it was necessary to sheathe the bottoms of the bents and the bracing to protect the falsework against ice. Work was resumed on 15th March, 1915, and the North anchor arm was completed, including the main pier posts, on 8th June, 1915. When these posts were erected the framing for camber caused the tops to be 15 inches out of the vertical. The erection of the cantilever arm was at once proceeded with and the traveller was moved over the first sub-panel point, C.M. 15, on June 24th, 1915.

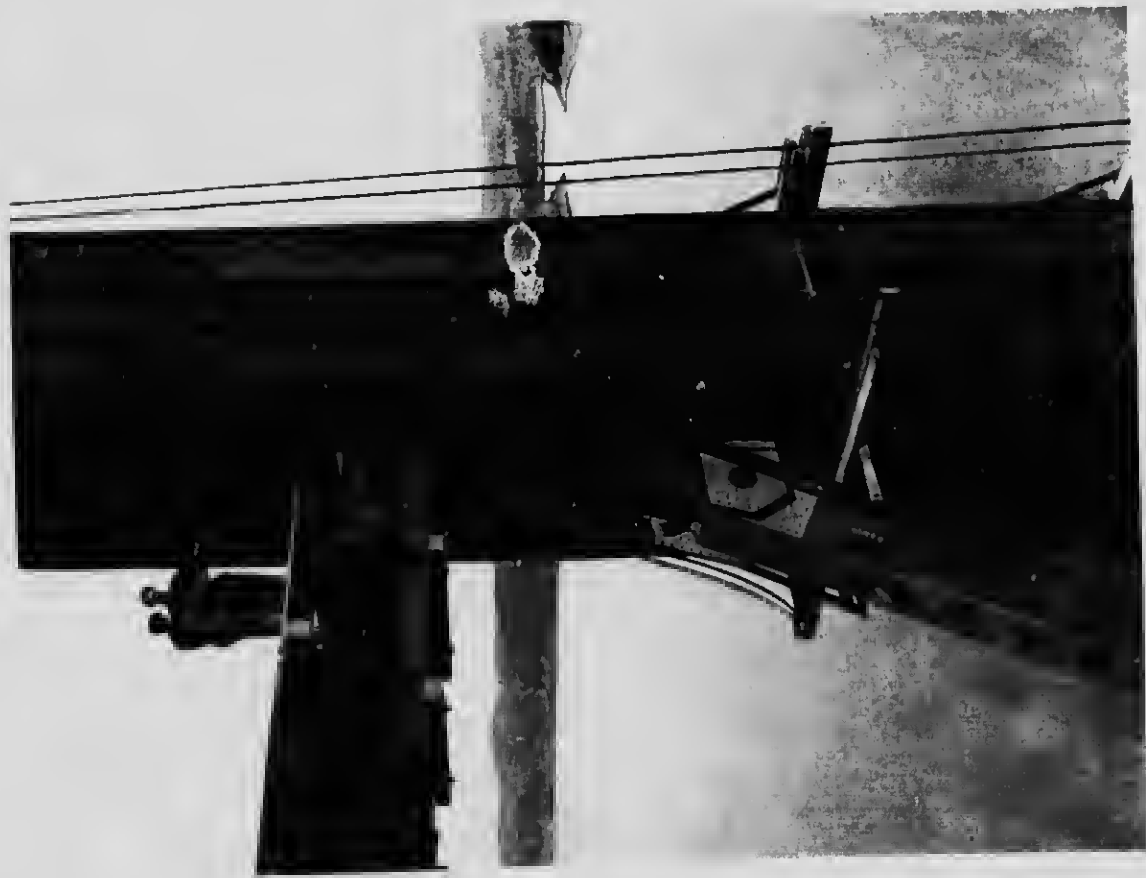
27 Connection of web members at the centre of the large pier over the main pier

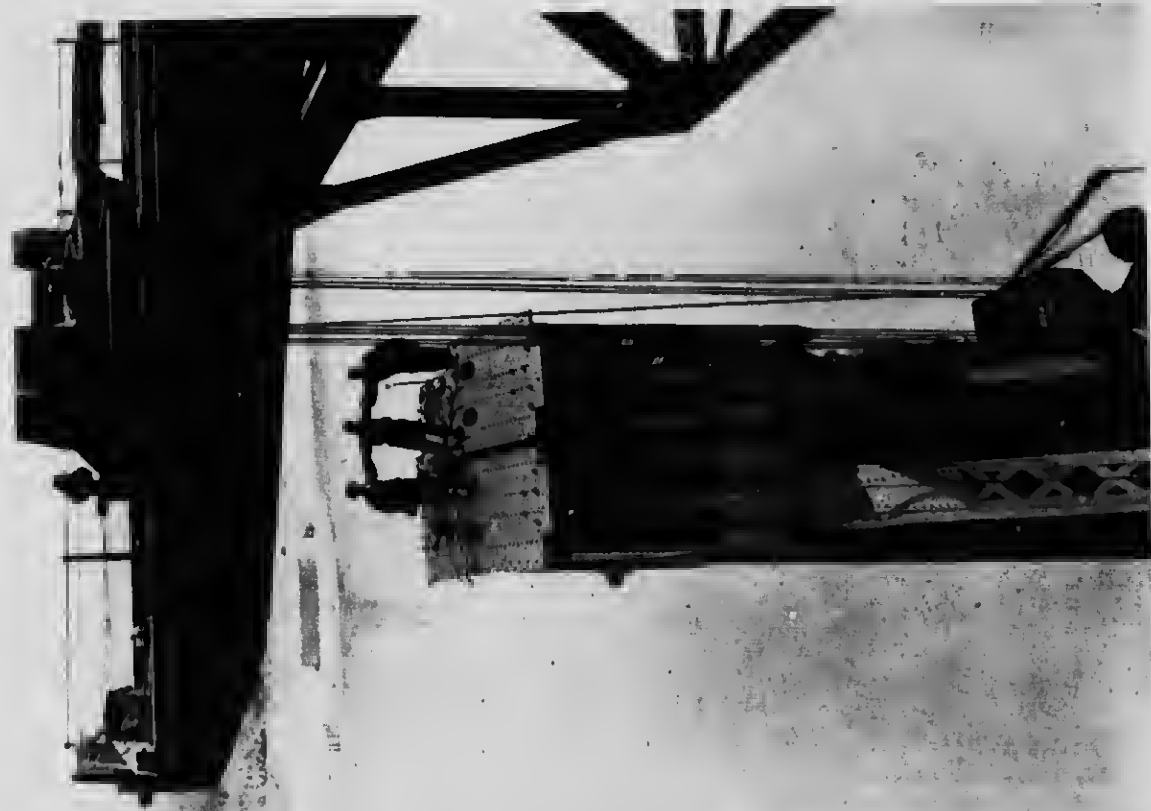
20—The large link at the top of the main pier post is placed

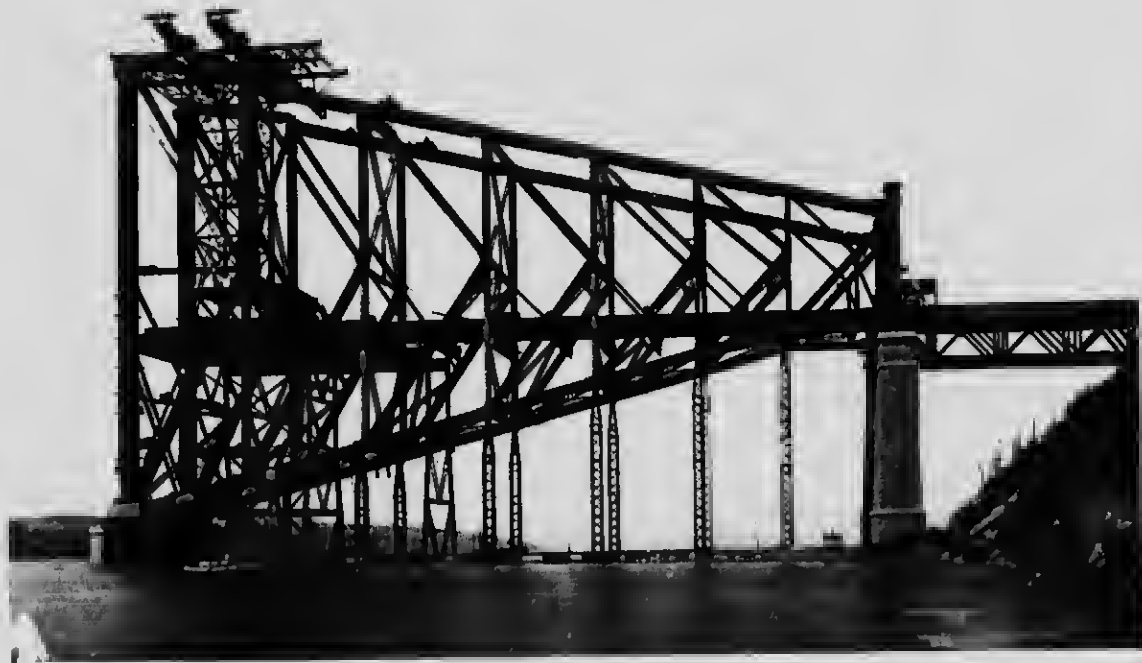
30 The erection of the North Shore anchor arm completed June 7th, 1915

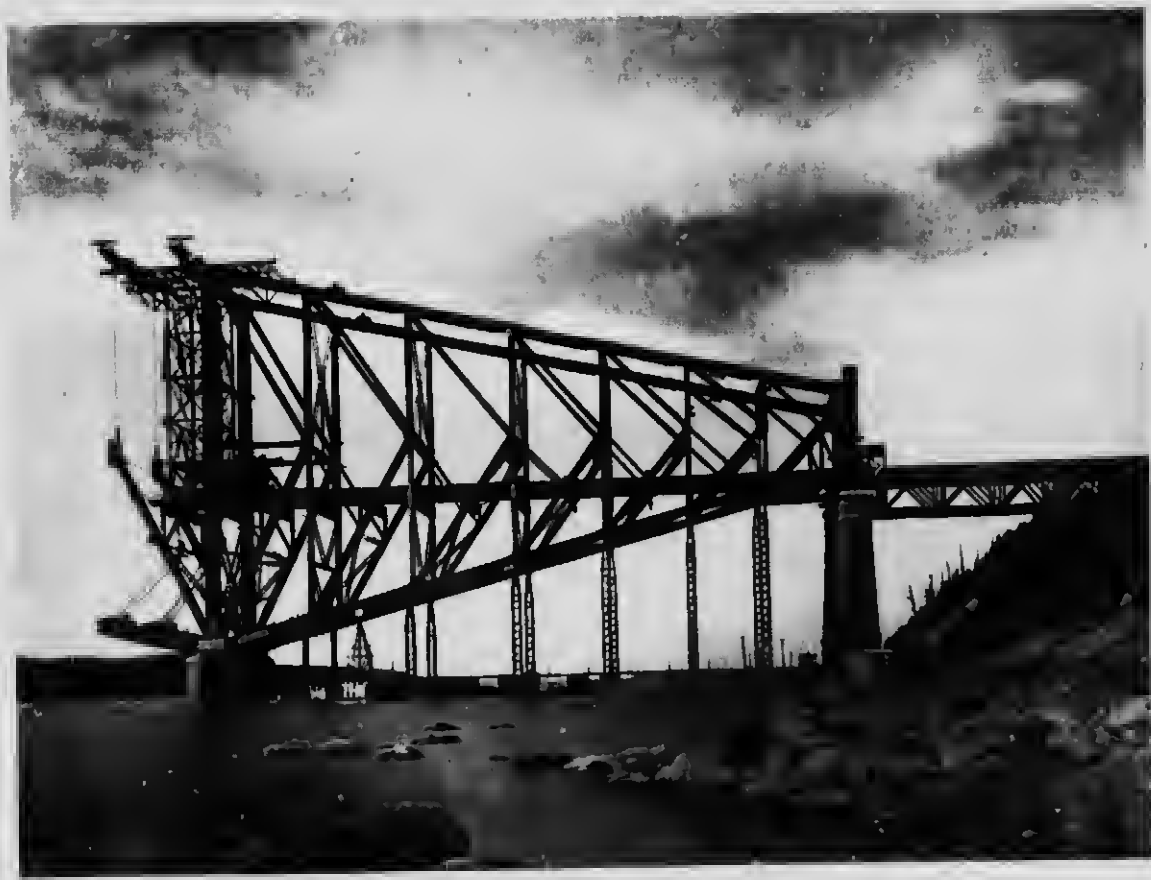
31 Starting the erection of the North Shore cantilever arm, showing the supporting platform in place carrying the first sections of the lower chord

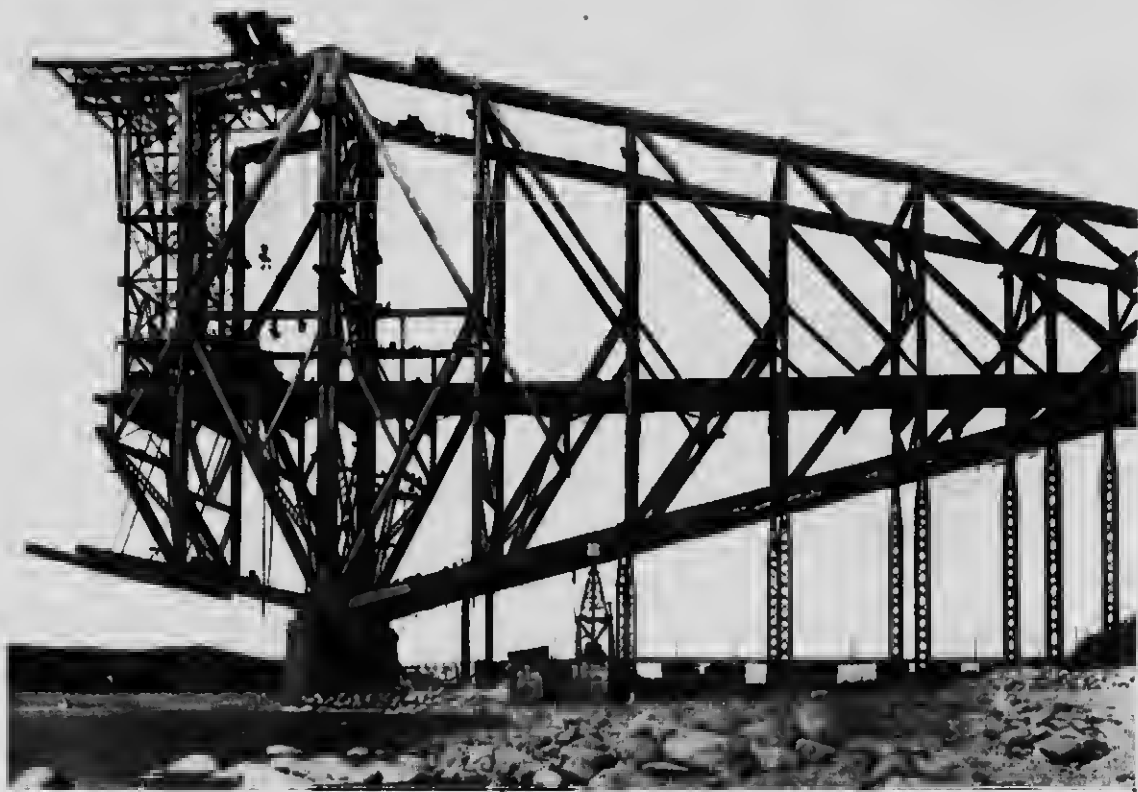
31-Connecting the first panel of the castliver crane

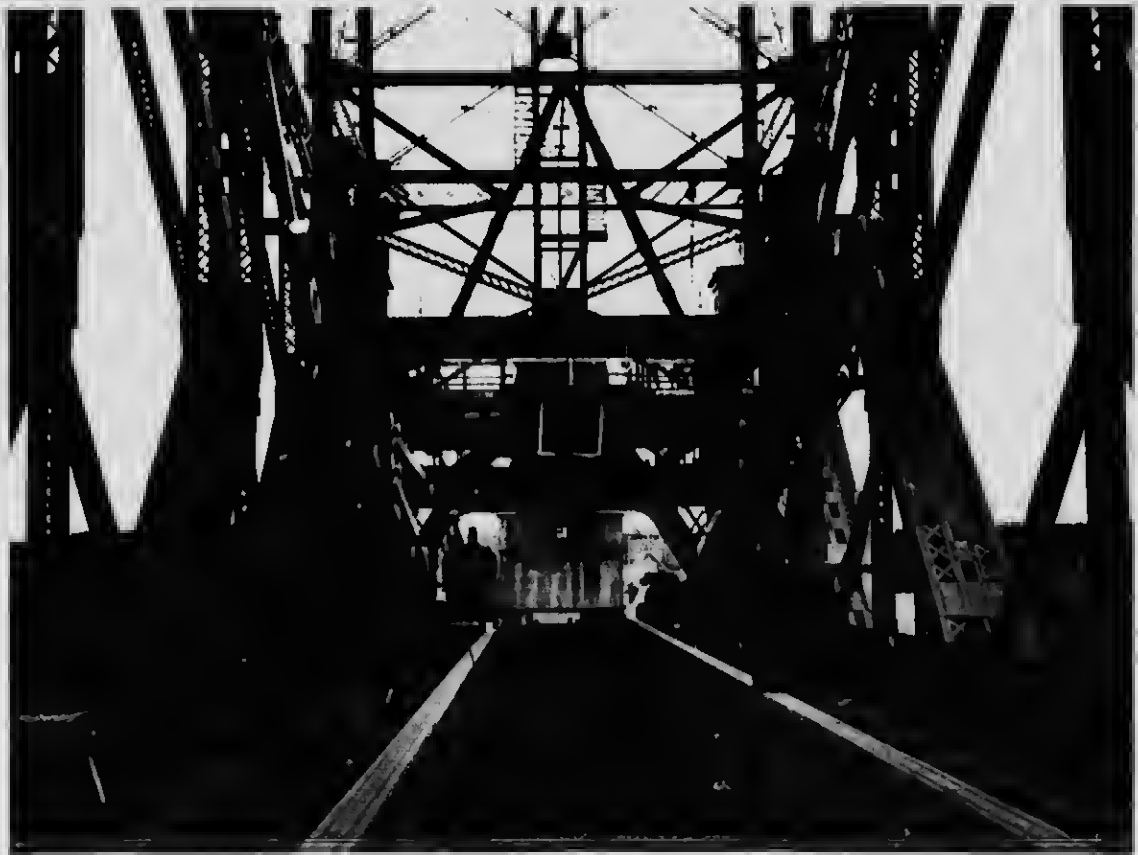
36 Erecting the third panel of the cantilever arm

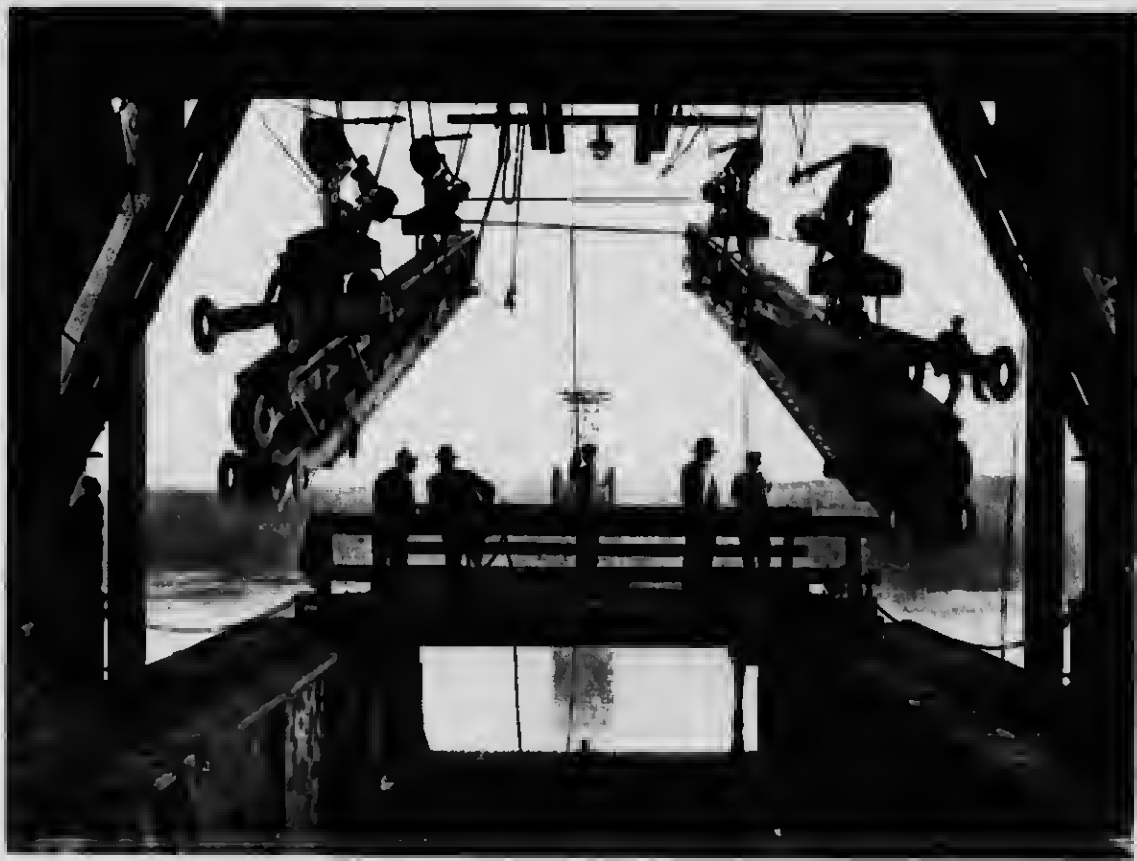
37 Lifting the upper chord eyebars assembled in permanent supporting lattice box girders. Also shows the floor system, the traveller tracks and the switch house

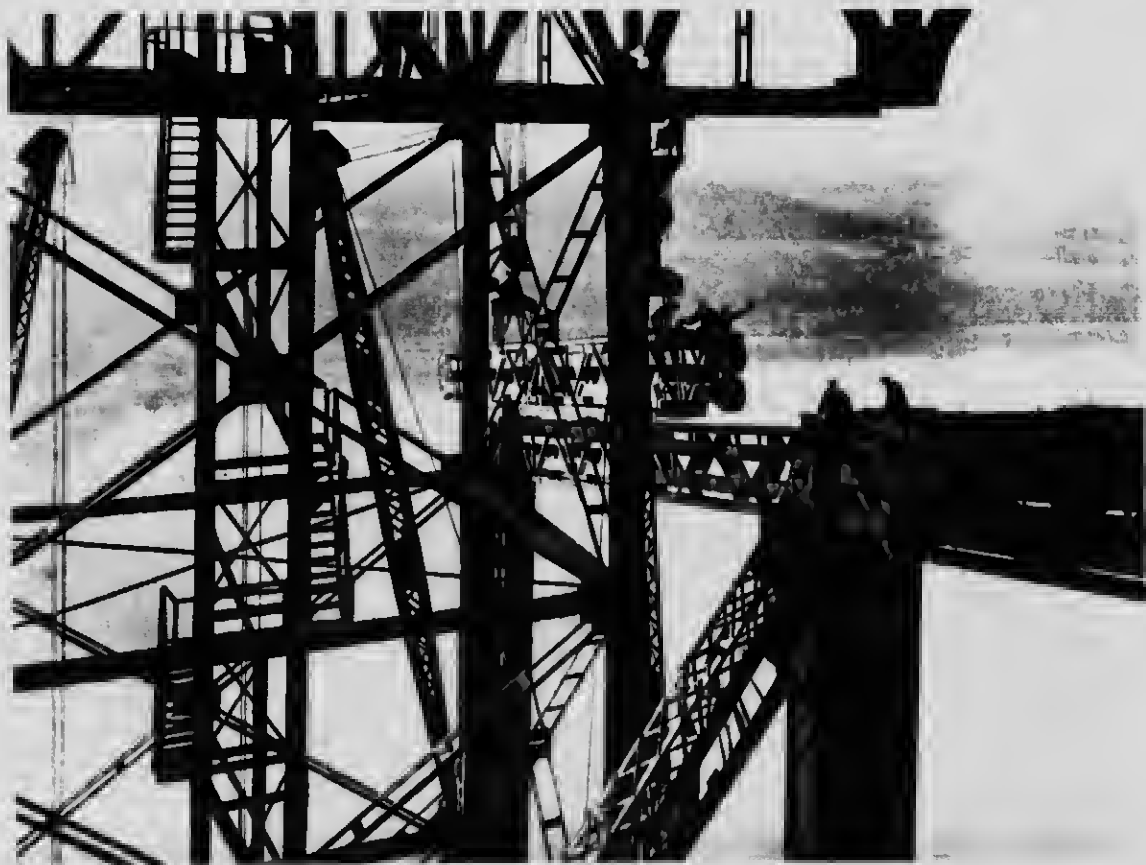
38. Another view of the upper chord eyebars being hoisted, assembled in the supporting box girders. Shows in the distance the South Shore traveller erecting the lower triangles of the South Shore anchor arm truss

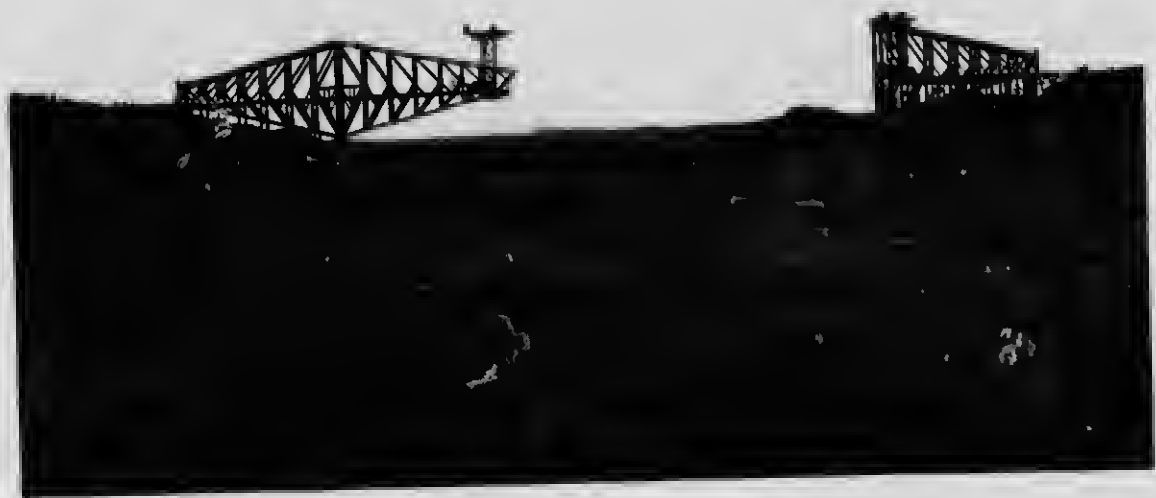
44 The North cantilever arm erected. November 7, 1915

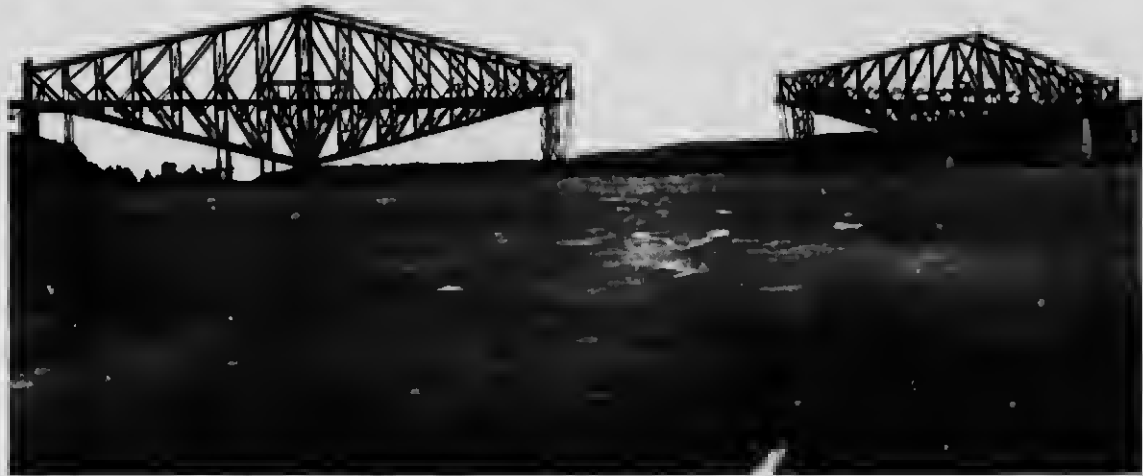
46—Cantilevers completed, hoisting apparatus partly assembled

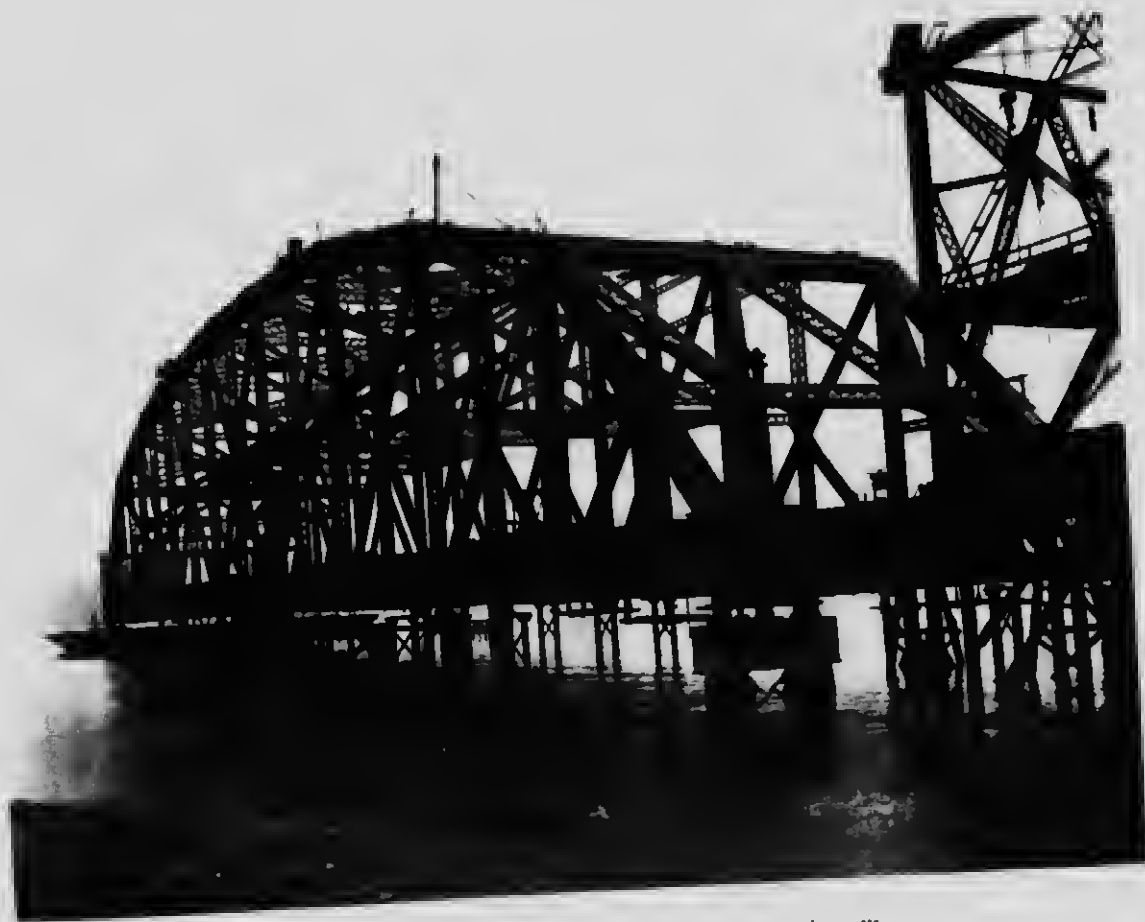
46—The suspended span erected on falsework at Sillery
