THE
QUEBEC BRIDGE

CARRYING THE
TRANSCONTINENTAL LINE OF THE CANADIAN GOVERNMENT RAILWAYS
OVER
THE ST. LAWRENCE RIVER
NEAR
THE CITY OF QUEBEC, CANADA

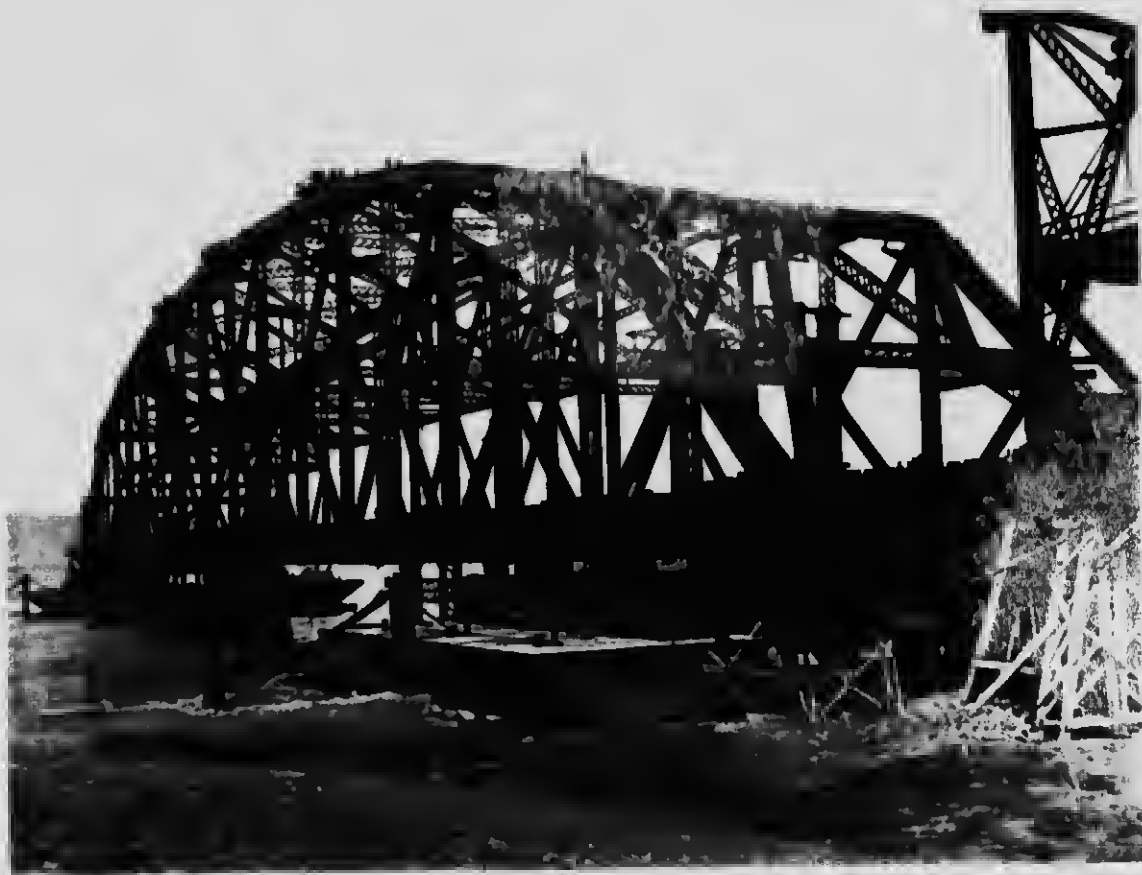
49 - The falsework removed with the suspended span resting on the end supports

The span was erected at such a height that pontoons could be floated under it at high tide and allowed to rest with the receding tide on foundations prepared for them at a height that would permit the blocking and steel grillage girders for distributing the load on the pontoons to be placed under the trusses. See Plate 50.

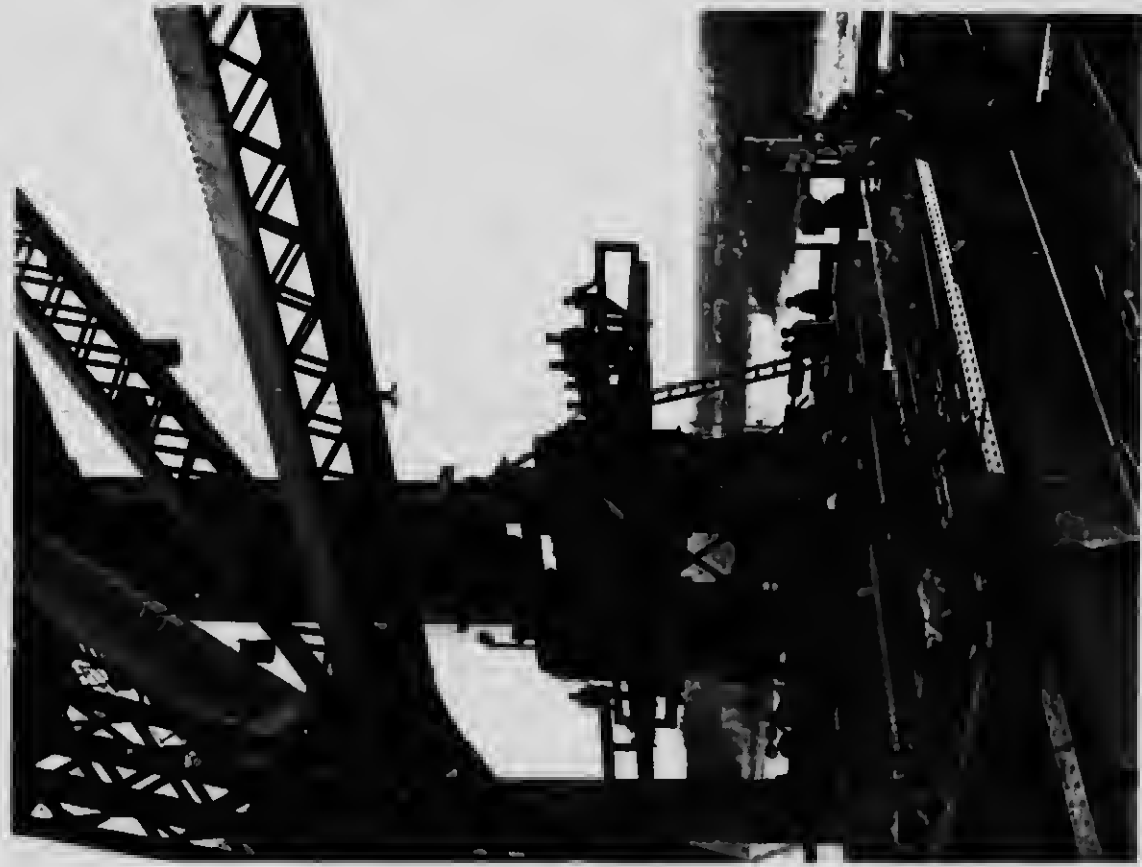
51—Details of the jacking apparatus

The suspended span in condition for hoisting was estimated to weigh about 5,100 tons; the suspension and lifting appliances added about 440 tons, making a total load of 5,540 tons to be lifted by the jacks. The rams of the jacks were 22 inches in diameter and the working pressure about 4,000 lbs. per square inch. The jacks and the lifting girders were tested under a pressure of 6,000 lbs. per square inch by pinning the jacking platform and the lifting girder together.

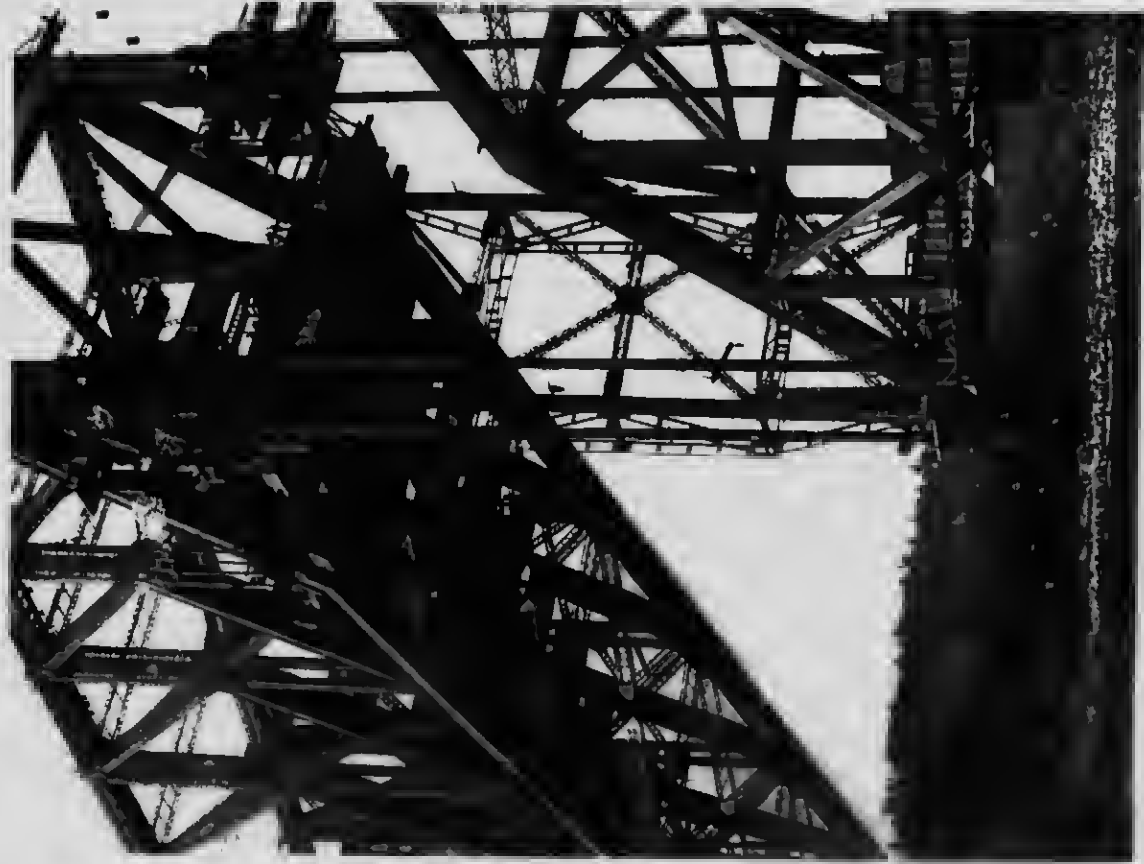
55 The jacking platforms

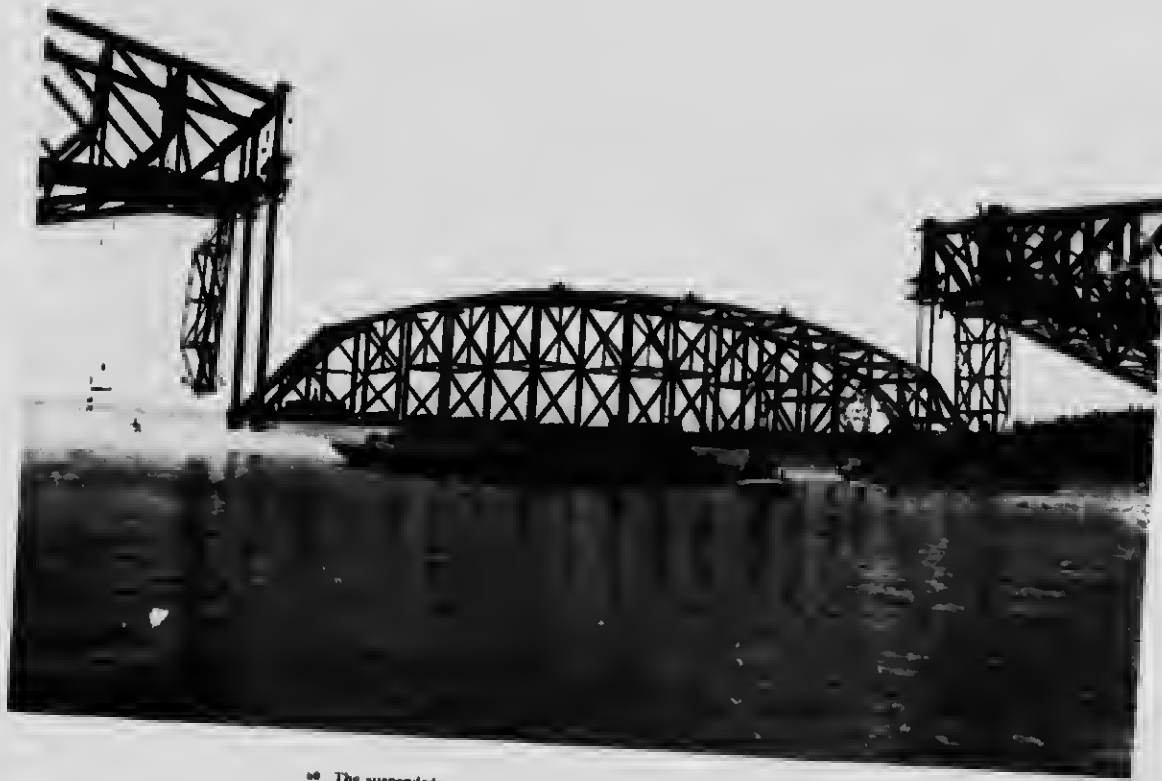
59 - The suspended span moored. Note the mooring ropes, also the hoisting chains being connected.

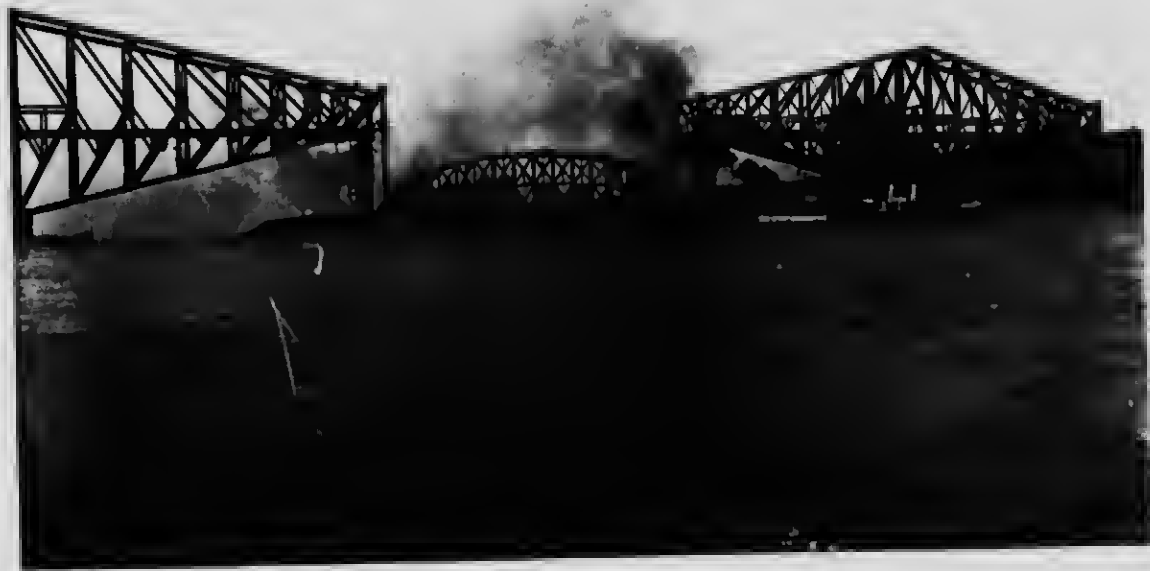
66 The suspended span carried by the hoisting chains; scows floating out

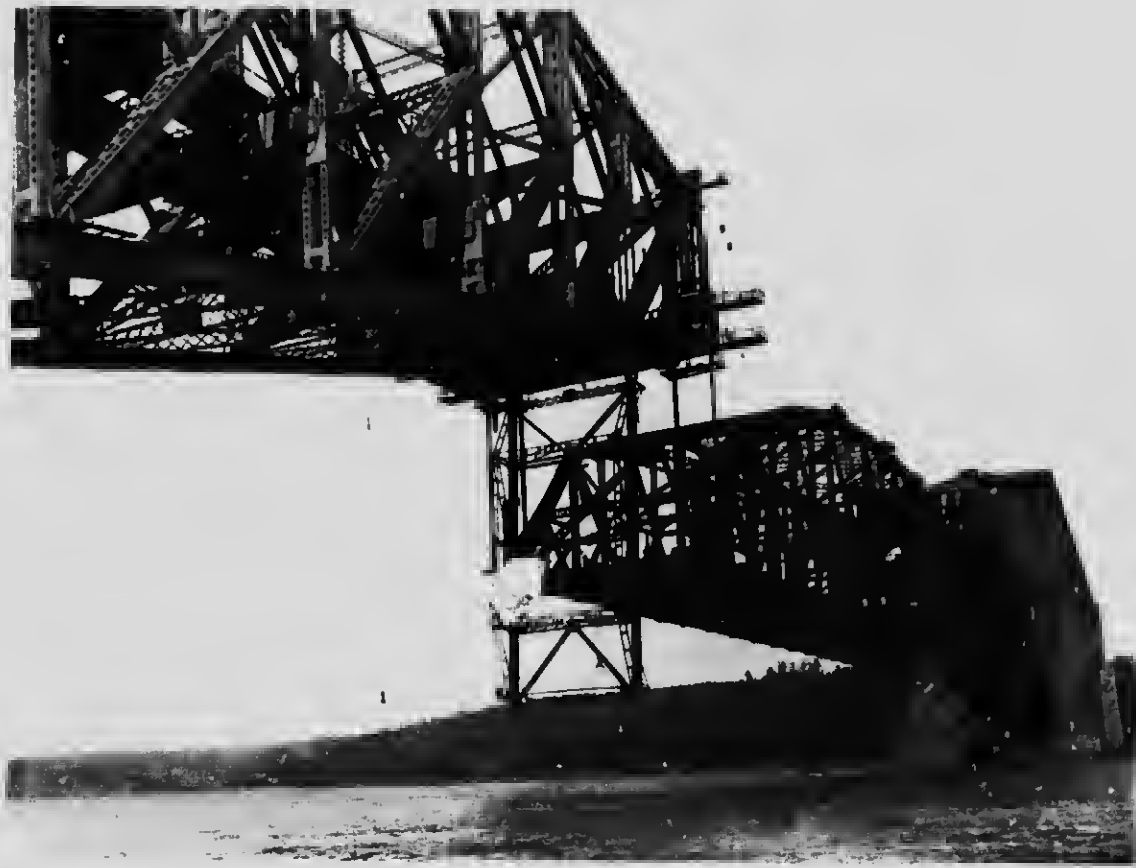
65 Condition of lower show and carrying glider after the loss of the suspended span

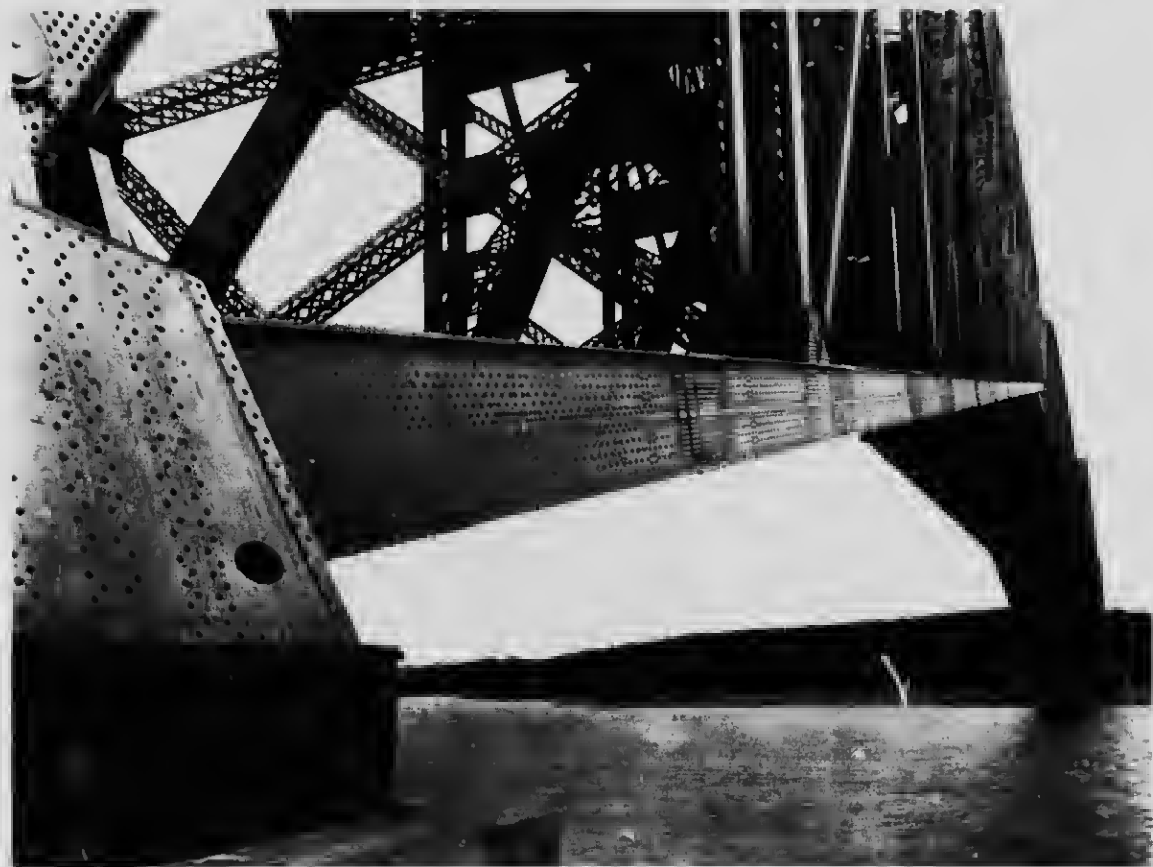
76 View from the top of the N W Main Post, showing inspector's walk, which is reached by means of 12 steel stairways
