The Canadian Society of Civil Engineers.

THE CONSTRUCTION OF A TIMBER DRY DOCK.

By G. B. Ashcroft, A. M. Can. Soc. C. E.

To be read before the General Section, 20th April, 1905.

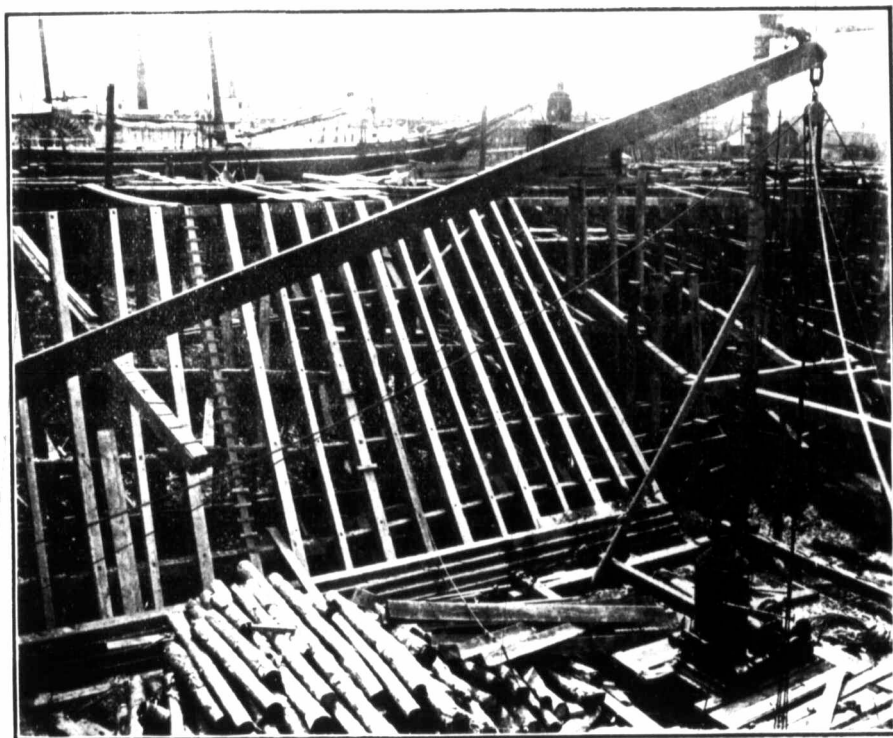
Shewing the side slope timbering.

They are secured to the slope timbers by 12 inch boat spikes, and abutting ends are doweled with 1 inch by 6 inch iron pins. They are laid with the treads horizontal, which causes the lowest course to disappear about every 170 feet, owing to the rise in the dock floor.

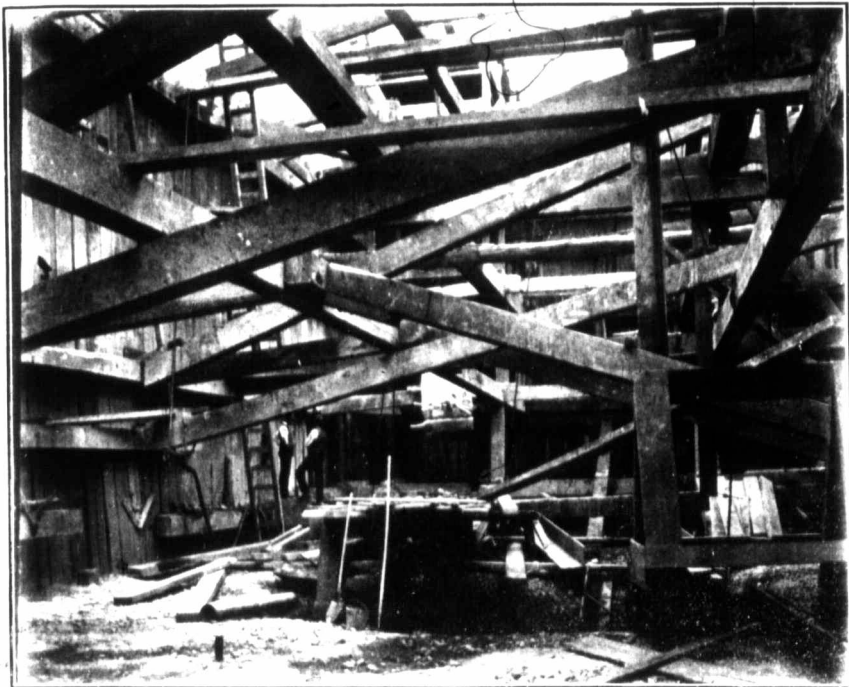
Showing temporary bracing required in foundation pit.

Within the box like enclosure formed by the bulkheads and the two rows of 34 foot sheet piles, excavation was started for the foundations of the masonry work and the engine pit. The more material removed, the greater became the need of temporary bracing to keep the sides of this box from collapsing. Complete sets of bracing were placed in position for every 6 or 8 feet of excavated depth and as the 12 by 14 and 8 by 14 inch slope timbers were used for this work it was important that they should be cut as little as possible.

Each set placed made it more difficult to place the next below, until the time came when the long timbers could not be landed in horizontal positions and had to be placed wherever a suitable opening could be found.

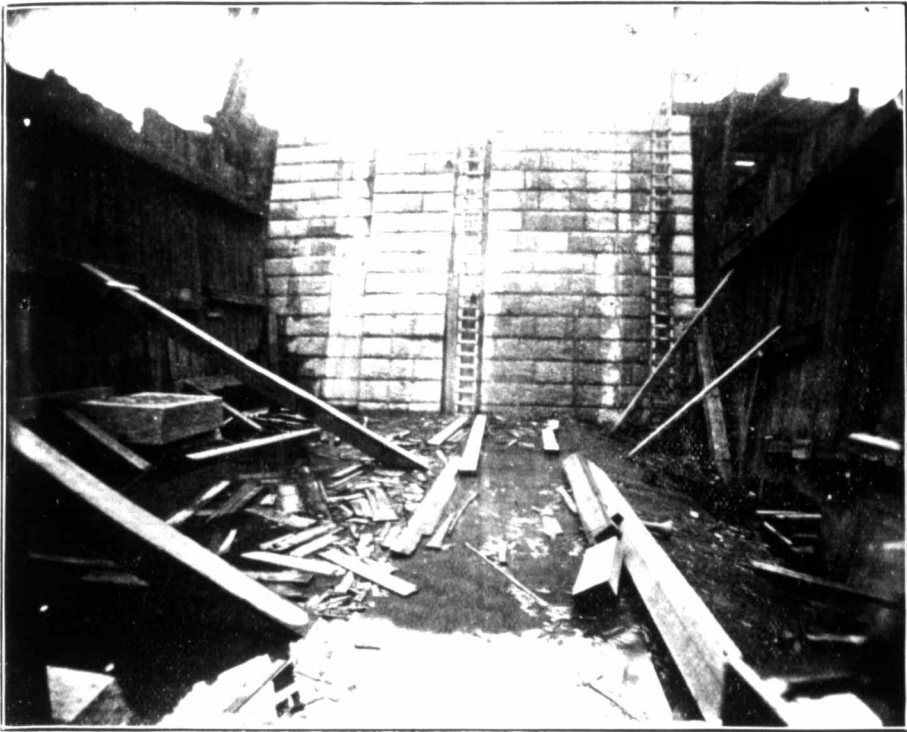
The Completed Abutment.

Upon a seven foot layer of this concrete as a foundation were erected the masonry aprons and abutments.

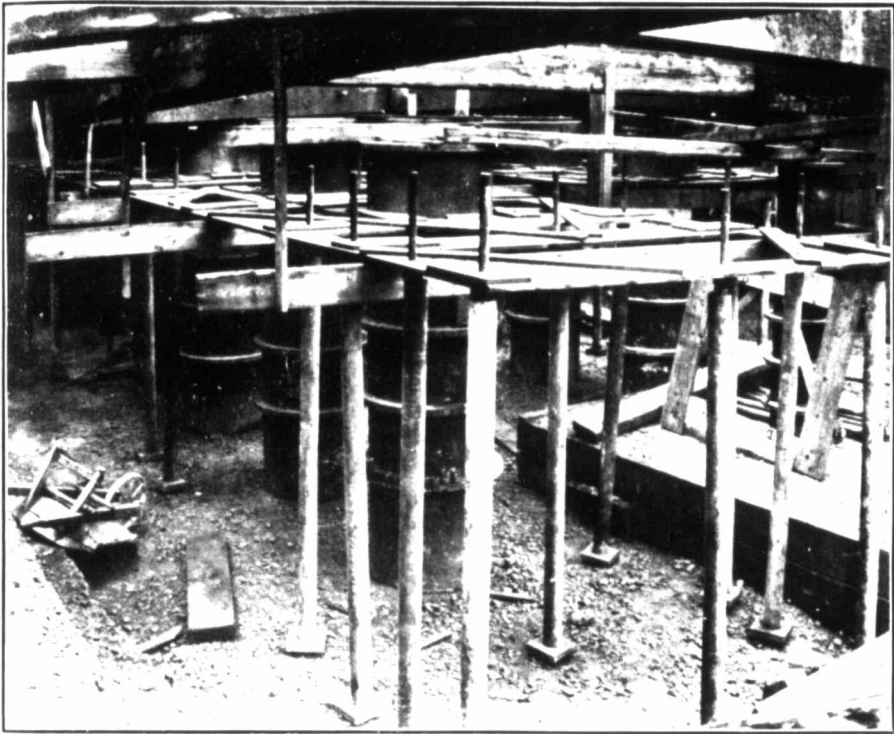
Shewing method of setting anchor bolts for engine bases.

Anchor bolts for the engine bases were about 7 feet long, set within a length of 4 inch gas piping, with heavy cast iron base plates at the bottom.

After the engines had been aligned these gas pipes were run full of cement grout.

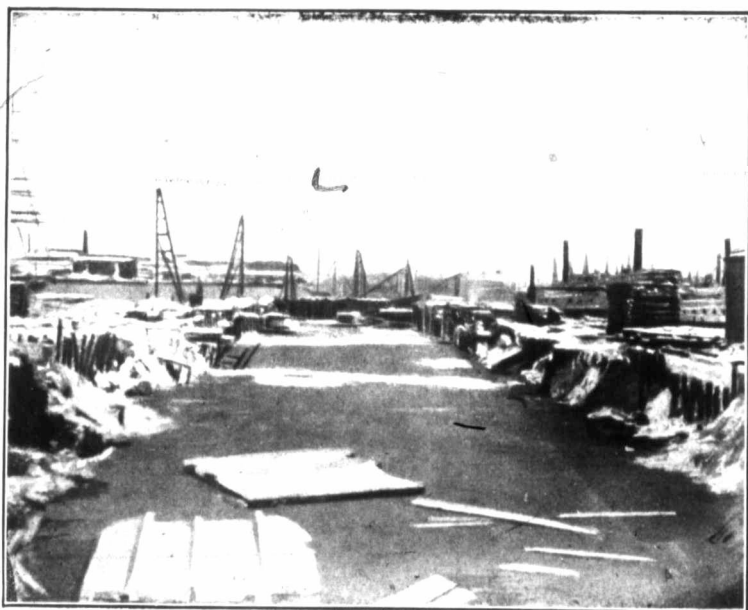
Driving piles from the Temporary Braces.

The pile drivers were placed on run-ways laid on top of these transverse braces, and from this elevation, the piles for the bottom and the side slopes of the first 200 feet of dock length, were driven.

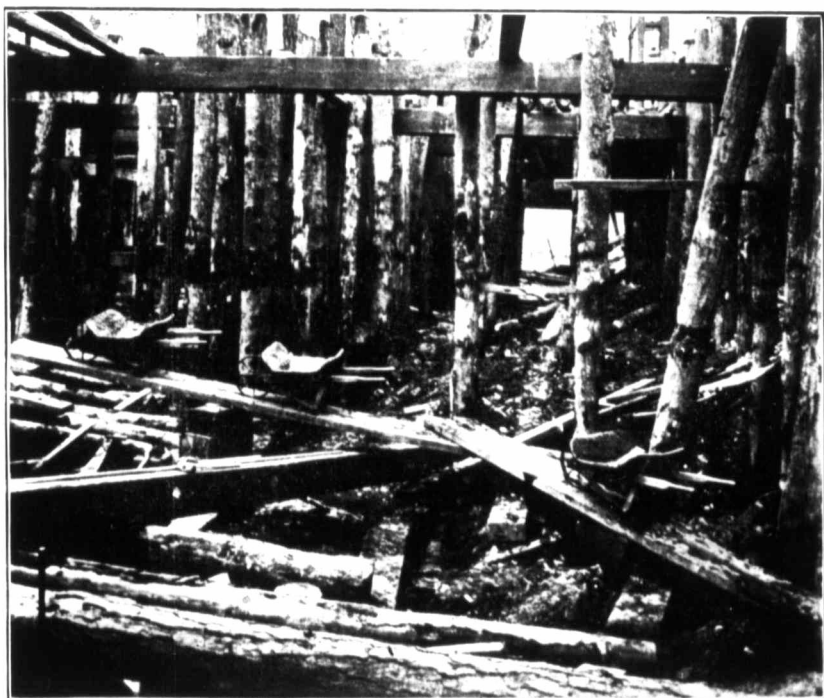
Shewing feet of piles, driven from temporary bracing, before excavation had been completed to point of cut off.

Meanwhile excavation was being completed to the final elevation of pile cut-off, and as fast as a portion could be cleared, the piles would be cut and capped, and the 70 foot cross floor timbers placed in position. The piles driven from the elevation of the temporary braces, shown above, were found to be badly out of line at the point of cut-off, some so badly out, that it was necessary to cut them off a foot lower and cross cap them, in order to obtain any bearing.

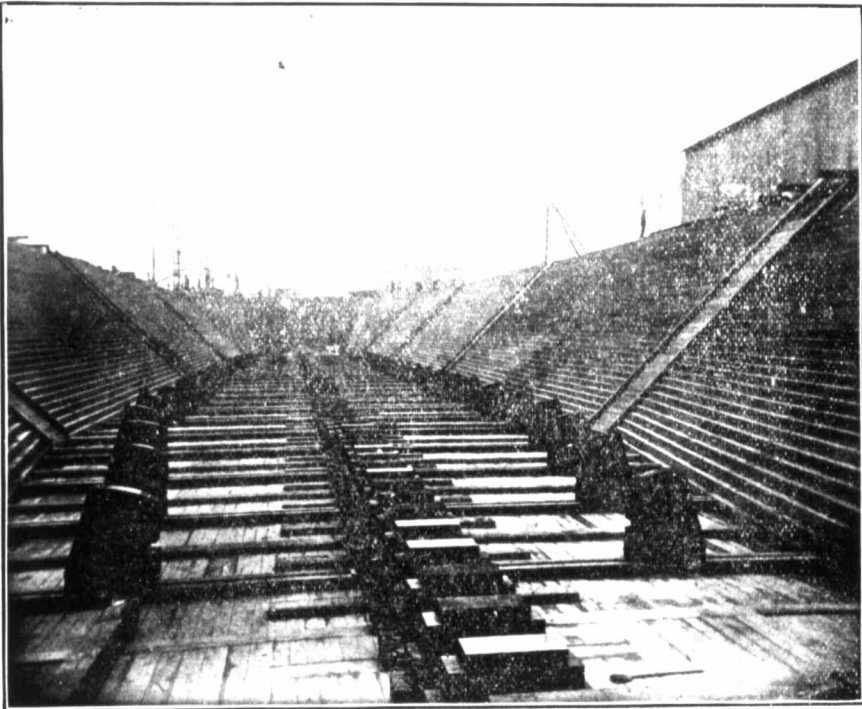
Showing main body of dock, looking from box in the head.
