The Canadian Society of Civil Engineers.

The general aspect of the Shubenacadie River at the bridge site is shewn by photos 1 and 1a. These show the tide about three parts run out.

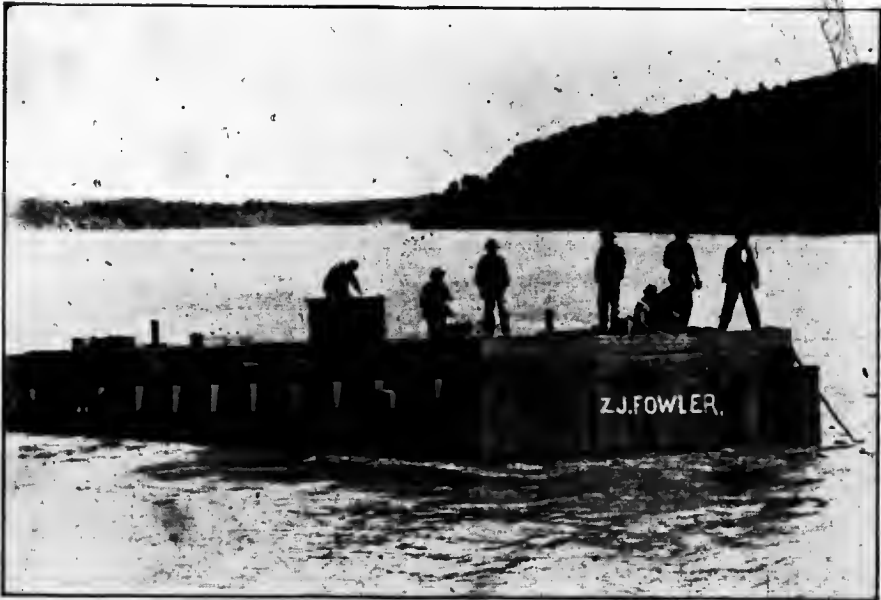
Photo 2.—Showing Caisson on way down from shipyard to Bridge site.

Photo No. 2 shows the caisson "Z. J. Fowler" for No. 4 pier, strengthened as above described, and on the way down from the shipyard to the bridge site. This view shows very little of the caisson proper, as that is submerged. It shows the first three 12 x 12 courses of crih timber above the caisson roof, also the first steel pneumatic section, the air admission pipe, and the blow out pipe, and the upper timbers of a very special feature of these caissons, namely:—the mooring crih, to which was secured the heavy steel cables which held the caisson in position against the fierce tides.
