ICE TROUBLE AT HULL ELECTRIC POWER HOUSE.

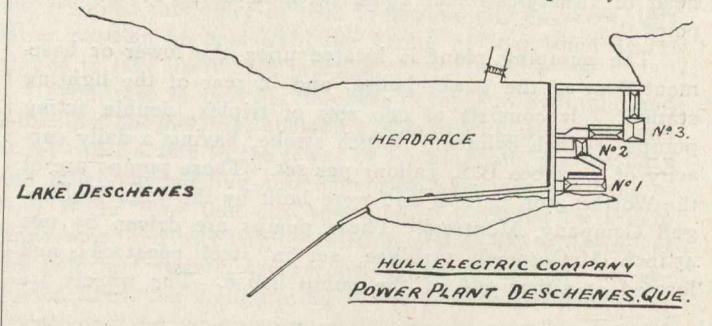
OTTAWA RIVER

It will be seen from the enclosed sketch that the power plant is located at the foot of Lake Deschenes, and in consequence comparatively free from frazil ice trouble.

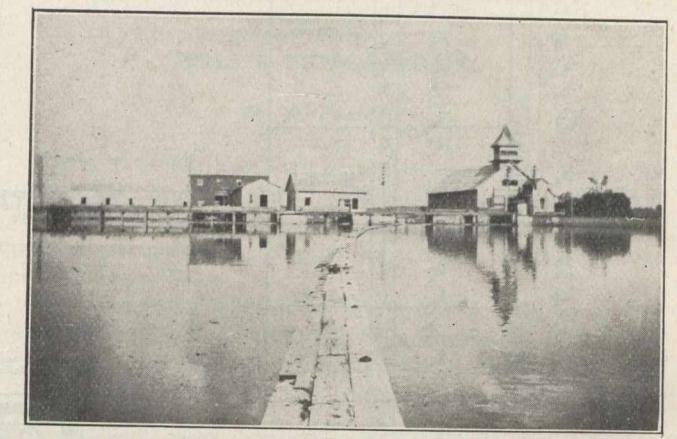
Head Race, Bulkhead and Power House of the Hull Electric.

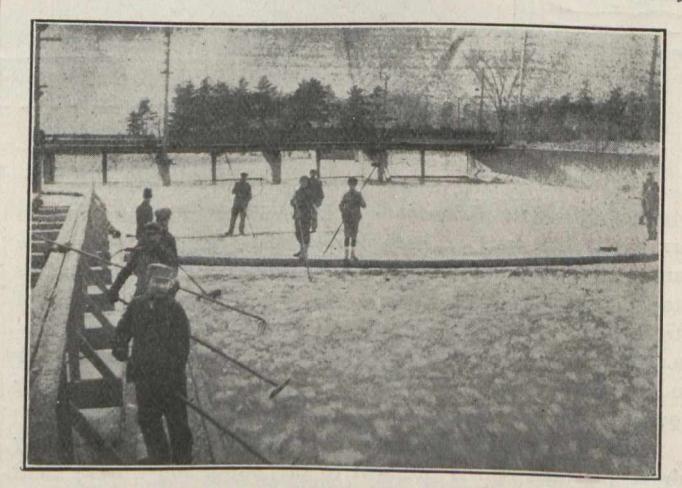
into the forebay and against the racks. Frazil began to form, blocking the racks, and the wheel gates had to be closed. The slush packed from the bottom of the forebay to, in some cases, two feet above the surface of the water,

and extended from the racks to the end of our wing dam. This had to be drawn towards the sluice way by a large gang of men armed with wooden scrapers. The sluice way not being of a very large area produced no appreciable current, so that this method proved very slow and little progress was made until the weather became colder and tended to solidify

Forebay at Hull Electric Power House. Forebay full of Slush, Frazil Ice, etc.

the mass. Virite was then used to advantage. About 300 lbs. of this explosive was used before a channel was opened up through the ice pack to the lake.
