Water Powers on St. Francis River

Spillway Deck, St. Francis Storage Dam

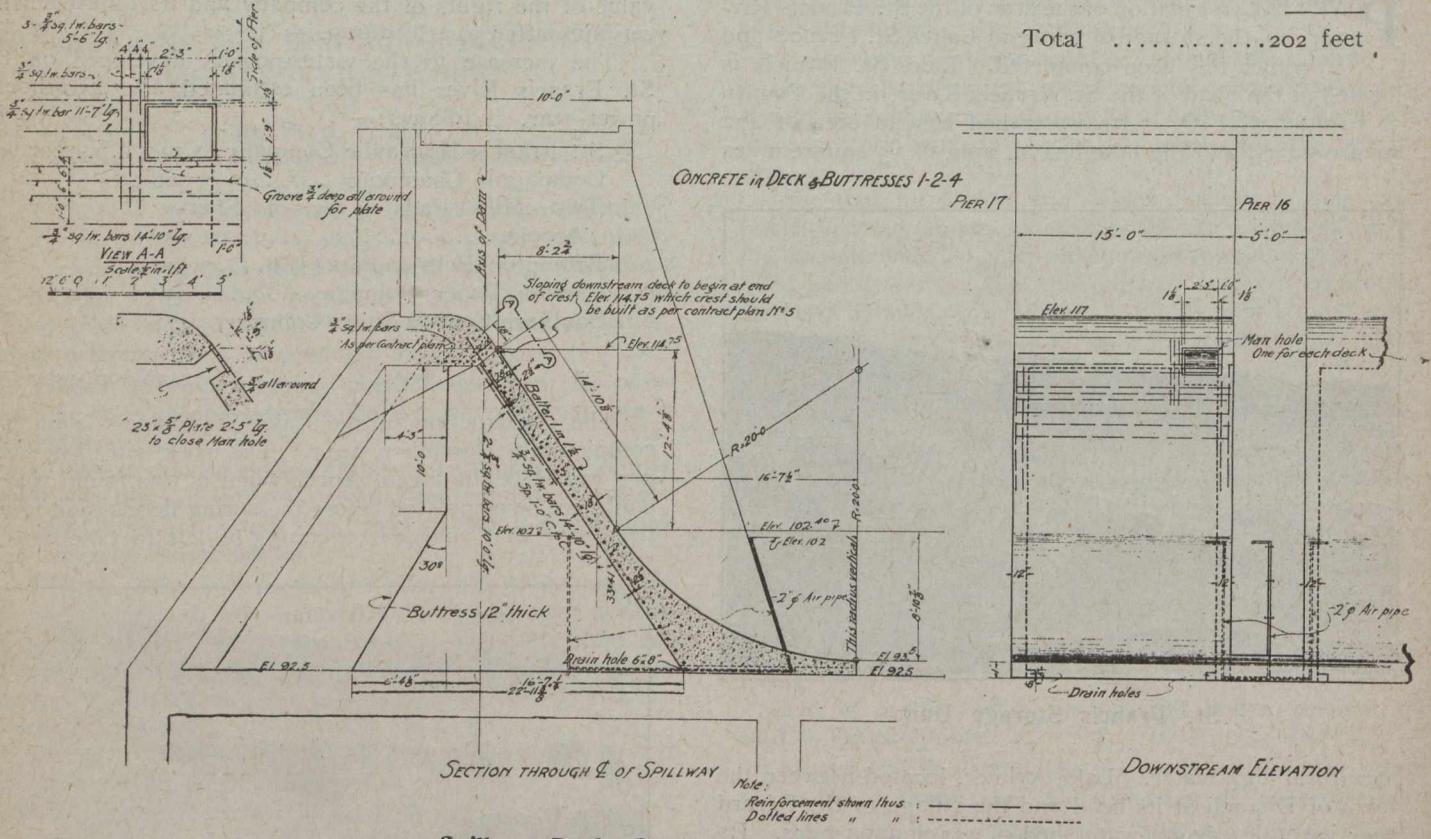
During construction it was thought advisable to build a concrete spillway deck in two spans of the spillway, so that the water let out from these two openings should not fall on the base of the dam but would be directed to the downstream apron, thus eliminating the impact due to the fall. Moreover, these two openings, which are adjacent to the log sluice, may be used to pass logs should an accident render the regular sluice not sufficient. The above drawing shows the construction details of these two decks.
