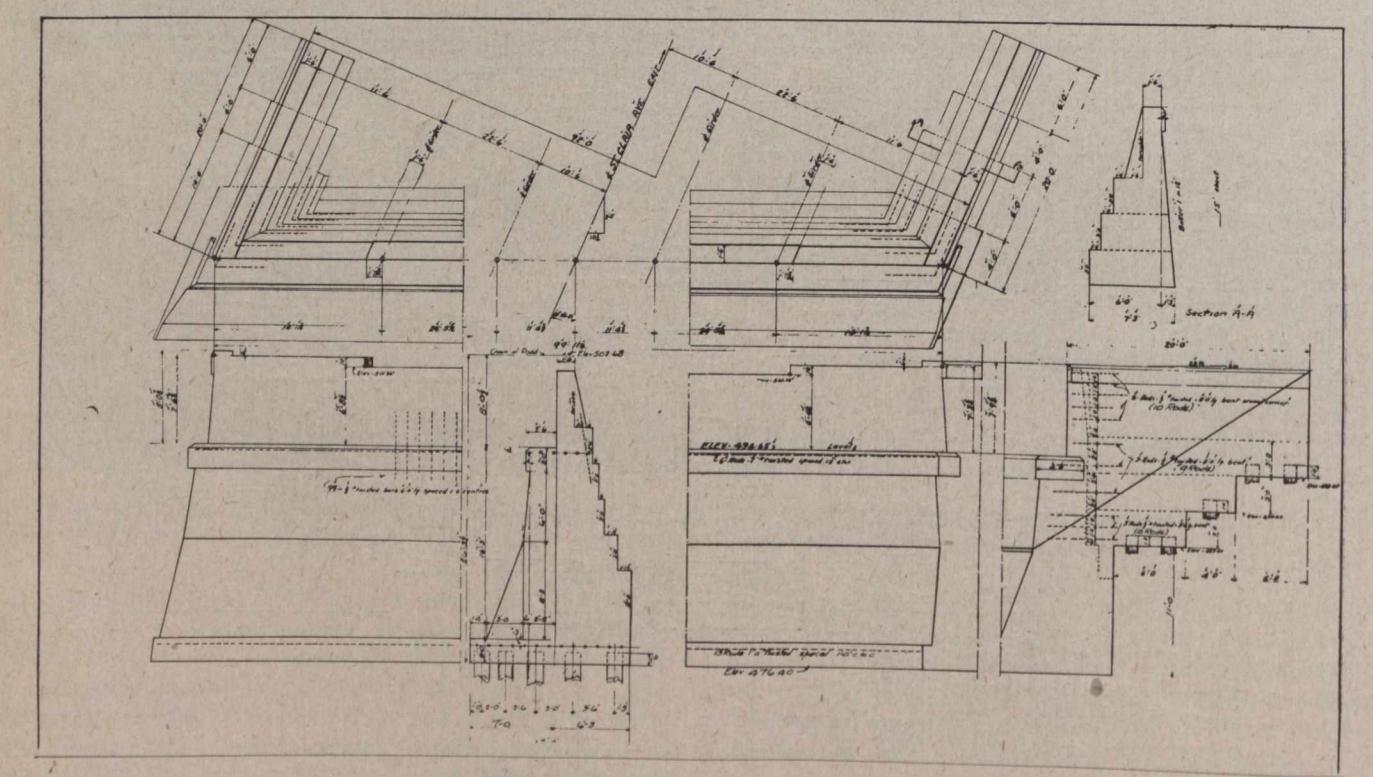
Fig. 5.—Design of East Abutment.

The abutments and piers are built of mass concrete with local reinforcement. The concrete mix was 1:3:5 below underside of coping and 1:2:4 above. The abutments are 26 ft. high and 100 ft. long with 20-ft. wing walls parallel with the street line. The base of the main wall is 13 ft. 3 in. wide. Reinforcing steel (square twisted rods) is supplied in the base over the piles, under the bridge seat, at the rear of the back wall and around the corners. No expansion joints were used.
