## crowd egress

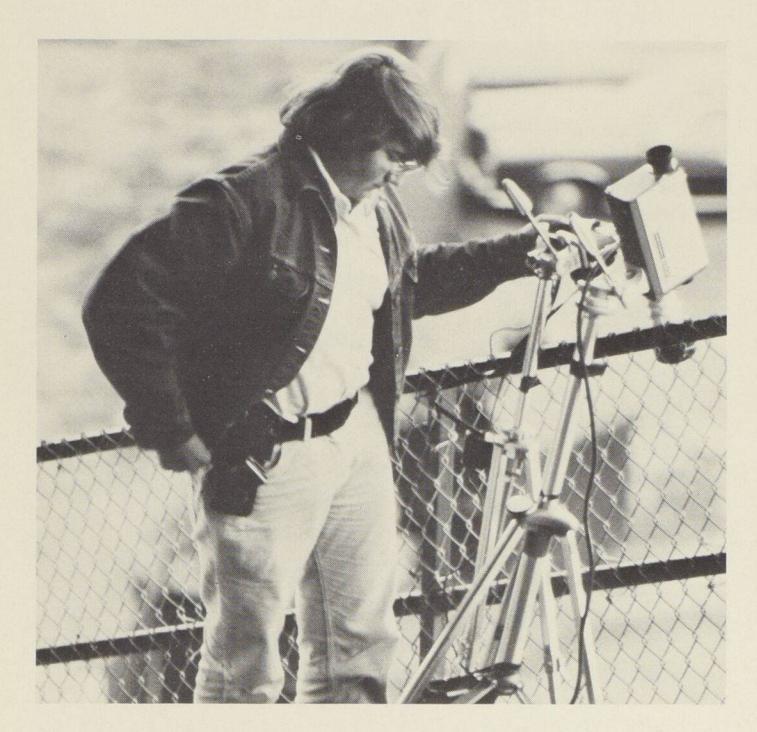
Cameras, tape recorders and two-way radios are used by observers to study crowd movement.

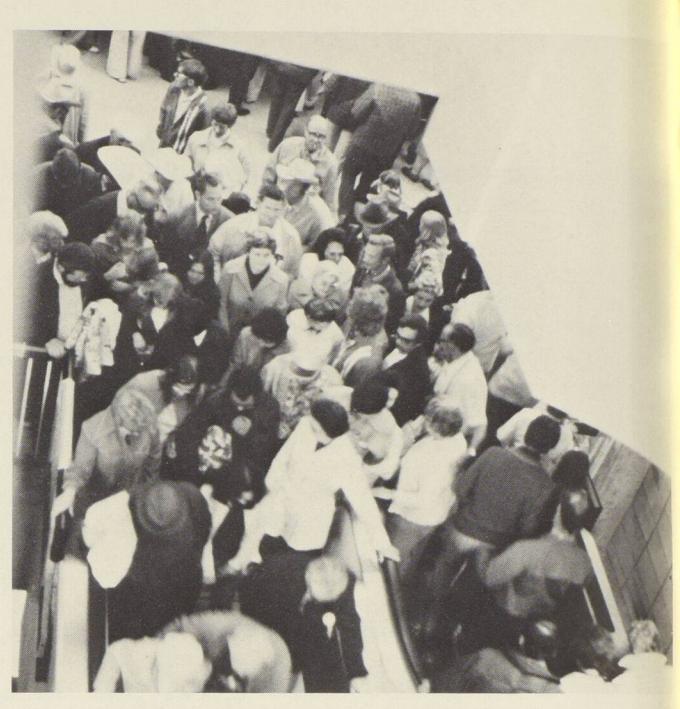
Crowd leaves Calgary grandstand via escalators. Note lack of channelization before permanent railings were installed. La foule quitte les tribunes de Calgary par ascenseur. A noter la congestion avant que des rails de guidage permanents aient été installés.

While the stairs created no problem, the escalators did. People hesitated while moving from one escalator to another and began to crowd together. With the large numbers involved, people could have been badly injured. Mr. Pauls made recommendations to temporarily correct this situation during the Stampede, and permanent railings were later installed.
