ST. CLAIR AVENUE BRIDGE, TORONTO.

By E. M. Proctor, B.A.Sc.,

Structural Designer, Bridge Department, City of Toronto.

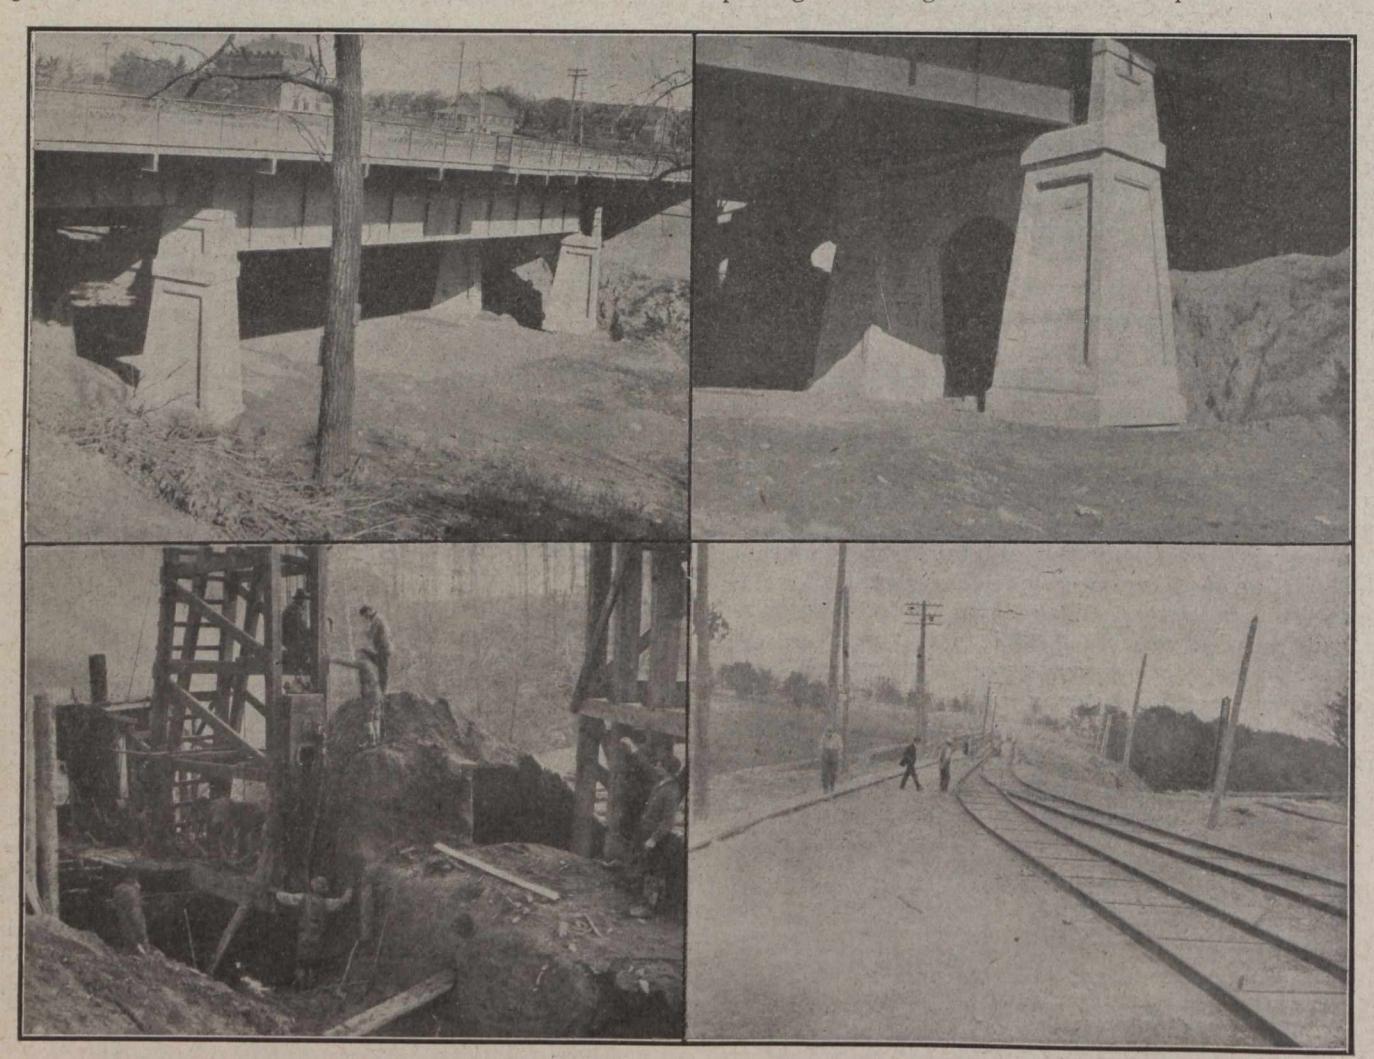
Fig. 1.—View of Completed Structure; Closer View of Pier, East Abutment; Pile Driver at Work on East Abutment; Gauntlet Track Under Construction on Temporary Trestle.
