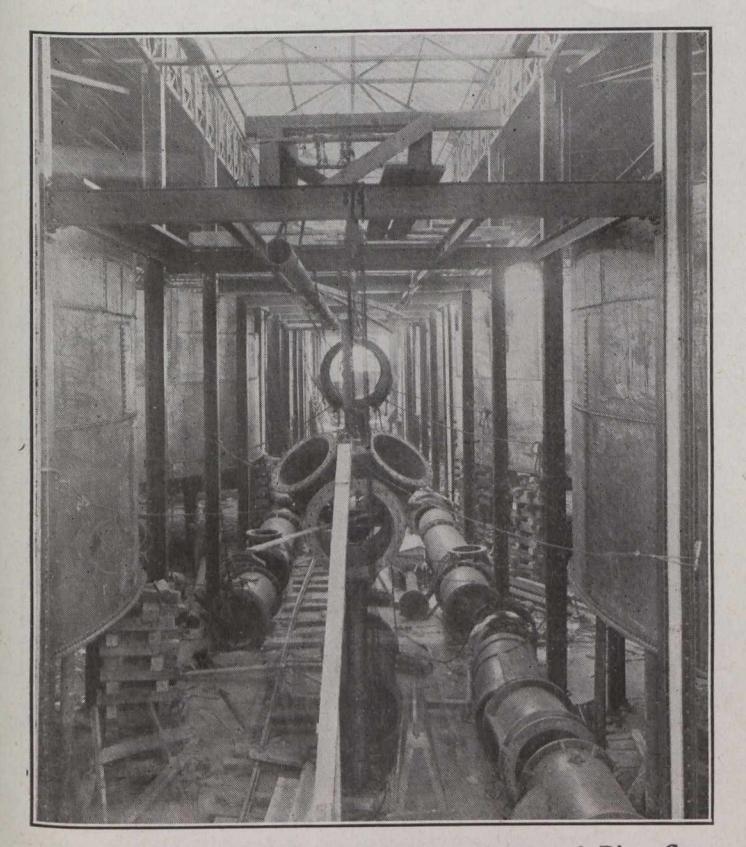
Fig. 3.—Filter House During Installation of Pipe Connections in Central Gallery. View Looking North.

Fig. 3 is an interesting interior view of the filter house, from the south end. It shows the circular steel filters on each side of the central gallery and gives a general idea of the type of construction used in the building. It also shows some of the pipes and connections to filters. The interior of a portion of a filter tank is shown in Fig. 4.

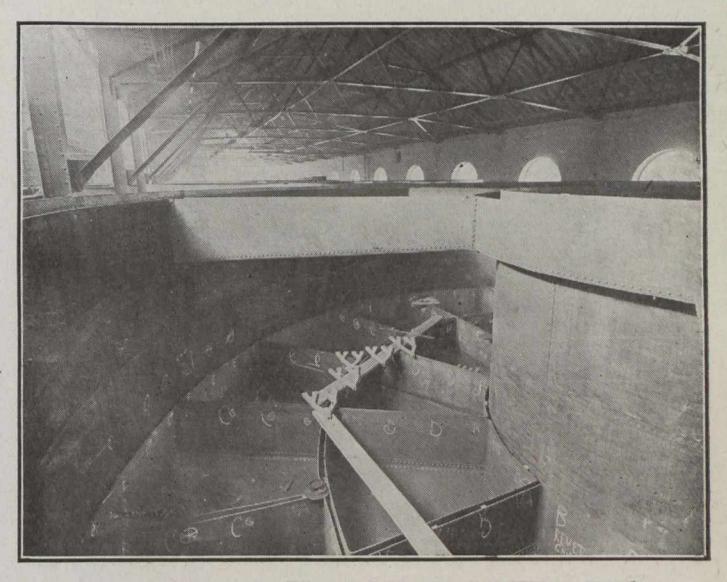
Fig. 4.—Interior View of Section of Filter Tank.

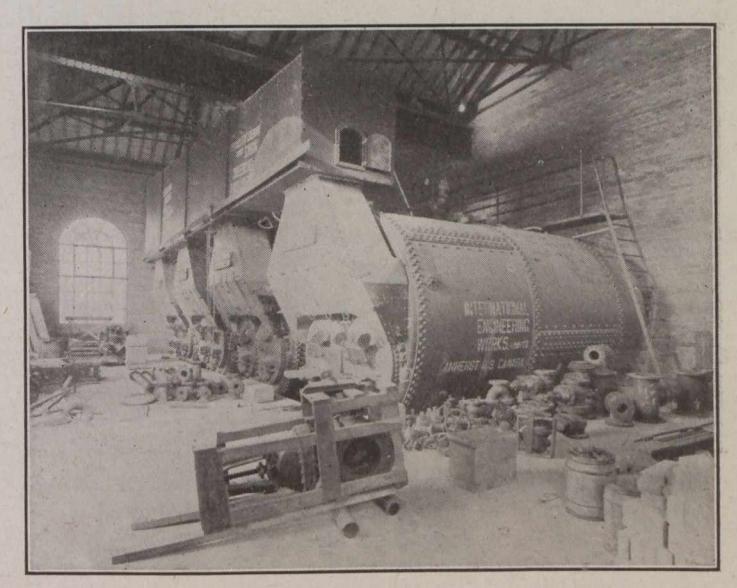
Fig. 5.—Installation of Boilers in Progress.

A construction view of the boiler room is shown in Fig. 5. These boilers, supplied by the International Engineering Works, Limited, Amherst, N.S., have each a capacity of 300 horse-power. Fig. 6 is a view of the southern portion of the pumping station with the three centrifugal pumps, direct connected to motors, and the
