## Weathering pyrite and Bacteria bug the Bell

At the corner of Albert and O'Connor Streets, stands a structure founded on Billings Shale — the Bell Canada building — originally constructed in 1929. A three-storey extension, which passes over a minor fault, was added 10 years ago.

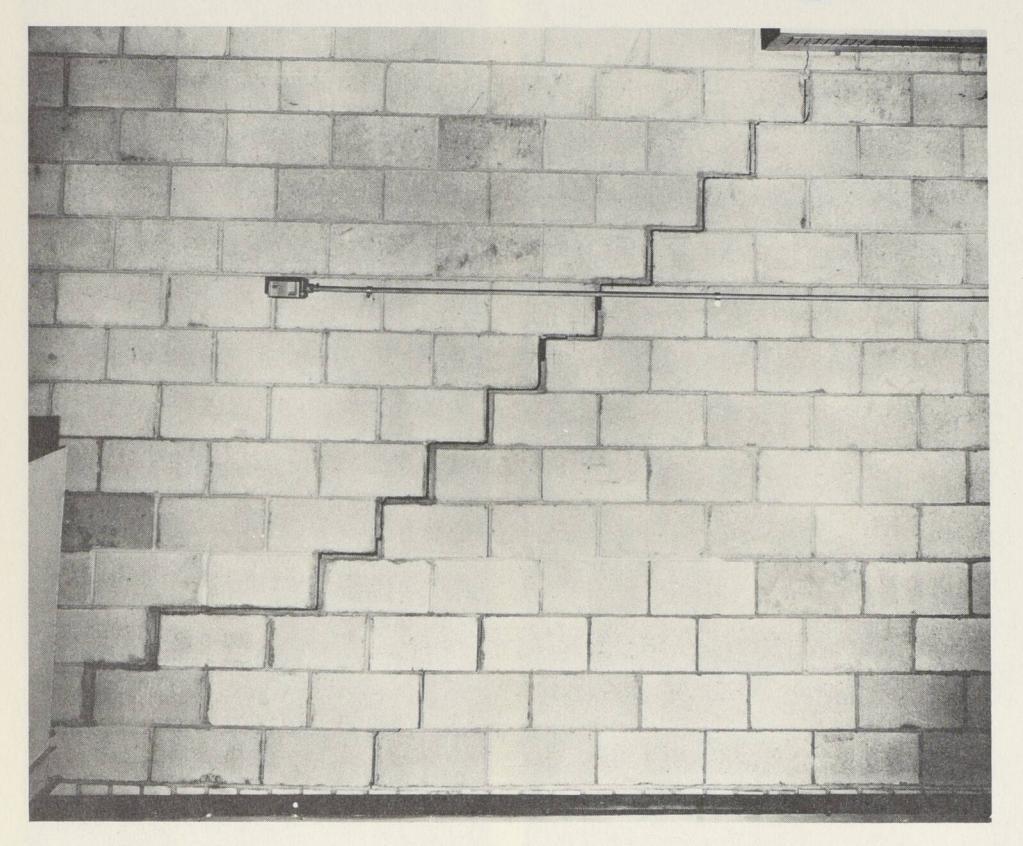
"We didn't know what it was at first either," says W. J. Eden of the Geotechnical Section of NRC's Division of Building Research. "Our first clue came when an excavation was dug for the Vanguard building next door to the Bell on Slater and O'Connor Streets. Heave caused diagonal crack from top to bottom on this non-loadbearing partition wall which had to be freed from the ceiling to avoid damage to the floor above.

le soulèvement a provoqué une fissuration diagonale de cette cloison non travaillante qu'il a fallu dégager du plafond pour éviter que le plancher de l'étage immédiatement supérieur ne soit endommagé.

In 1967, Bell initiated precise level surveys. Since that time, the position of maximum displacement in one area shows heave of 2.04 inches, or 0.07 inch per month. Total heave since construction is 3.72 inches. In another area, the total heave is 2.16 inches and the heave rate during the survey period was 0.02 inch per month. These two heaved locations cover a floor area of some 2,400 square feet. This space is used for generators, batteries and switching units which power telephone service in Ottawa. Heaving of the floor necessitated continual realignment of equipment and in addition, a non-loadbearing partition wall had to be freed from the ceiling to avoid damage to the first floor.
