Flashlight Signalling

A SYSTEM IN PRACTICE IN SWEDEN WHEREBY SPECIAL SIGNALS ARE UNMISTAKABLY IDENTIFIED BY ENGINE-DRIVERS

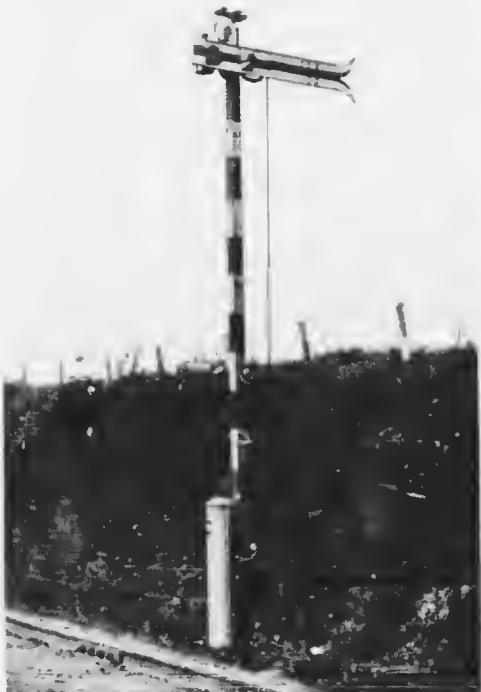
A DISTANT SIGNAL ON THE DANISH STATE RAILWAY, FITTED WITH THE AGA FLASHING LIGHT.
