Plan showing
WINNIPEG ELECTRIC RAILWAY TRACKS
AND LOCALITIES

where water pipes have been damaged
BY ELECTROLYSIS.

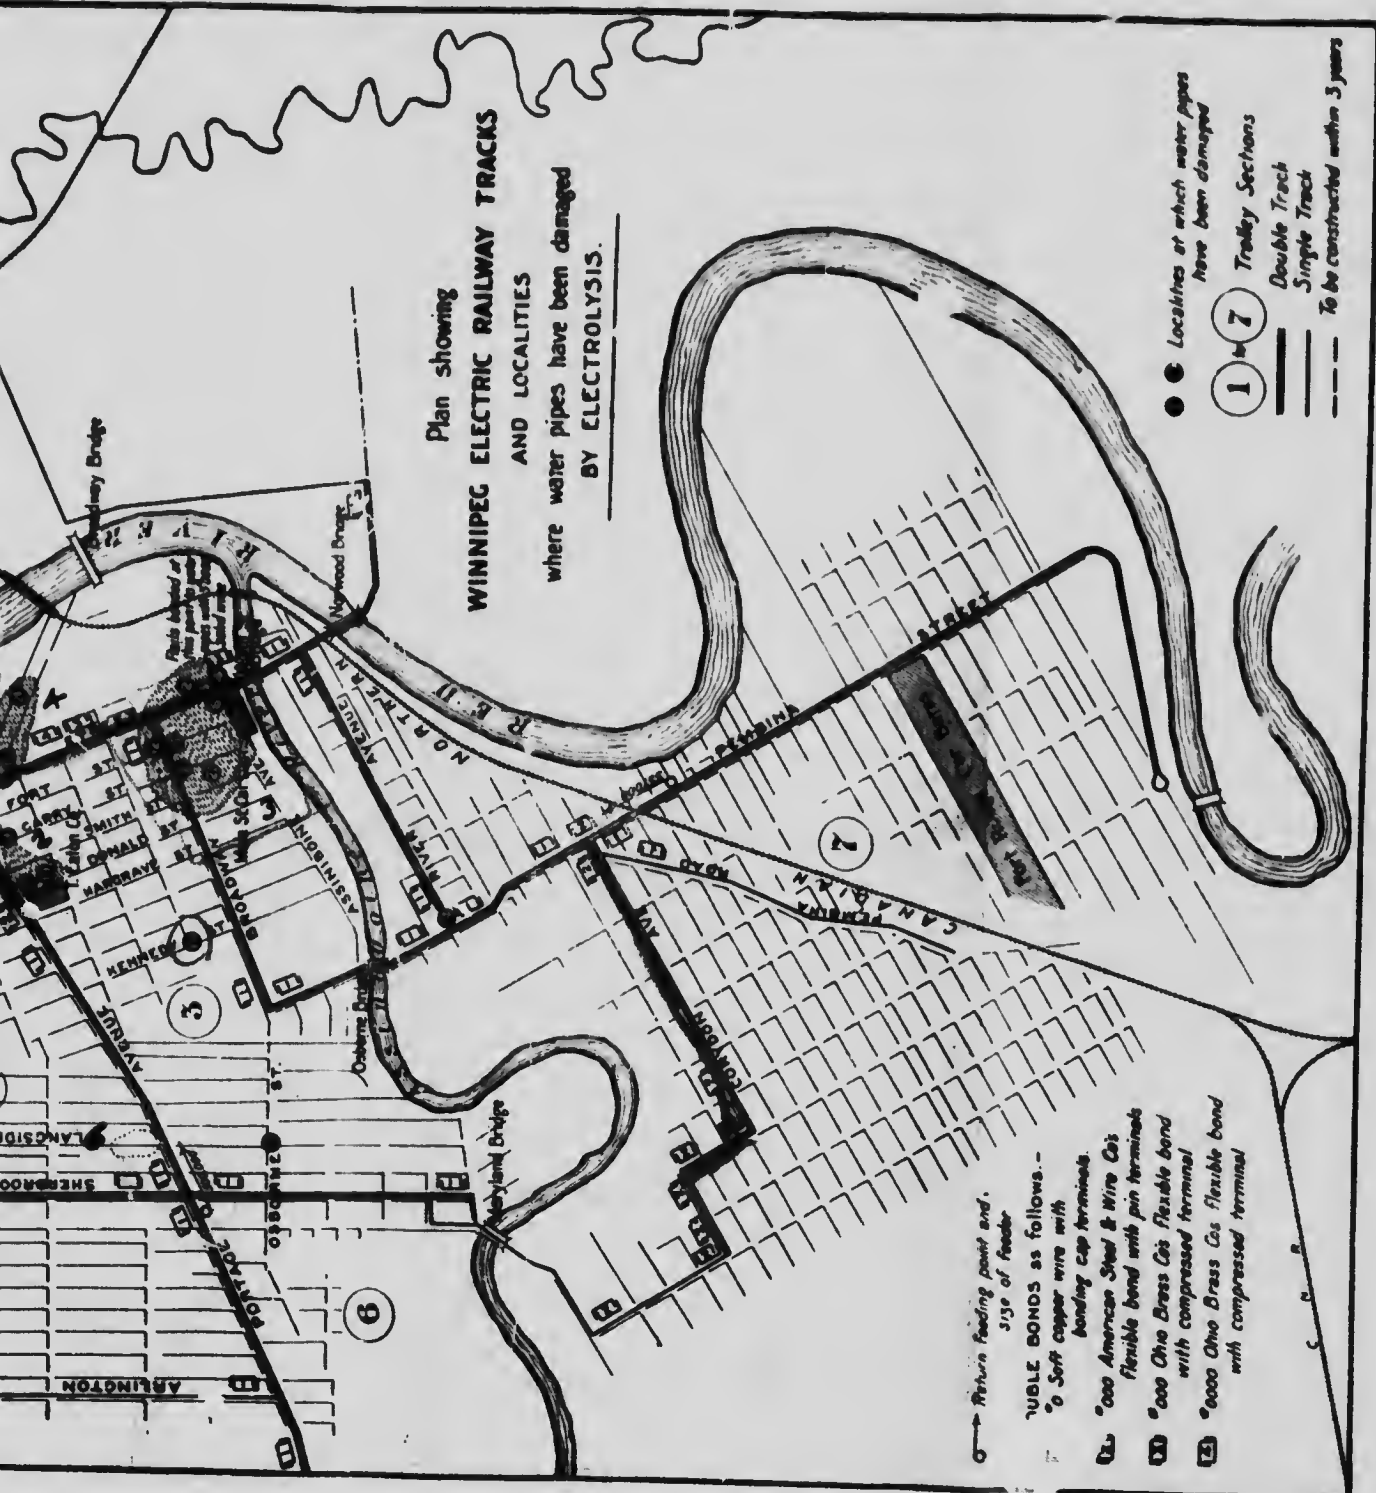
- Localities at which water pipes have been damaged
- ①-⑦ Trolley Sections
- ==== Double Track
- ===== Simple Track
- To be constructed within 3 years

Return feeding point and size of feeder

DOUBLE BONDS as follows--

- ① Soft copper wire with bonding cap terminals
- ② 000 American Steel & Wire Co's Flexible bond with pin terminals
- ③ 000 Ohio Brass Co's Flexible bond with compressed terminal
- ④ 0000 Ohio Brass Co's Flexible bond with compressed terminal
