#### DAM AND GATE HOUSE.

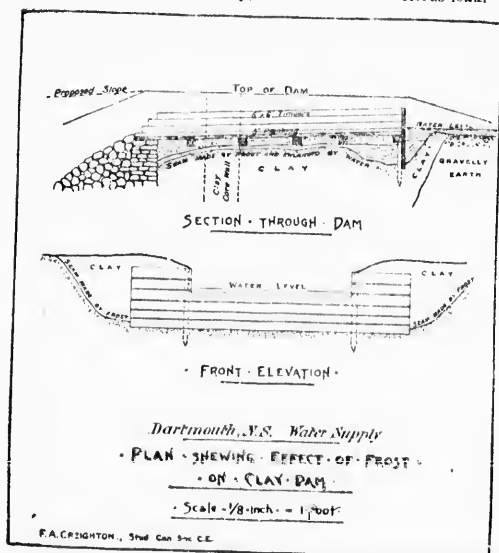
*Frost action.*—It is known that as frost works down through clay it expands the clay, which of course must rise, and anything in the clay must of necessity rise with it. Thus it will be seen that as the frost found its way down past the apron in front of the dam, each plank, as the frost reached it, rose and separated from the one below it. In our case there were spaces of from ½ to 1 inch between them, while the first short plank at the sides was separated from its neighbour fully 2 inches.

Then as frost goes down through clay there is always a space (usually half filled with ice needles) between the frozen ground on top and that unfrozen underneath. It will readily be seen that as soon as the frost had worked down below the water-level, the water would begin to find its way between the lifted planks in front, and along the seam made by the frost, and out into the stones behind the dam. It would not be long before the water would wear away a considerable quantity of the soft clay, and thus make a serious leak.

The dam and gate house are situated at the foot of Lamont Lake. The original dam was built to supply water for a grist mill, but the mill had not been in use for some years when the town took the lake for its supply. The old dam, which was built roughly with stones, brush, and other rubbish, was raised 2 or 3 feet and the gate house built in the front part. When the lakes rose, the dam was found to be leaking considerably. The different leaks were repaired as they appeared, but finally a trench 2½ feet wide was cut along the whole length of the dam, down to a bed of clay some 2 feet under the original ground surface, and filled with well puddled clay. This seemed to stop the leaks effectually, and no trouble was experienced till February 7, 1893, when it was found to be leaking about the waste-weir, and an examination showed as follows: It will be seen by the sketch how the waste-weir is constructed. It is 12 feet wide and set into the dam some 2½ feet. 6 in. x 8 in. timbers bedded in the clay are put in running across the weir 4 feet apart. These are planked over with 3 in. plank, caulked and run with tar to keep the water from making its way through to the clay. Another layer of 3 in. plank is put on as a protection from the sun when no water is running over the weir. Stakes are driven down in front at the lake end of the weir, and 3 in. plank extending 4 feet out on each side of the weir spiked to them. 6 in. x 6 in. timber sides are then put in, with the timbers well fastened together with ragbolts. Then clay is well rammed down in front of the apron and around the sides. A dry wall is built at the back of the dam under the weir, and loose rock thrown in behind to break the force of the water falling over.
