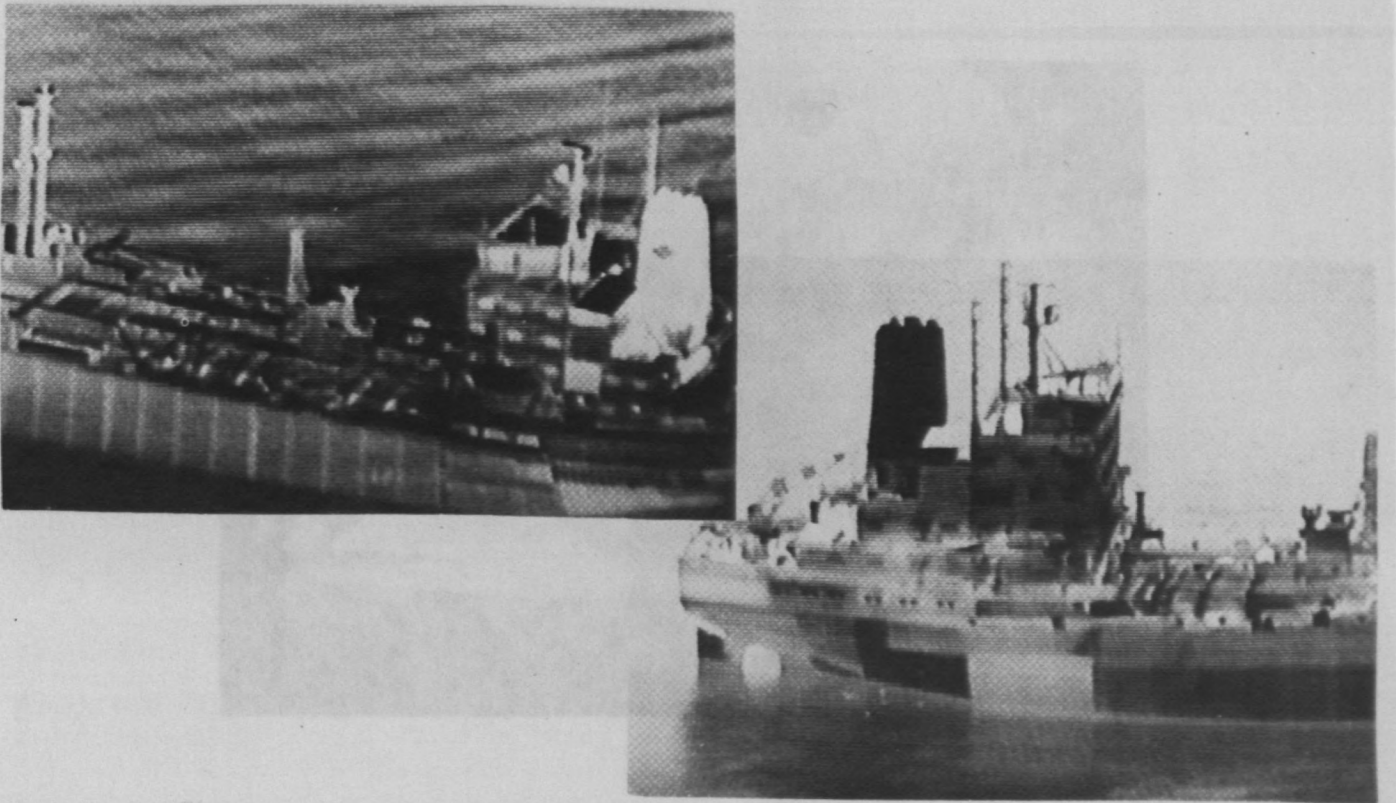
Figure 10. FLIR images of freighters. Notice the hot stack in the left image and the ability to "see through" the hulls because of differences in surface temperature resulting from contents of the holds. (Courtesy of David Dorschner, Aviation Resource Management.)
