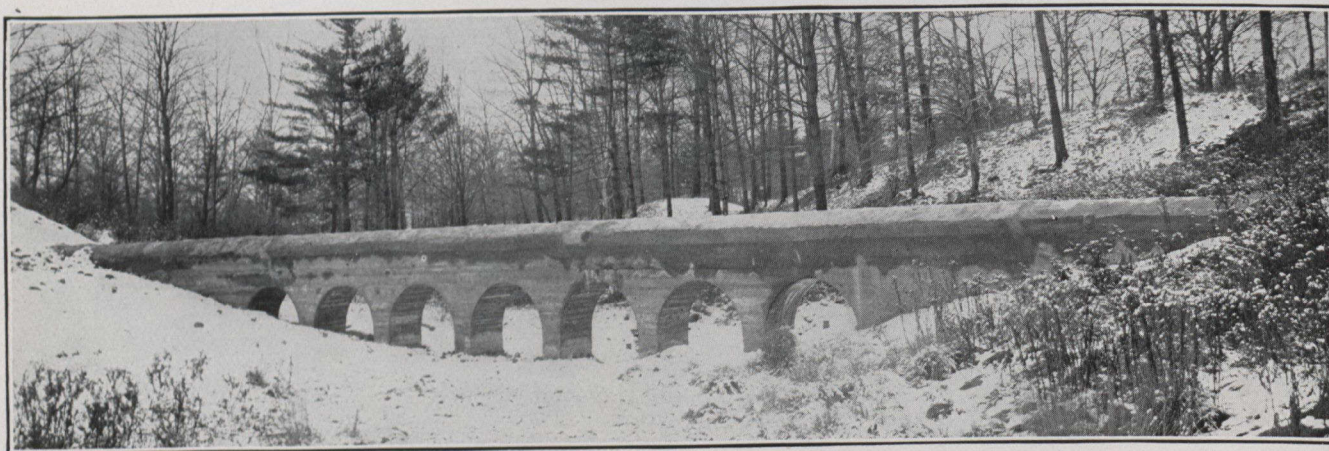
Concrete Viaduct, built by the City of Toronto, for carrying sewer pipe over Sunnyside Avenue Ravine.
