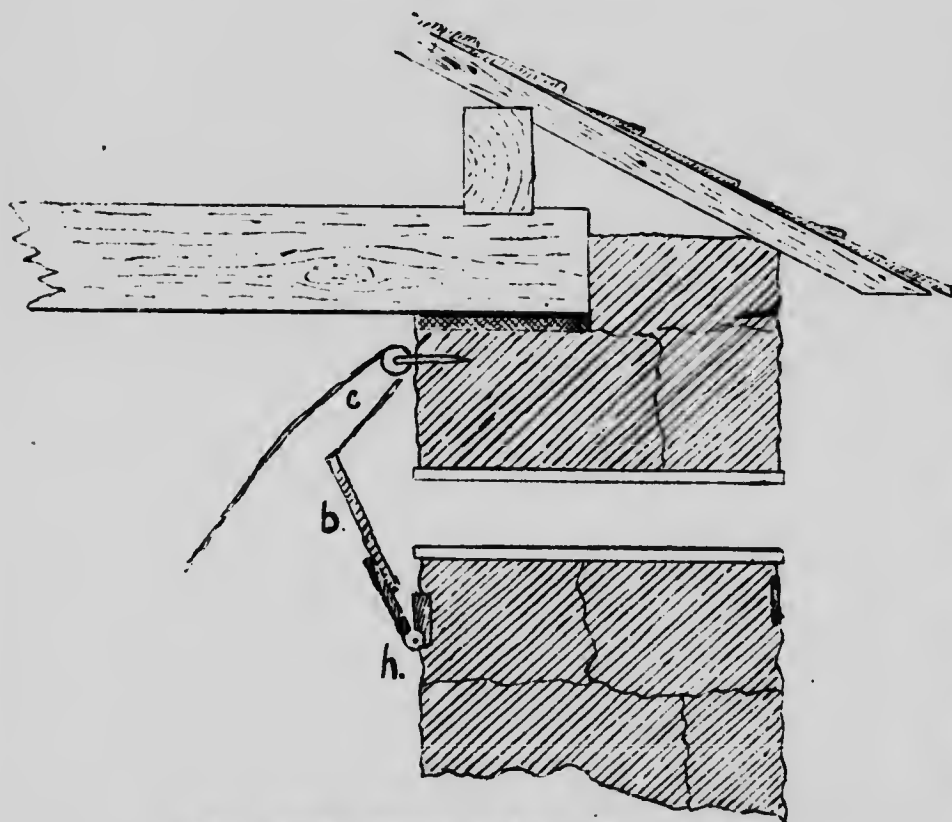
Fig. 4. System of ventilation by means of tile built in the wall.
