# Cement Siding Construction

C. W. NOBLE\*

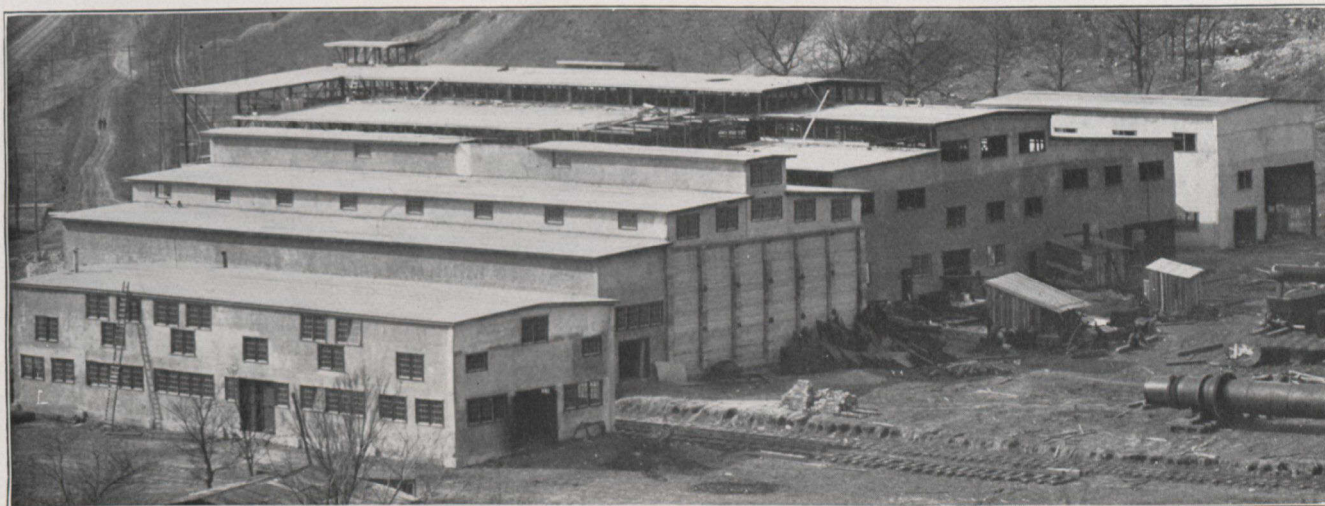
Bonner Springs Portland Cement Co., Kansas City, of cement siding construction.
