### BOILER EXPLOSION AT RIDGETOWN.

BOILER EXPLOSION AT RIDGETOWN, ONT.

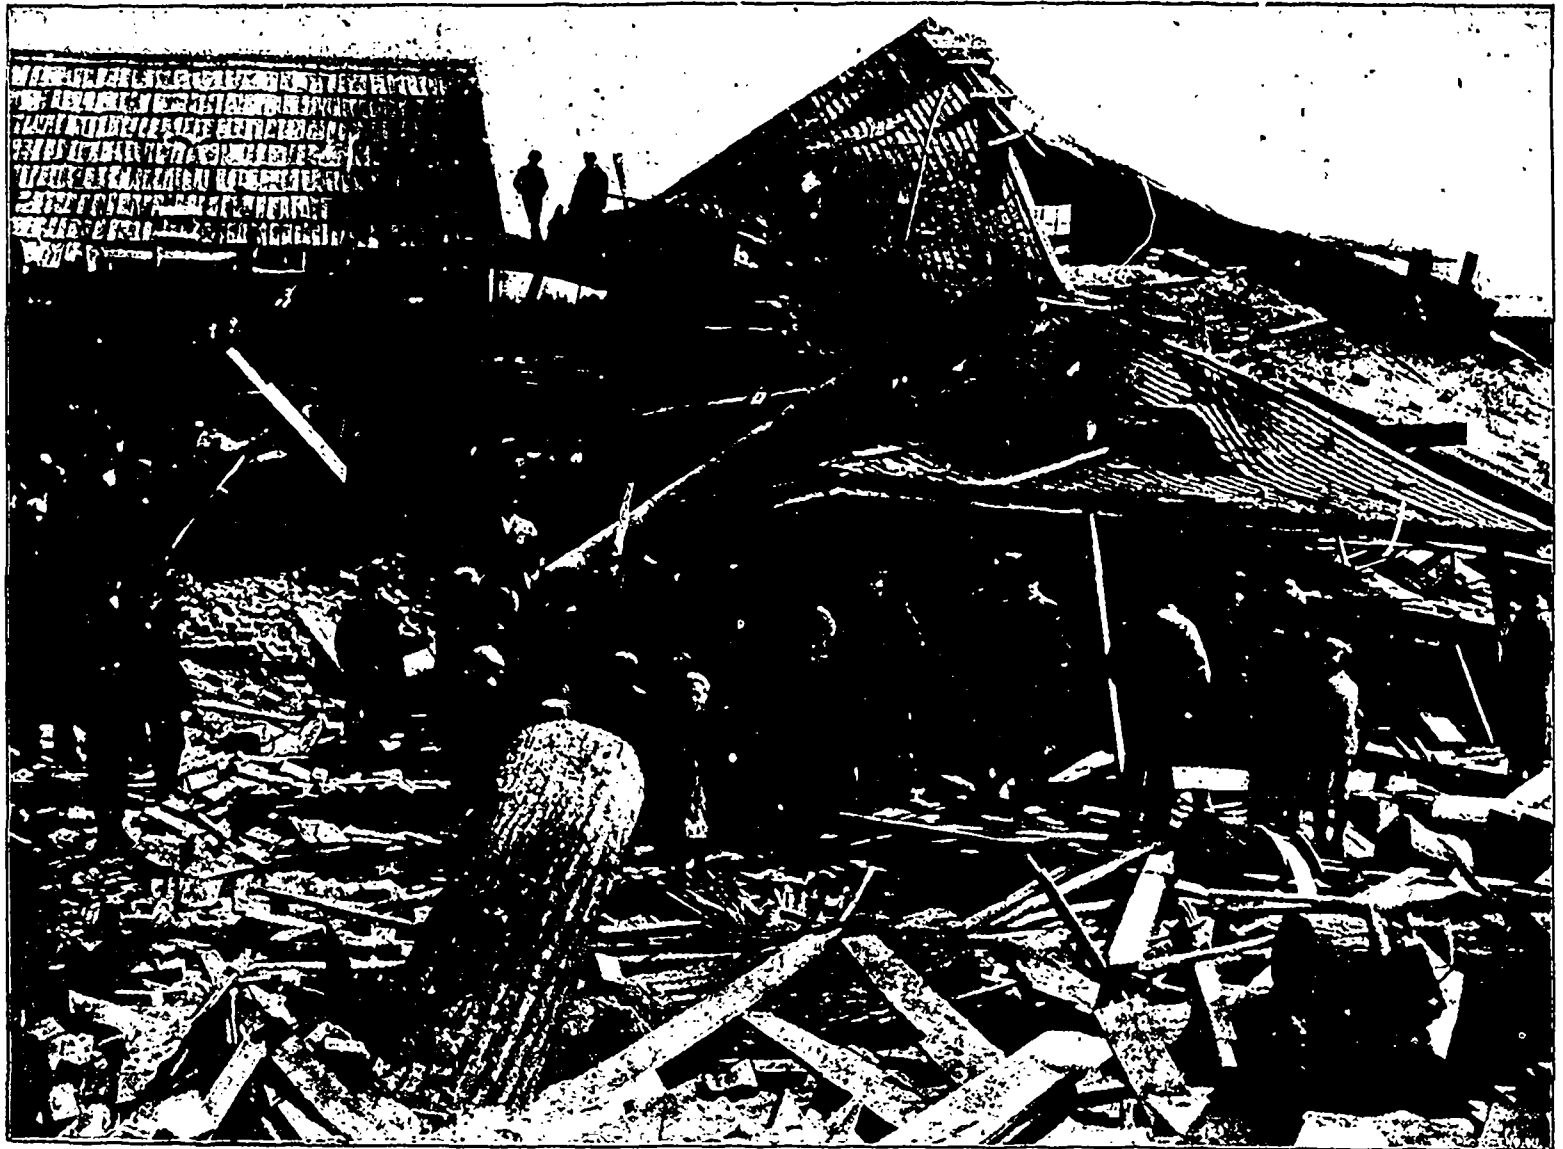
On the 6th of April a boiler exploded in the saw, stove and heading mill of Watson Bros., at Ridgetown, Ont., which completely wrecked the mill and has thus far resulted in the death of four persons. The accident occurred just as the employees were preparing to enter upon their day's work. The fire had been under the boiler for some time, but the machinery had only been in operation about a minute and a half.

The boiler was a horizontal tubular one, 54 inches diameter and 11 feet 6 inches long, with 58 tubes 3 in. in diameter, and a dome 20 in. diam. and 27 in. high. The plates were iron and were a little over one-quarter inch thick.

and uninjured, with bridge and bolt attached.

The dome was thrown about 600 feet, and the plate to which dome had been attached went about 700 feet in a different direction. The position of the front part of shell and of the back part confirm the theory that the boiler gave way first at the upper part, as these pieces were thrown in opposite directions and appear to have been turned end for end in their flight.

A second boiler which had no steam on at the time was thrown bodily over the engine and badly ruptured.

The violence of the explosion is clear proof that there was plenty of water in the boiler at the time, and the back head showed no sign of ever

The joints were all single riveted, the lap of plates being 2 in., and the rivets were  $\frac{5}{8}$  in. diam. and 2 in. pitch. Manhole was 15 in. by  $11\frac{1}{2}$  in. and had a strengthening ring around it  $1\frac{3}{4}$  in. by  $\frac{5}{8}$  in. The boiler was in general good order and fairly clean inside.

After explosion there was no evidence that the boiler had been neglected or had been carelessly used. The back head had been renewed at some time and was in very good condition, and evidently was stronger than the front head. The boiler had been used at a pressure of nearly 90 lbs. per sq. inch, and was supposed to be quite safe for a higher pressure. It apparently gave way first at the manhole, or near to it, and was split open from the top across the boiler. The manhole cover was picked up about 60 feet from the original position of the boiler, complete

having been over-heated. The quality of the plates seemed to be common boiler iron, and the most probable cause of the explosion was that the pressure carried was too high for the strength of the shell at the manhole and at base of dome. The severe strain put upon these parts had gradually weakened the boiler, so that it gave way at the ordinary working pressure.

traced out to the maker, or seller, or user of the boiler, and the blame fixed upon the right person.

The coroner's jury, in their verdict, stated that the cause of the explosion is unknown, but recommended that the government make it compulsory to users of steam boilers of all kinds to have them periodically inspected by competent boiler inspectors.

How best to prevent similar accidents is a question well worth considering. In Great Britain where so many boilers are in use, Government inspection has been carefully avoided, but the Boiler Explosions Act requires the user of a steam boiler to report to the Government every accident, no matter how trifling, and an investigation is held and the owner has to prove that he was using all proper precautions. Under this system the fault which led to the accident is
