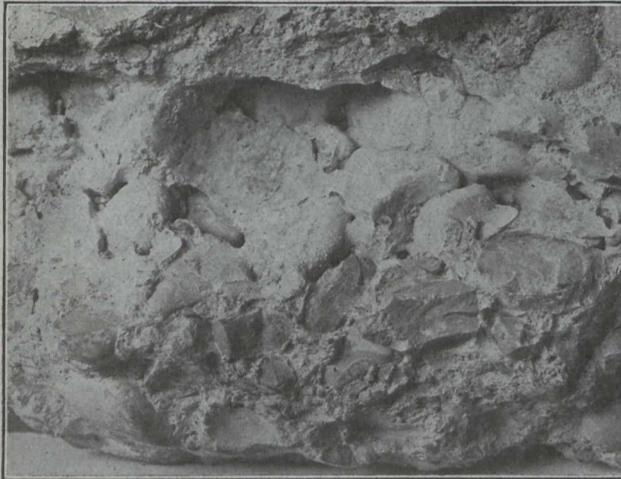
Fig. 2.—Block Cut from Pavement, Showing Segregation of Stone and Bridging Effect

There are two methods of improving this condition:—

- (a) By the addition of enough stone to make the proportions 1:3:5.
- (b) By separating the gravel into sand and stone and remixing them in the proper proportions on the site of the work under construction.

Remedy (b) provides the safer means of surmounting the difficulty. In all kinds of government and civic concrete work the use of unscreened gravel has been as far as possible abandoned on account of the very great uncertainty of the proportions. Exceedingly few men are able to look at a sample of gravel and guess the proportions correctly, and as this generation has hung up, in a conspicuous place, the sign "Safety First," engineers generally have adopted this motto with regard to unscreened gravel.

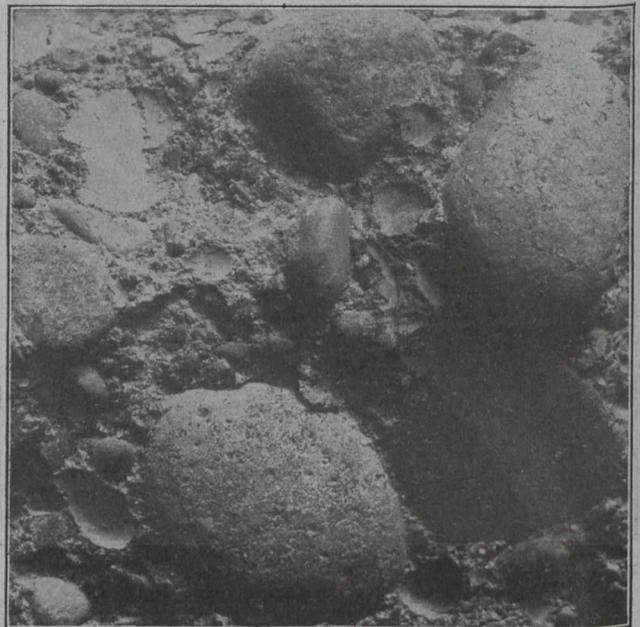
Fig. 3.—Fractured Surface of 6-in. Cube, Showing Effect of Segregating Coarse Aggregate
