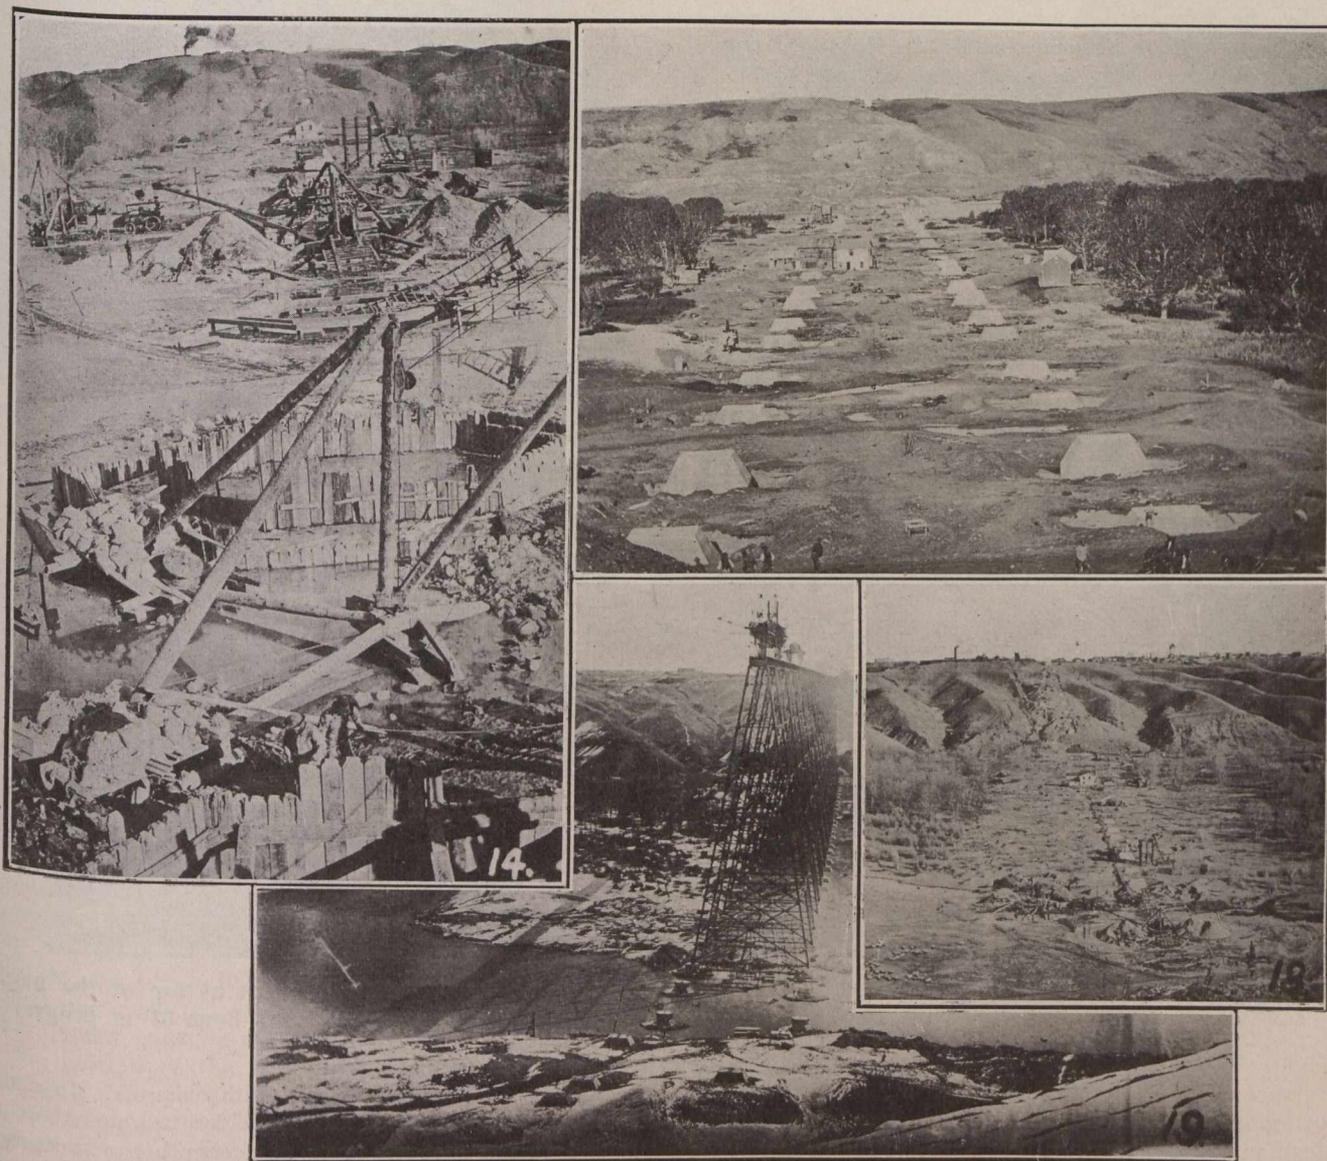
Fig. 14.—River work being carried on during winter of 1907-08. Fig. 15.—Pedestals complete on river bottom with work on west bank in progress. Fig. 18.—Looking eastward, showing sub-structure in progress. Fig. 19.—Erection of steel-work. Bent 47 just completed.
