House of Industry and Refuge County of Elgin

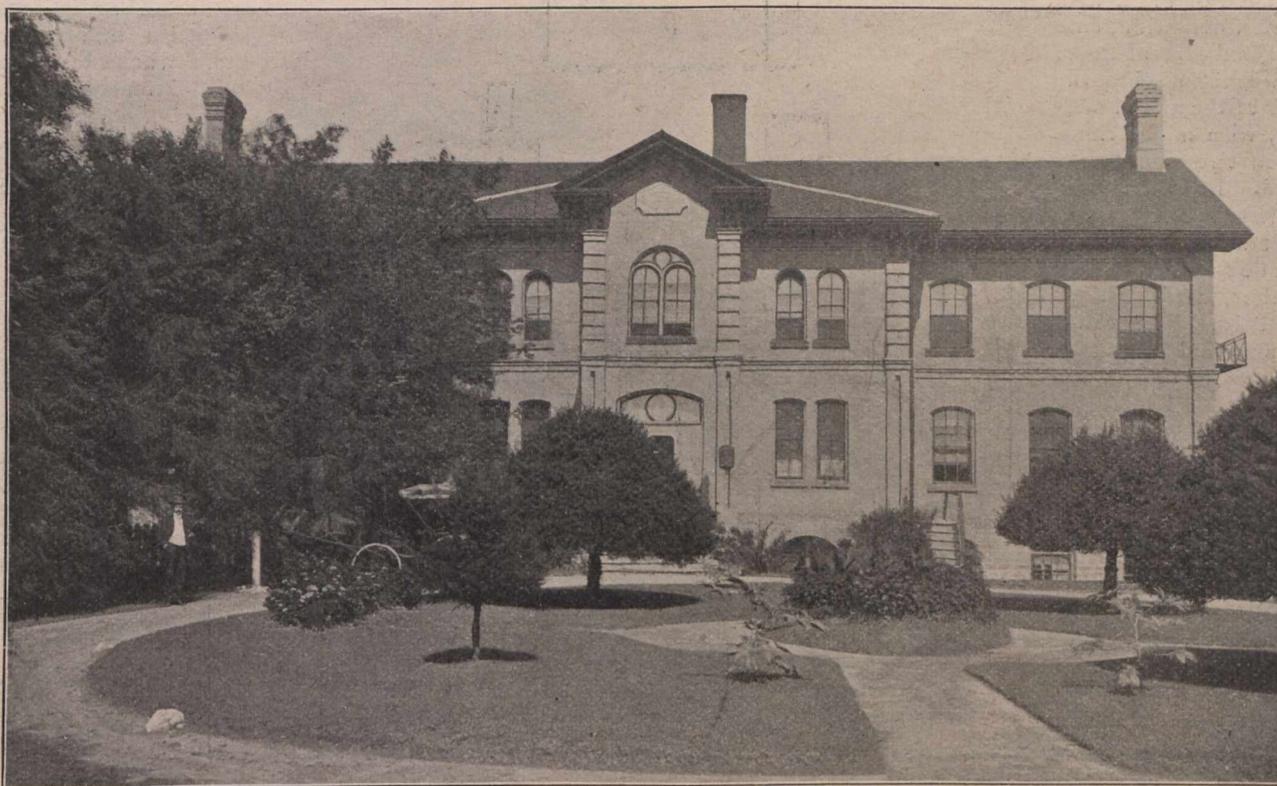
The main building is constructed of brick with stone foundation and slate roof. At first the building had but two wings, which did not provide sufficient accommodation, or for the complete separation of the sexes. In 1891, when the Government grant was received, an additional wing now occupied by the women was erected. The three wings are 26 x 31 feet, one occupied by the men and the other by the women, while the rear wing is used for hospital wards and a sleeping room at the top for men.
