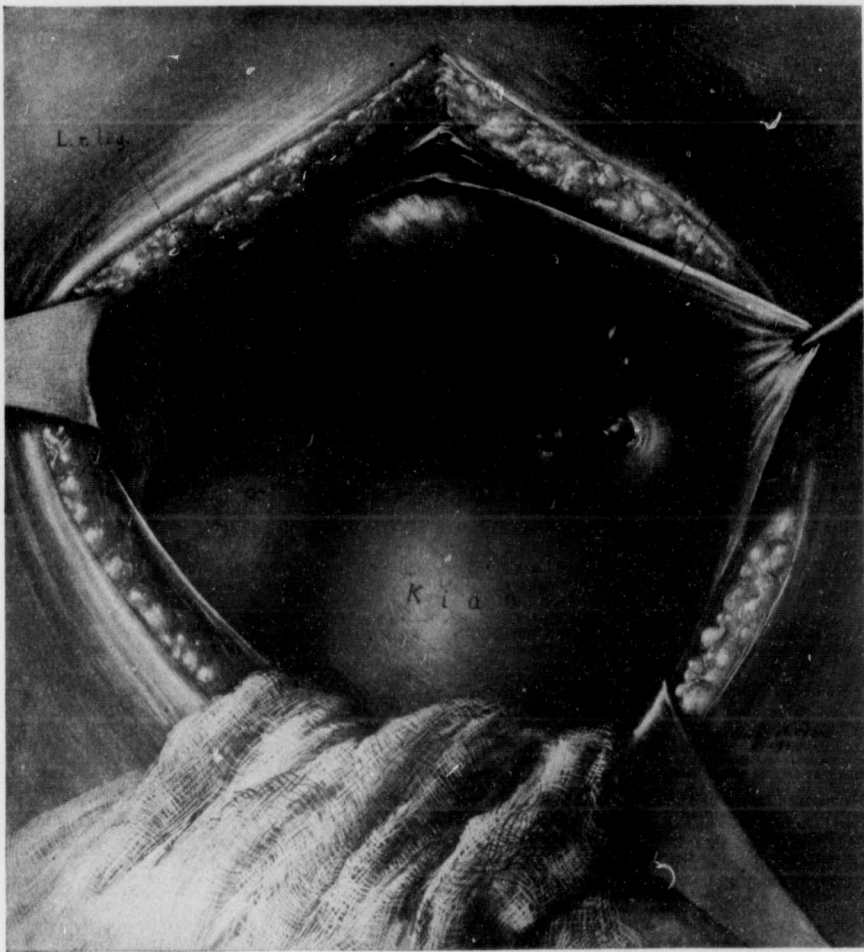
Fig. 2. A right pelvic kidney. The kidney is seen from above through the abdominal incision. It fills the right half of the pelvis and extends to the pelvic brim. On the left side the kidney is wanting. There is no uterus. A portion of the right tube is seen emerging from the inguinal ring. The bulging at the inguinal ring is made by the ovary and the remaining portion of the tube both of which are extraperitoneal. The right round ligament emerges from the inguinal canal, forms a loop on itself and then again disappears. The left round ligament is recognized as a little bud. The left tube and ovary were in the inguinal canal.

The firm mass felt in the vagina and thought to be due to an accumulation of retained menstrual flow proved to be solid. It felt like a kidney, the hilus being easily demonstrable on the inner side. It was about half as large

again as a normal kidney and lay extraperitoneally. It almost completely filled the right half of the pelvis. I examined the usual site of the right kidney and found no kidney in this position.
