Damage at Willow Park

Special Railway Construction Organization

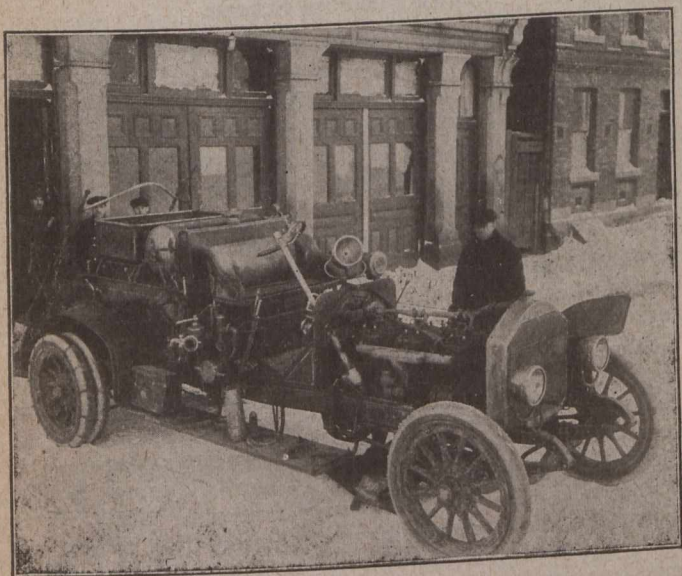
This Fire Department Auto was Travelling a Street Half a Mile from the Waterfront When the Explosion Occurred. The Driver was Blown Out of His Seat and the Machine Wrecked
