C25  
Bulletin No. 1

DEPARTMENT OF TRADE AND COMMERCE  
DOMINION GRAIN RESEARCH LABORATORY

# REPORT OF TRIAL SHIPMENT OF BULK WHEAT FROM VANCOUVER VIA THE PANAMA CANAL TO THE UNITED KINGDOM

F. J. BIRCHARD and A. W. ALCOCK

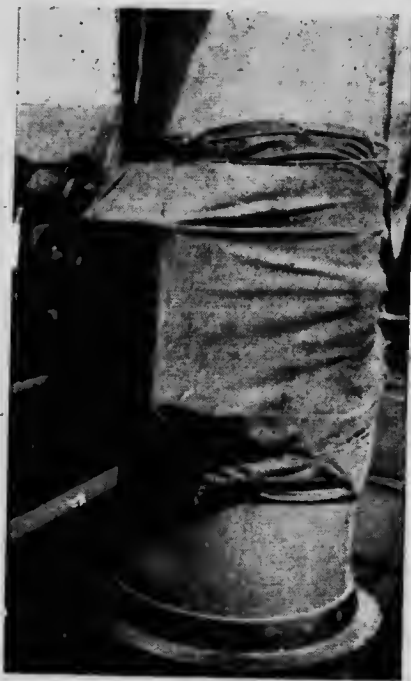
Fig. 6. Illustration showing one of the covered boxes.

Fig. 6 shows one of the covered boxes, and Fig. 7 is a photograph of a box containing two switches with the indicator and battery connected ready for taking temperatures, while Figs. 8-11 show the positions of the thermometers in the grain.

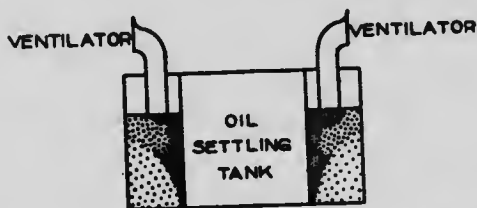
While the reported damage was evidently due to "sweat" or the admission of water into the hold, the cause of the heating near the stokehold bulkhead is not quite so clear. As will be seen from Figure 19 the heating took place under the ventilators, down which a little water may have dripped during and after the loading. Tests on samples of heating wheat from layer C showed 15.2 and 15.7 per cent of moisture while a sample from

Fig. 19. Section through heating wheat near stokehold bulkhead.

layer E, contained as high as 21 per cent of moisture. These percentages do not however, necessarily indicate the admission of water into the hold, since the chemical changes due to respiration, which is very rapid in warm grain, always result in an increase in the proportion of water present. But whether the cause of the heating was the drainage of some water from the outside, or whether the moisture content of the wheat as loaded was dangerously high for the conditions in that part of the ship, there is no doubt whatever that the temperatures close to this bulkhead were altogether too high for safety.

(2) The temperatures recorded by the thermometers against the false bulk-heads near the engine room and stokehold are evidently too high for safety, and an unventilated air space of nine to twelve inches cannot then be considered sufficient protection. It is recommended therefore, that when it is necessary to stow grain close to the engine room or stokehold, these spaces be either ventilated or extended. The records clearly show that it was only in these portions of the holds and close to the propeller shaft tunnel that dangerously high temperatures occurred. The conditions will vary in different ships but the adequate protection of the grain cargo in these parts of any vessel is one of the most essential conditions for its safe transportation.
