MEMOIR No. 27

REPORT OF THE COMMISSION

*Commissioners appointed to investigate the condition of Turtle mountain.*

# TURTLE MOUNTAIN, FRANK, ALBERTA.

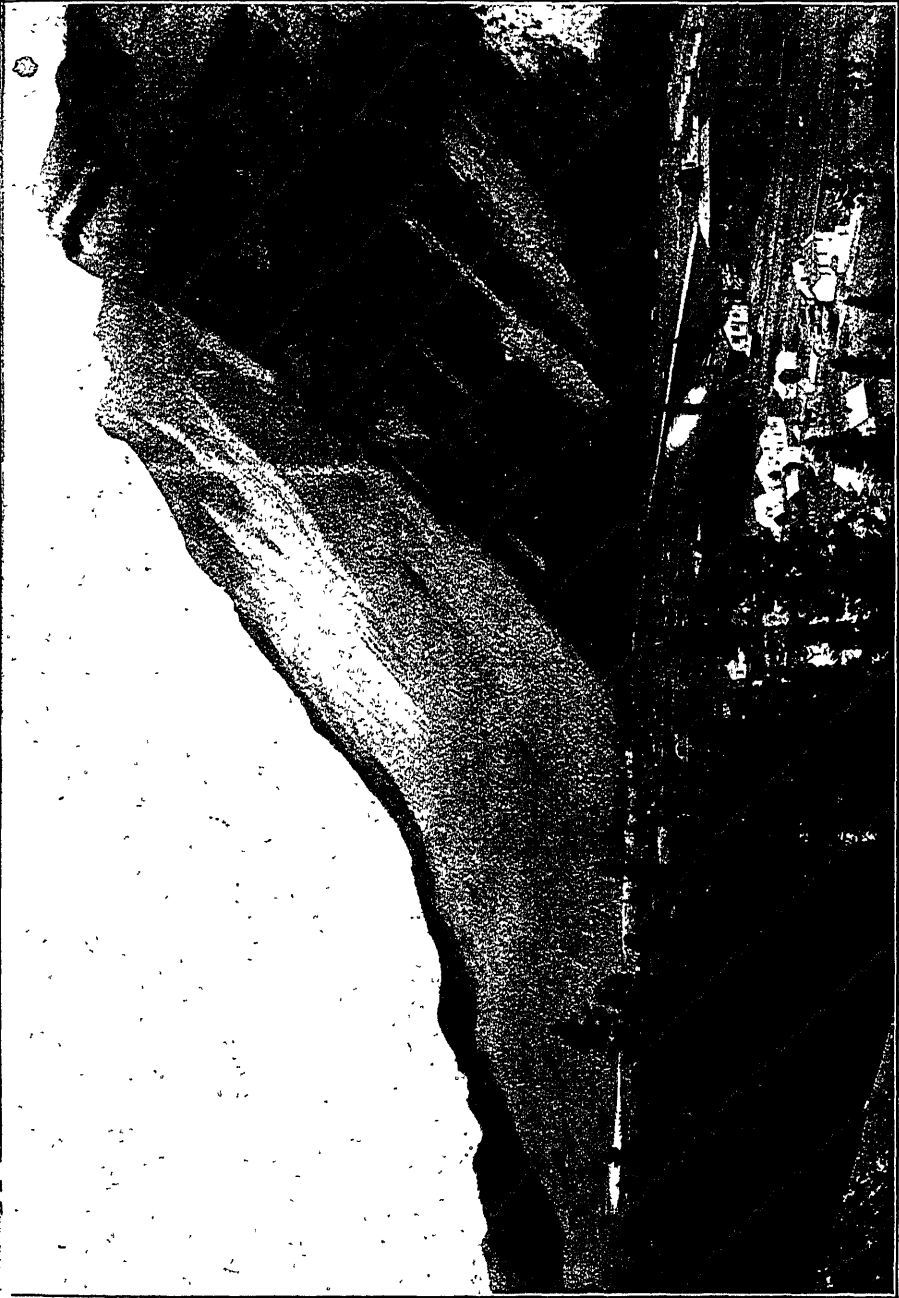
Looking south over Frank to 1903 slide. The "epitortel zones" in the limestone at the base of the "North Peak Block" appear above the smoke-stack of the Power House.

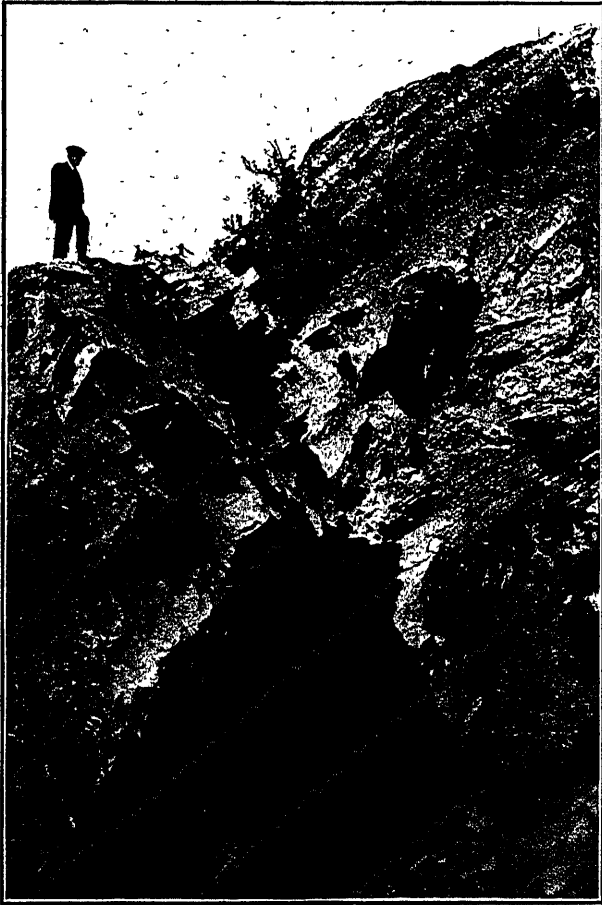
Looking northward along one of the larger fissures in the limestone on Turtle mountain. The limestone on the right has slipped down fifteen or more feet. The fissuring and slipping (faulting) were clearly facilitated by the joint-planes, some of which appear in the photograph. The North peak is seen in the upper right-hand corner.

town), the average dip is about  $50^\circ$  to the west. This means that many of the joints mentioned dip directly eastward at an angle of  $40^\circ$ . Other systems of these joints dip towards the northeast and southeast quadrants at still higher angles. The relation of the easterly dipping joints to the topography is illustrated in Figure 5. The diagram is intended to make clear this highly important cause for instability in the mountain. If the dip of the bedding were notably *steeper* than  $50^\circ$ , the easterly dips of the joints would be correspondingly flatter, and the danger of bodily slipping along that joint system would be materially less than under the present conditions. If the dip of the bedding were notably *flatter* than  $50^\circ$ , the easterly dips of the joints would be correspondingly steeper, and continued spalling of small blocks along those joints would have produced a steep but stable profile for the mountain in prehistoric time. The actual dips of the bedding and joints are almost ideal for the production of great intermittent slides from a mountain with the steepness of Turtle mountain. The slipping on joint-planes during the slide of 1903 is illustrated in Plates V and VI.

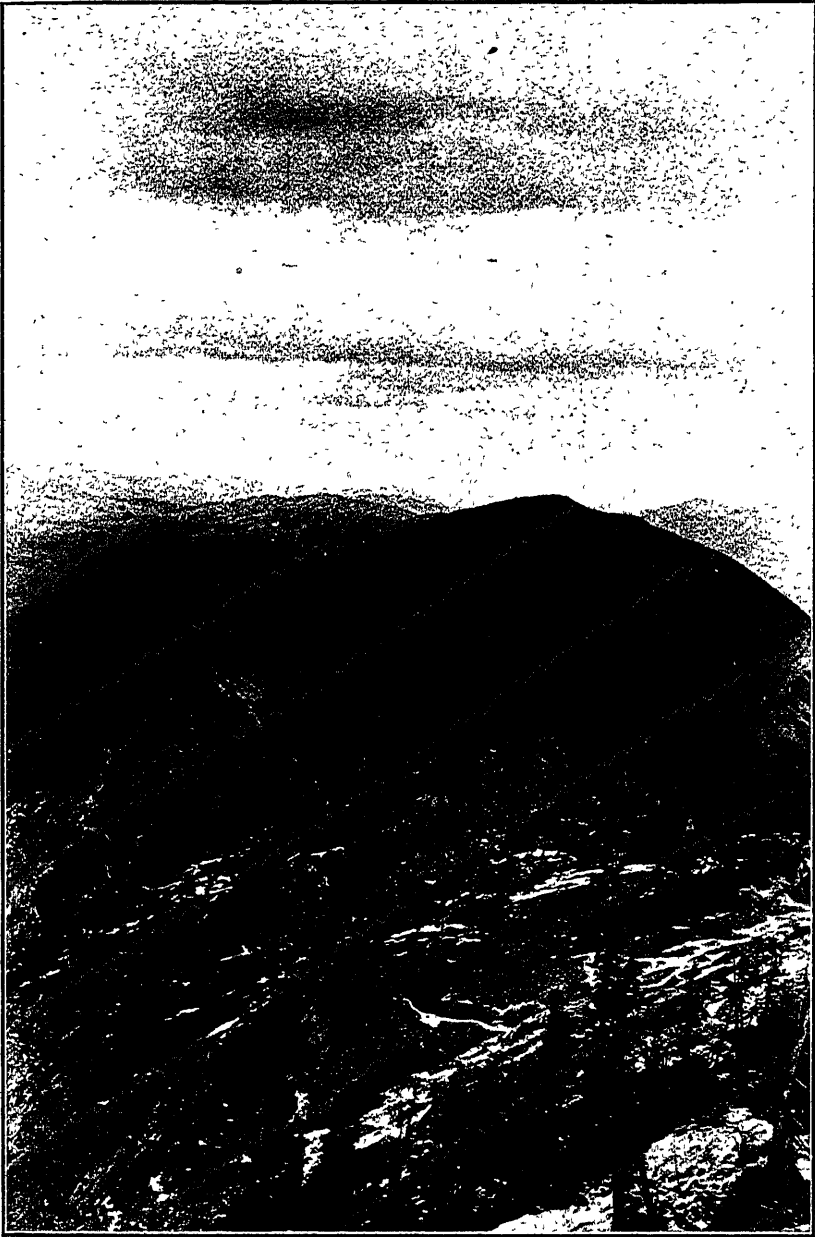
View of the fissured area looking north from South peak.

As a result of the 1903 slide, many profound fissures were opened on the North and South peaks, and in the part of the summit area between the peaks (Plates VII-XII). These are partly due to a powerful pull exerted by the huge rock prism as it fell outward and downward. These fissures are as noteworthy for depth as they are for extent along the surface. In general, they run nearly parallel with the edge of the main eastward-facing escarpment, i.e., that overlooking the town. They not only show movement of vast masses of rock towards the brink, but they also represent deep openings into which surface water from rain and heavy snow must run, and at certain times of the year be frozen at the bottom of each fissure. It is impossible to say exactly what effect this action may have in the future, but there is evident danger of the wedging out of huge prisms of rock through frost action. That displace-

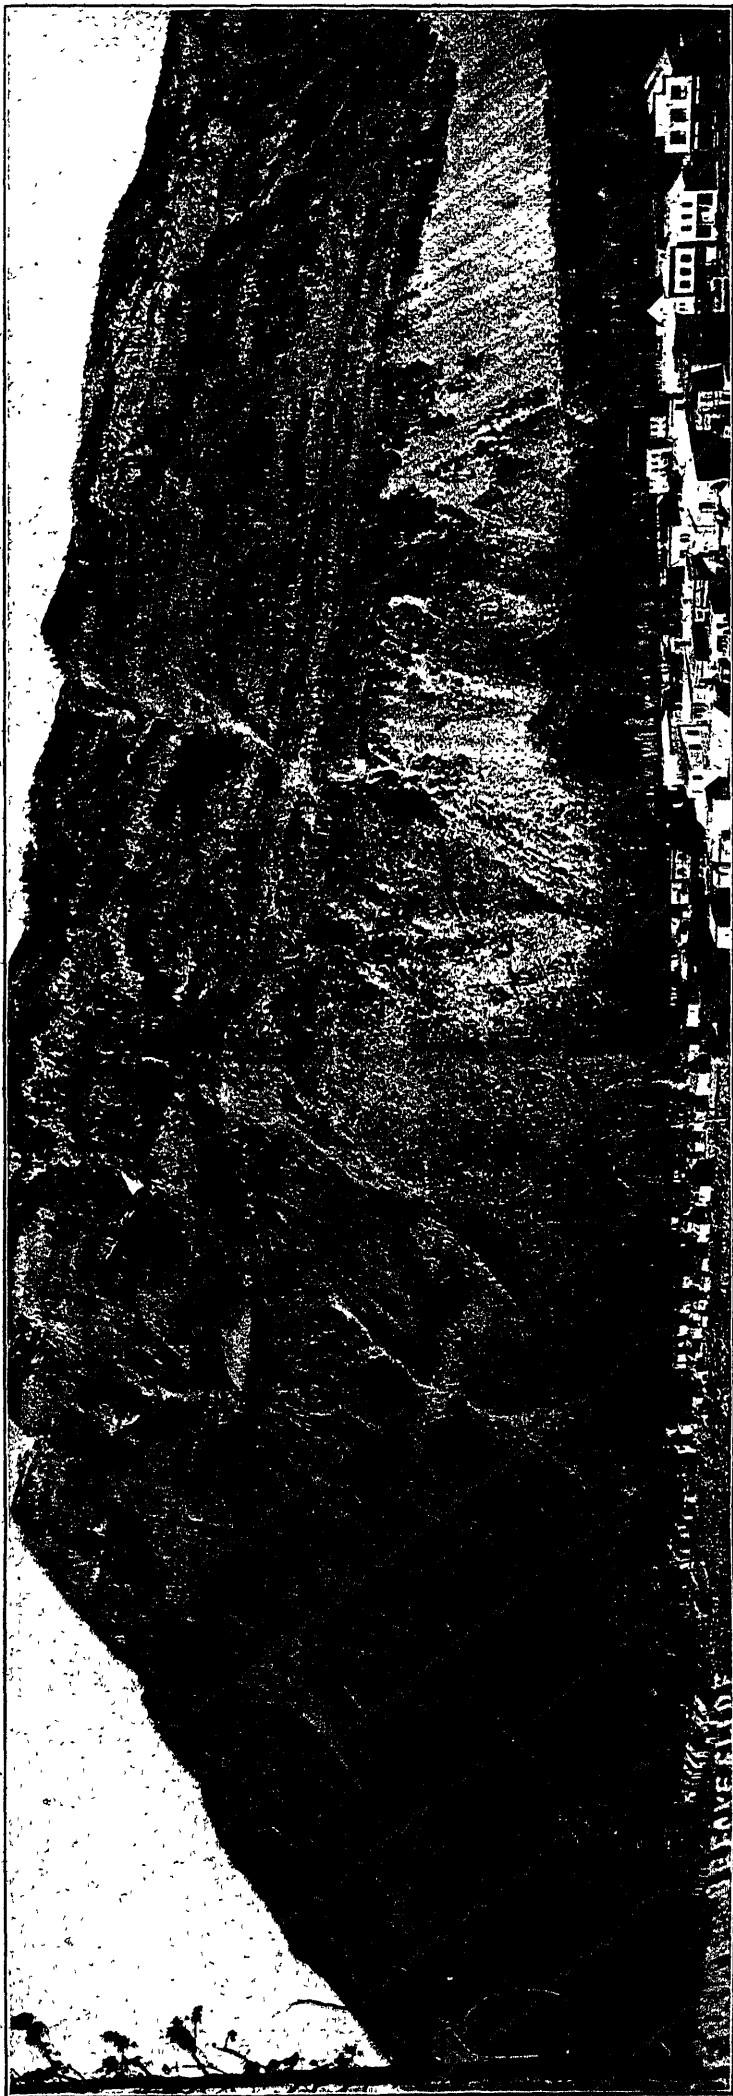
View of Turtle mountain before the slide of 1908, taken from the bluff two hundred yards east of the railway station.

The comparison of these photographs has corroborated your Commission's opinion that, so far as steepness of slope alone is concerned, the large block culminating in North peak is nearly or quite as liable to fall as was the rock prism which actually fell in 1903.

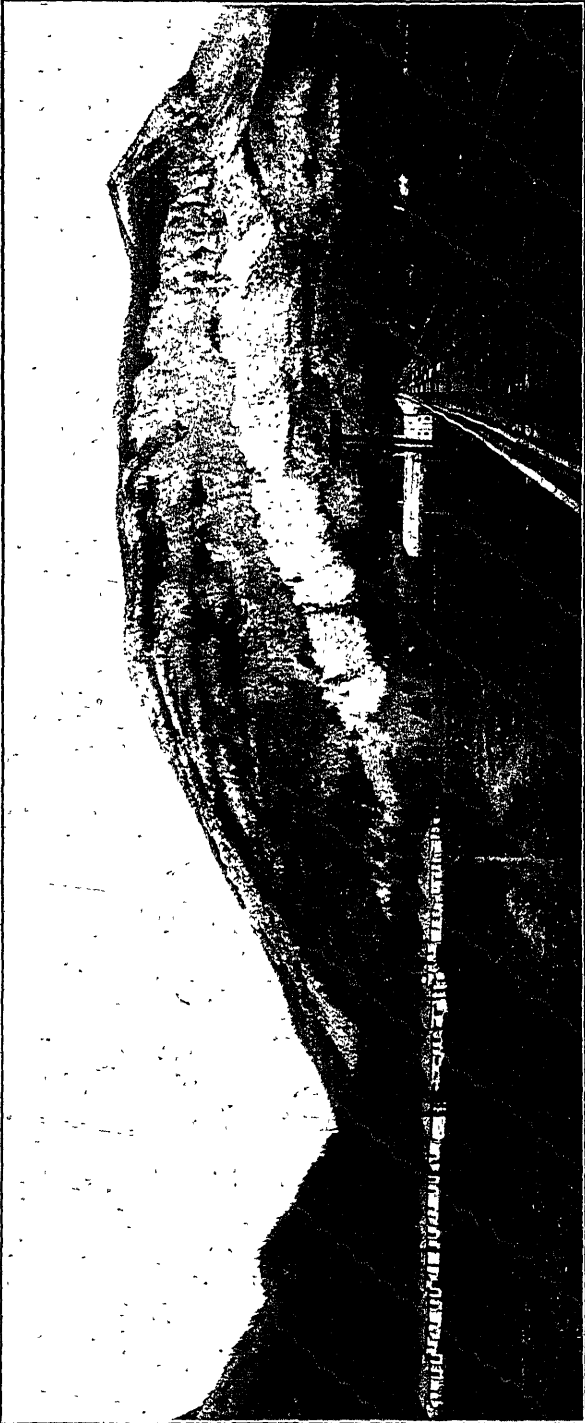
View of Bluff (Goat) mountain looking northward from the tippie. The great cliff is composed of Carboniferous limestone. The smooth, darker slopes on the right of the picture are underlain by the Cretaceous coal measures. The plane of overthrust is beneath the talus slope.
